UNITED STATES ENVIRONMENTAL PROTECTION AGENCY

Official Photograph Log

Location: 1702 Haldeman Road **City/County:** Artesia **State:** New Mexico

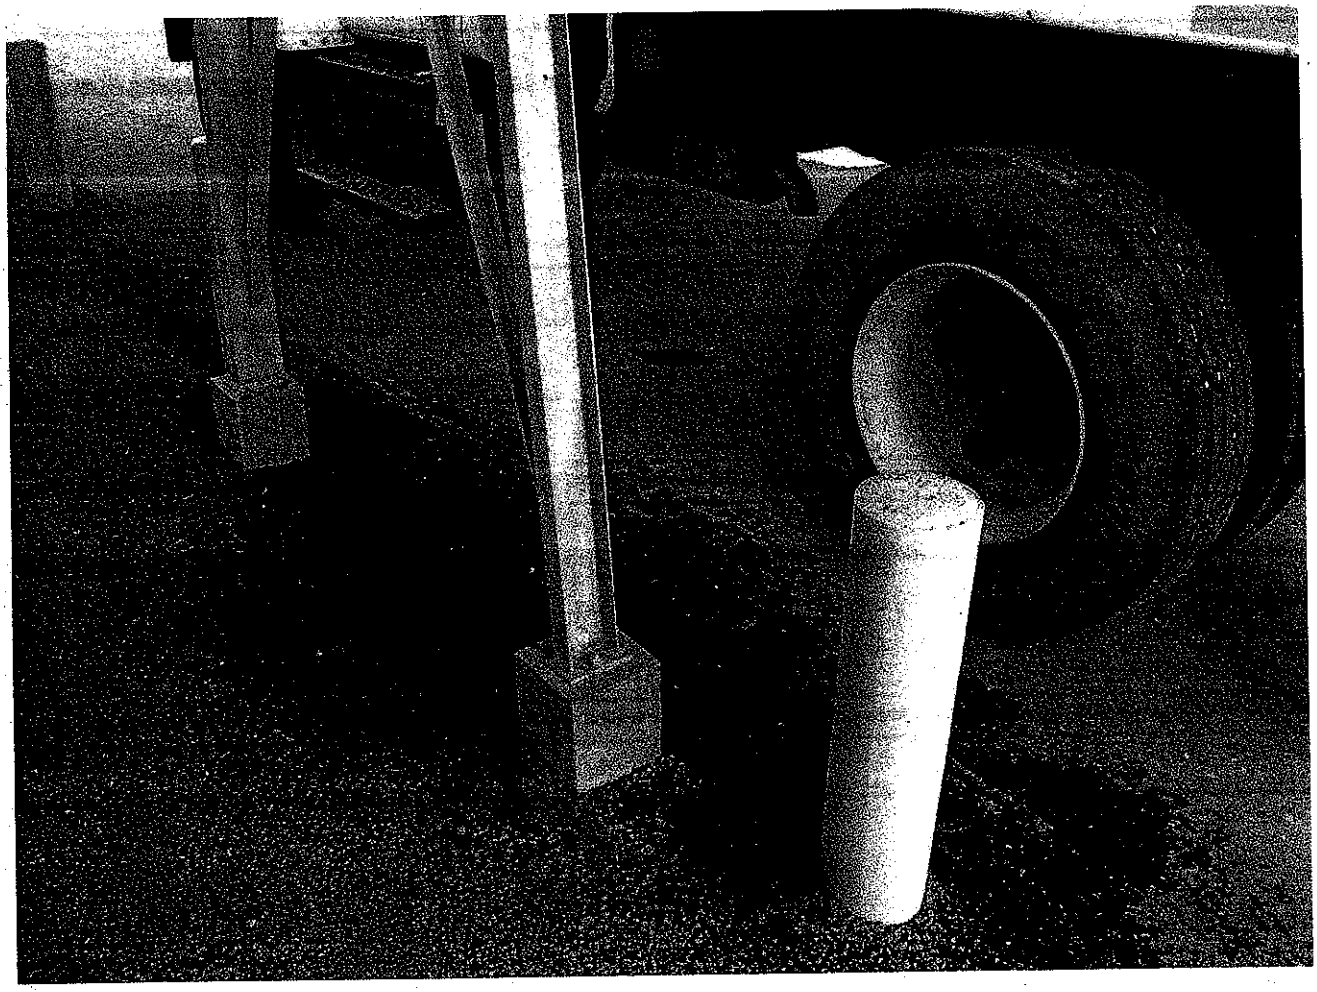
Photo: 17 of 22

Subject: Staff failed to clean residue from the belt press/truck transfer station. Residue was located on the ground.

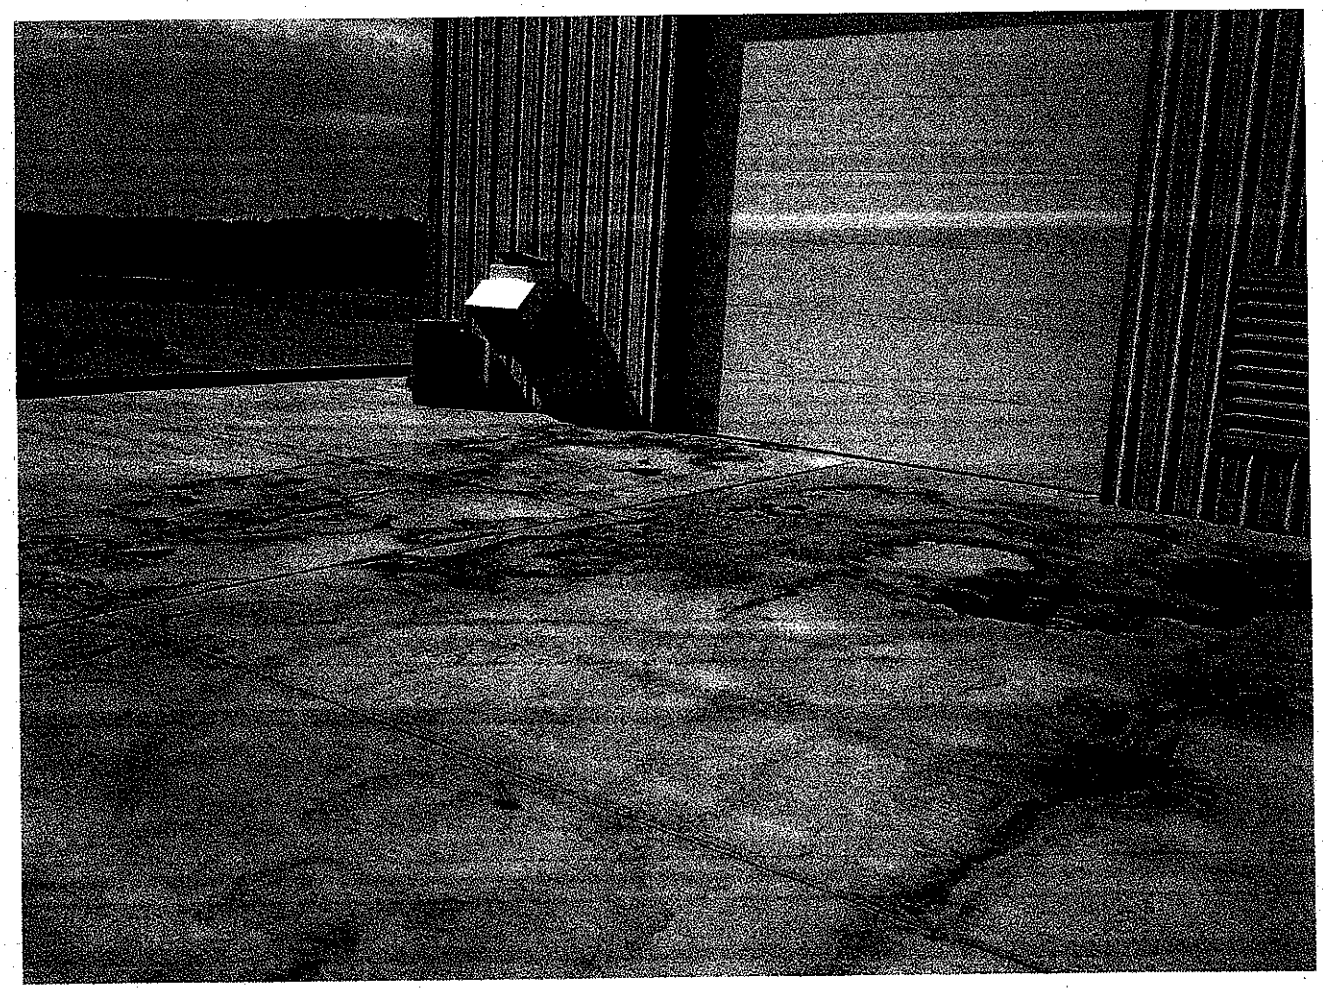
Photo: 18 of 22

Subject: Staff failed to clean residue from the belt press. Residue was located on the ground.

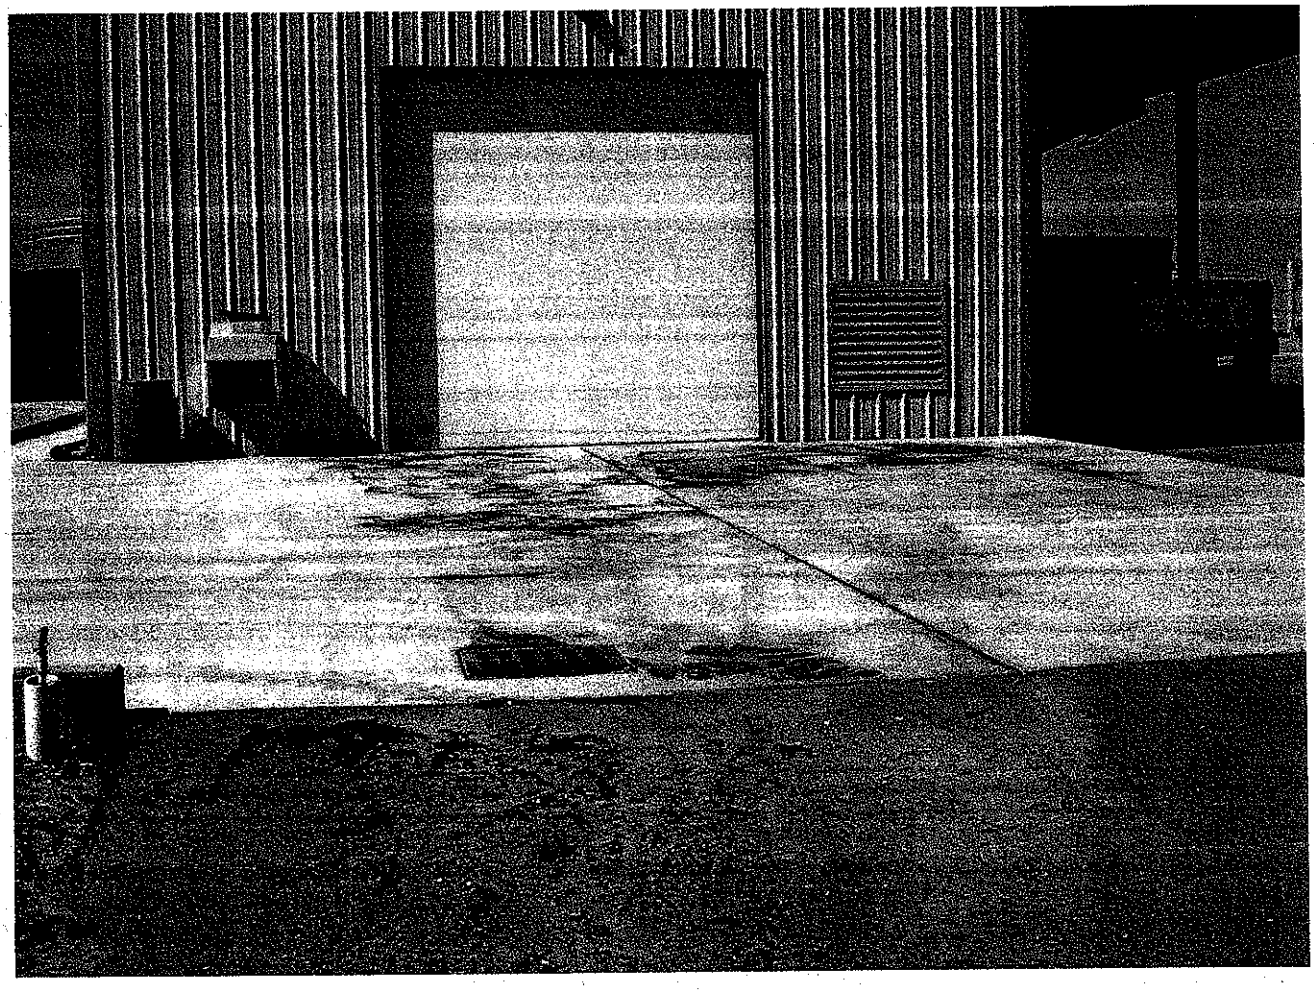
Official Photograph Log
Photo: 19 of 22

Subject: Staff failed to clean residue from the belt press. Residue was located on the ground.

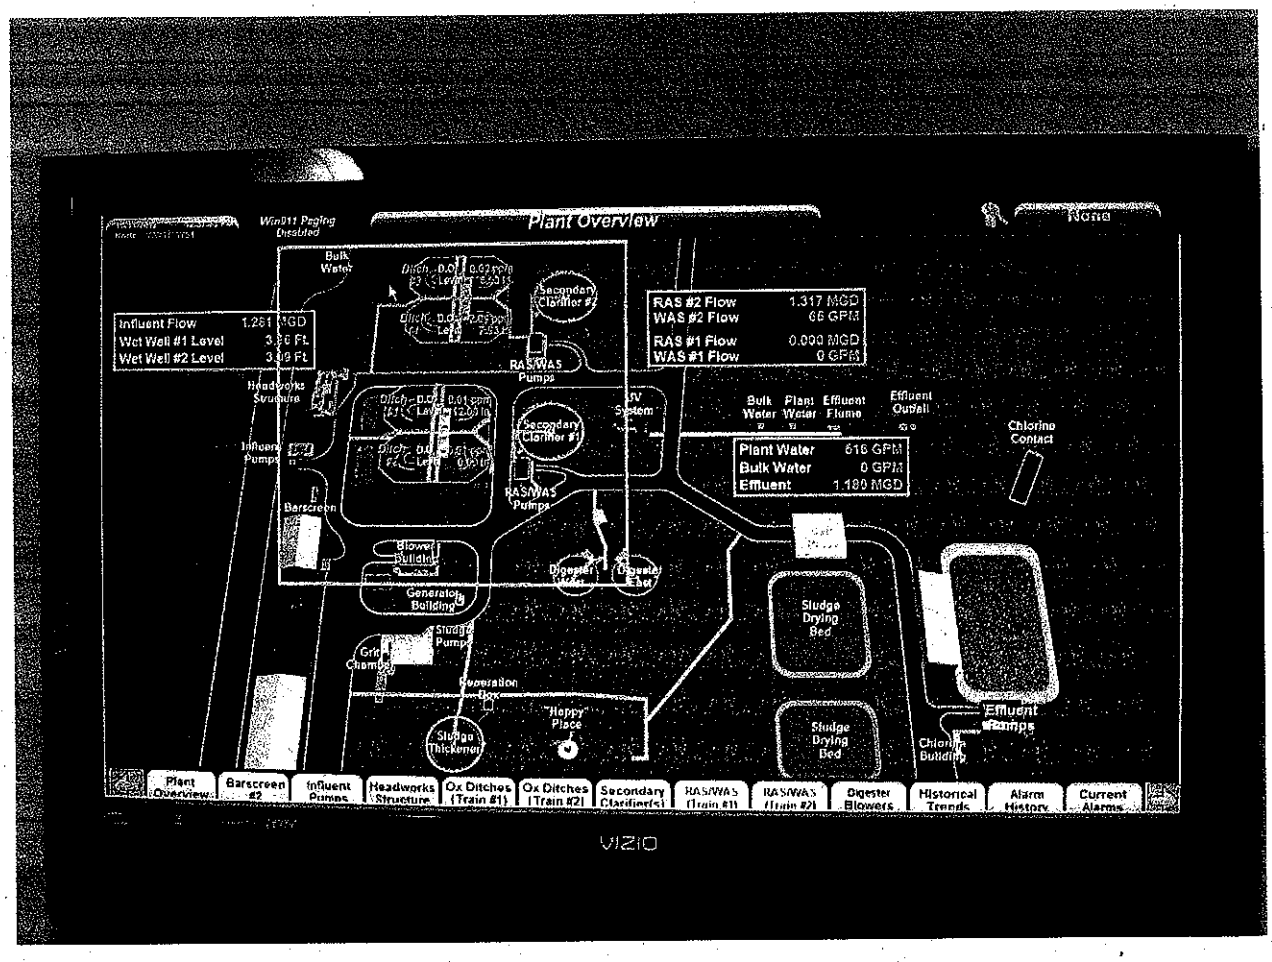
Photo: 20 of 22

Subject: SCADA – Wastewater Treatment Plant Overview.

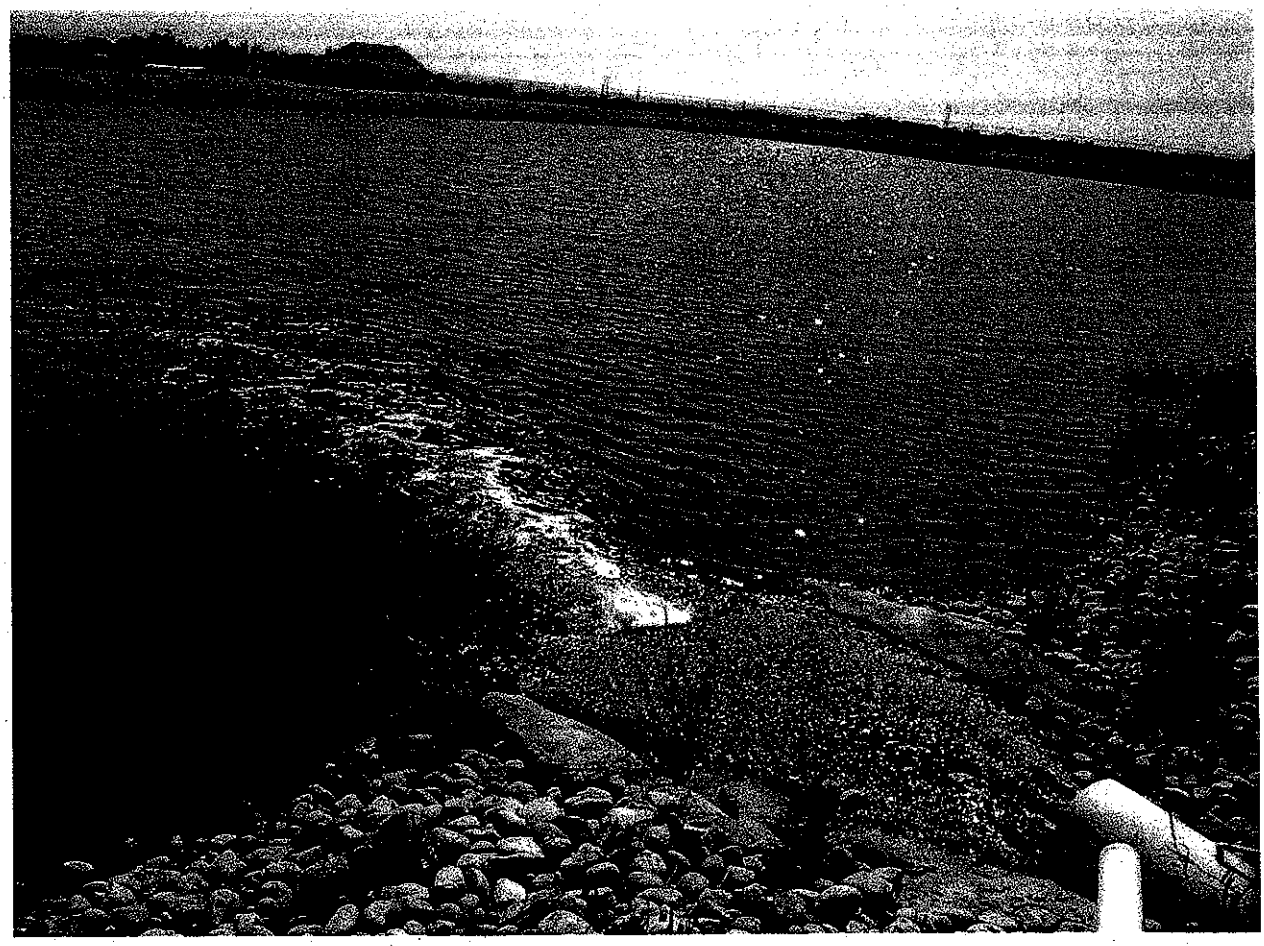
Subject: Discharge to retention lagoon.
