OFFICIAL PHOTOGRAPHIC LOG

Clean Harbors El Dorado
Inspection Conducted on:
November 1 through November 4, 2011*

Facility: Clean Harbors ED
309 American Circle
El Dorado, AR 71730

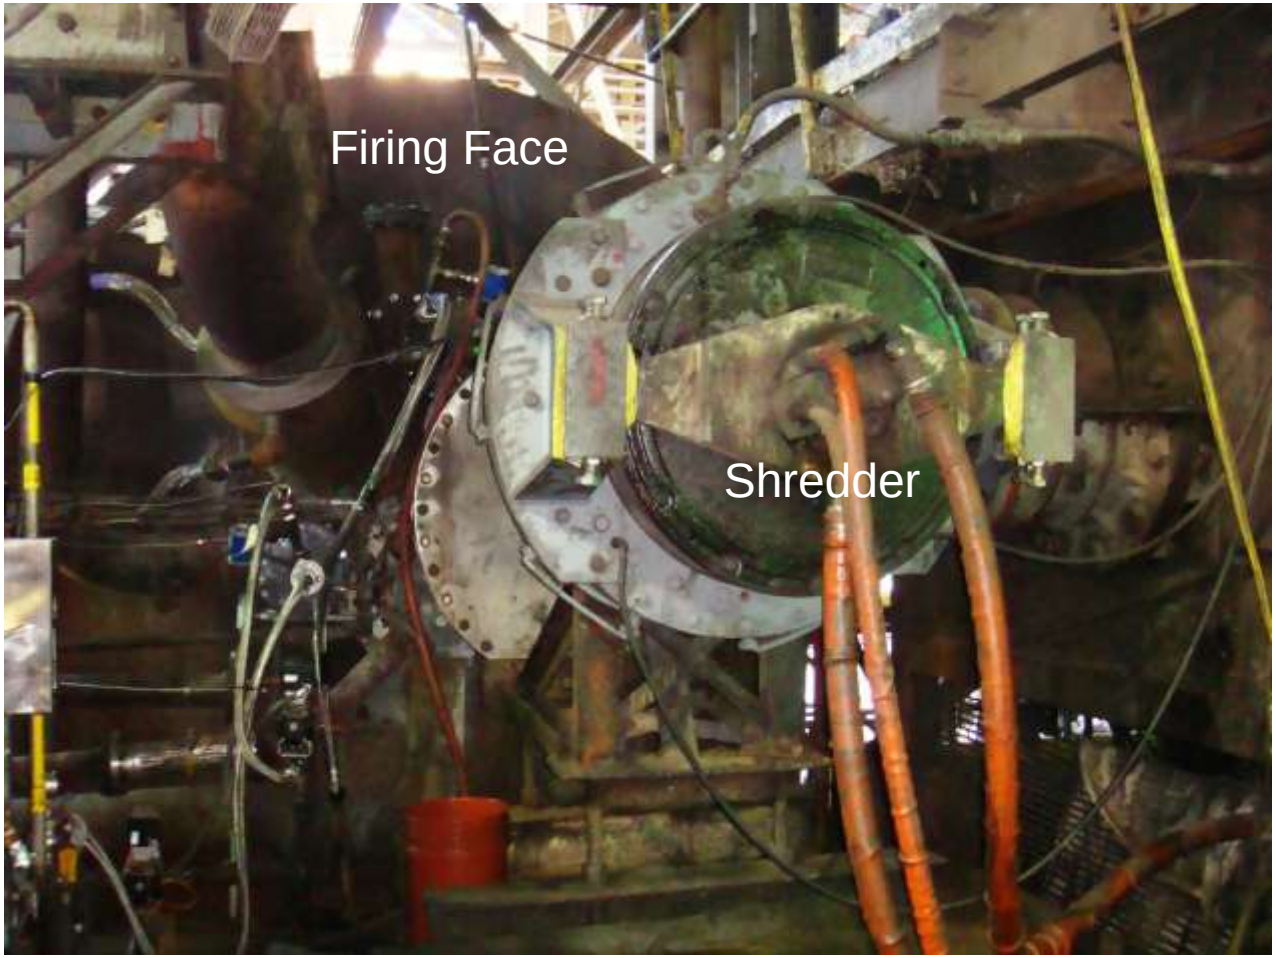
Photo # 10

Kiln 1 firing face and shredder unit.

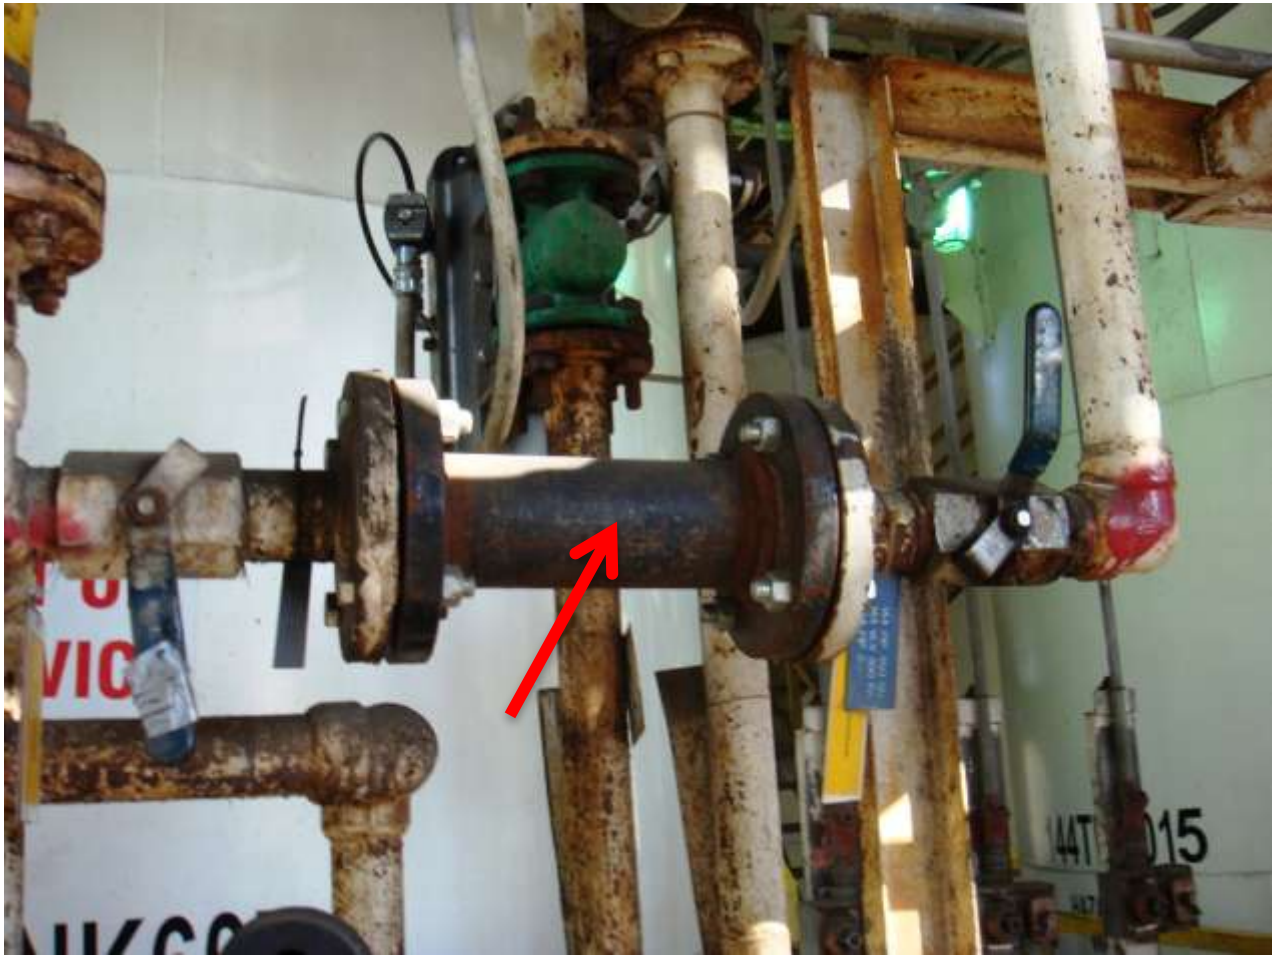
Photo # 14

A block placed where a grinder was previously located during an inspection in 2009. The block was placed to address air compliance (BB) concerns.

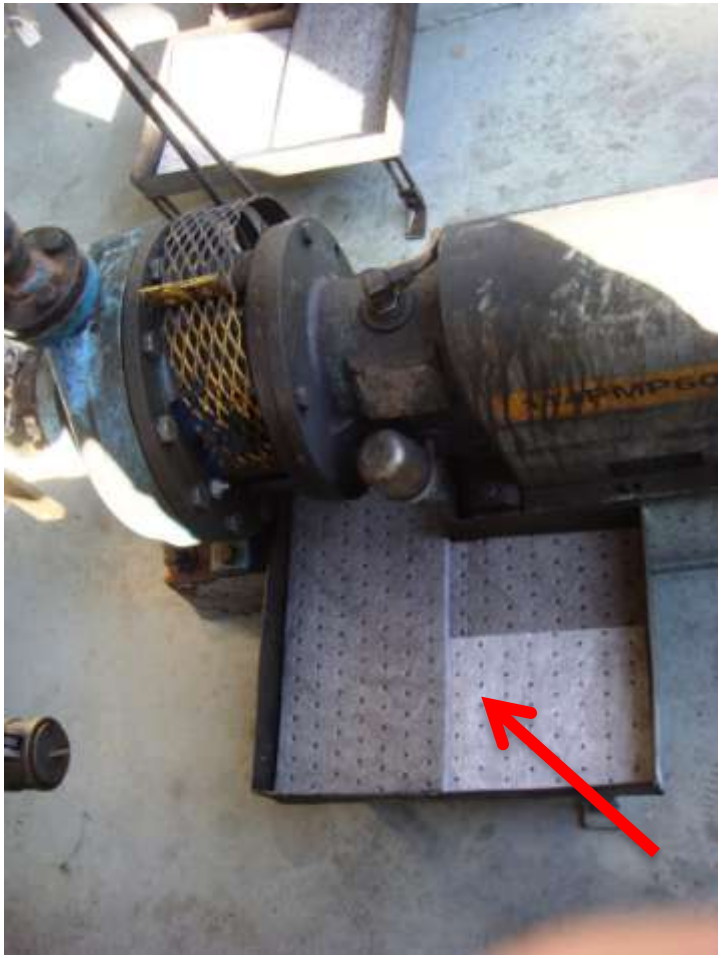
Photo # 19

Specially constructed secondary containment drip units to catch maintenance oil leaks from pump units.

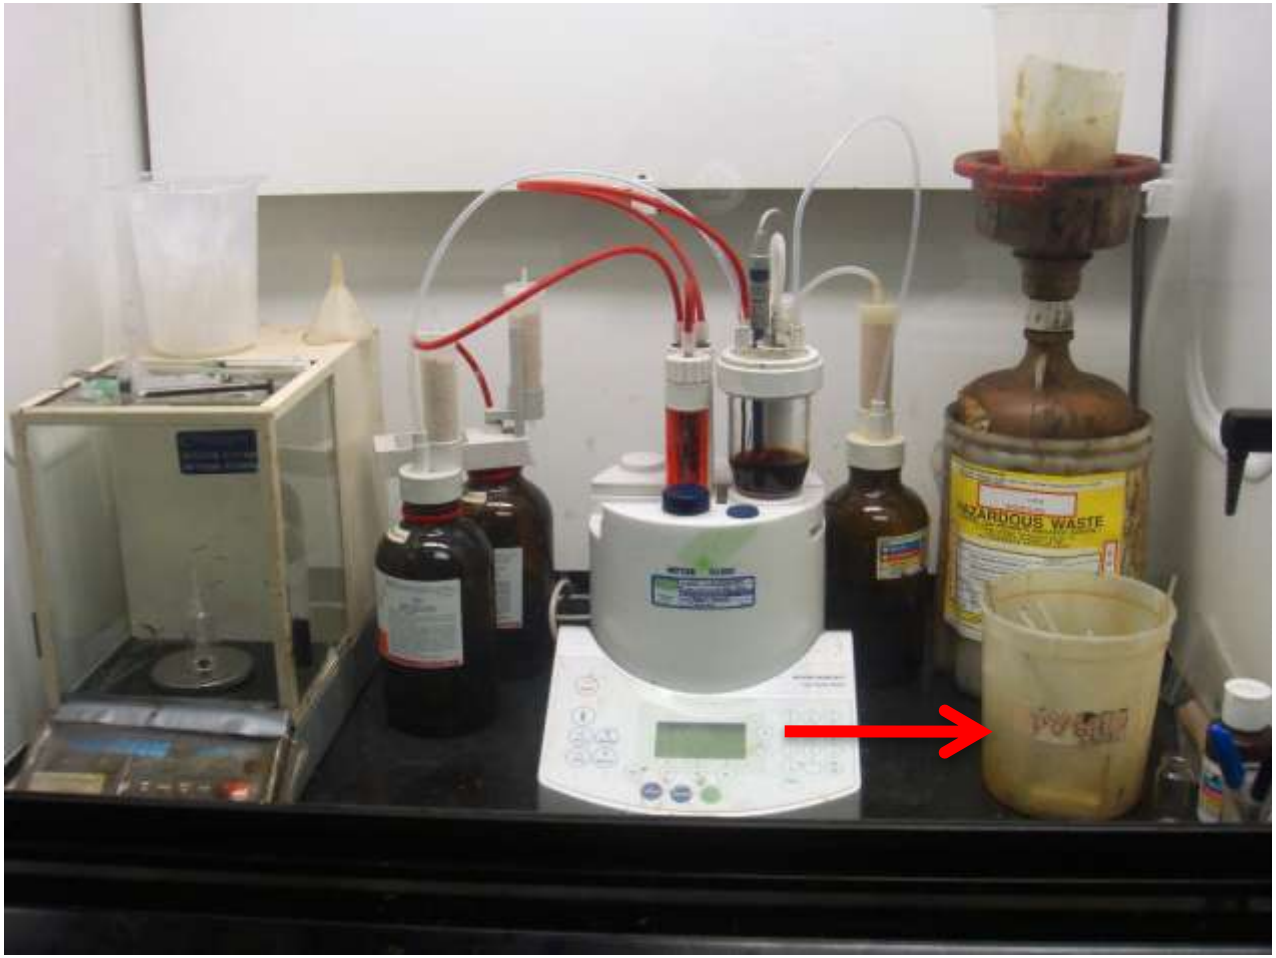
Photo # 21

A container under a laboratory vent hood without a label. Contents of container were self enclosed units, so the container did not require a lid.

A container under a laboratory vent hood with label, correction from Photo 21. Contents of container were self enclosed units, so the container did not require a lid.
