NPDES Compliance Inspection Report

Texas Co...nission on Environm...tal Quality
Investigation Report
FORMOSA PLASTICS CORPORATION TEXAS
CN600130017

Investigation # 400202

Investigation Type : Compliance Investigation

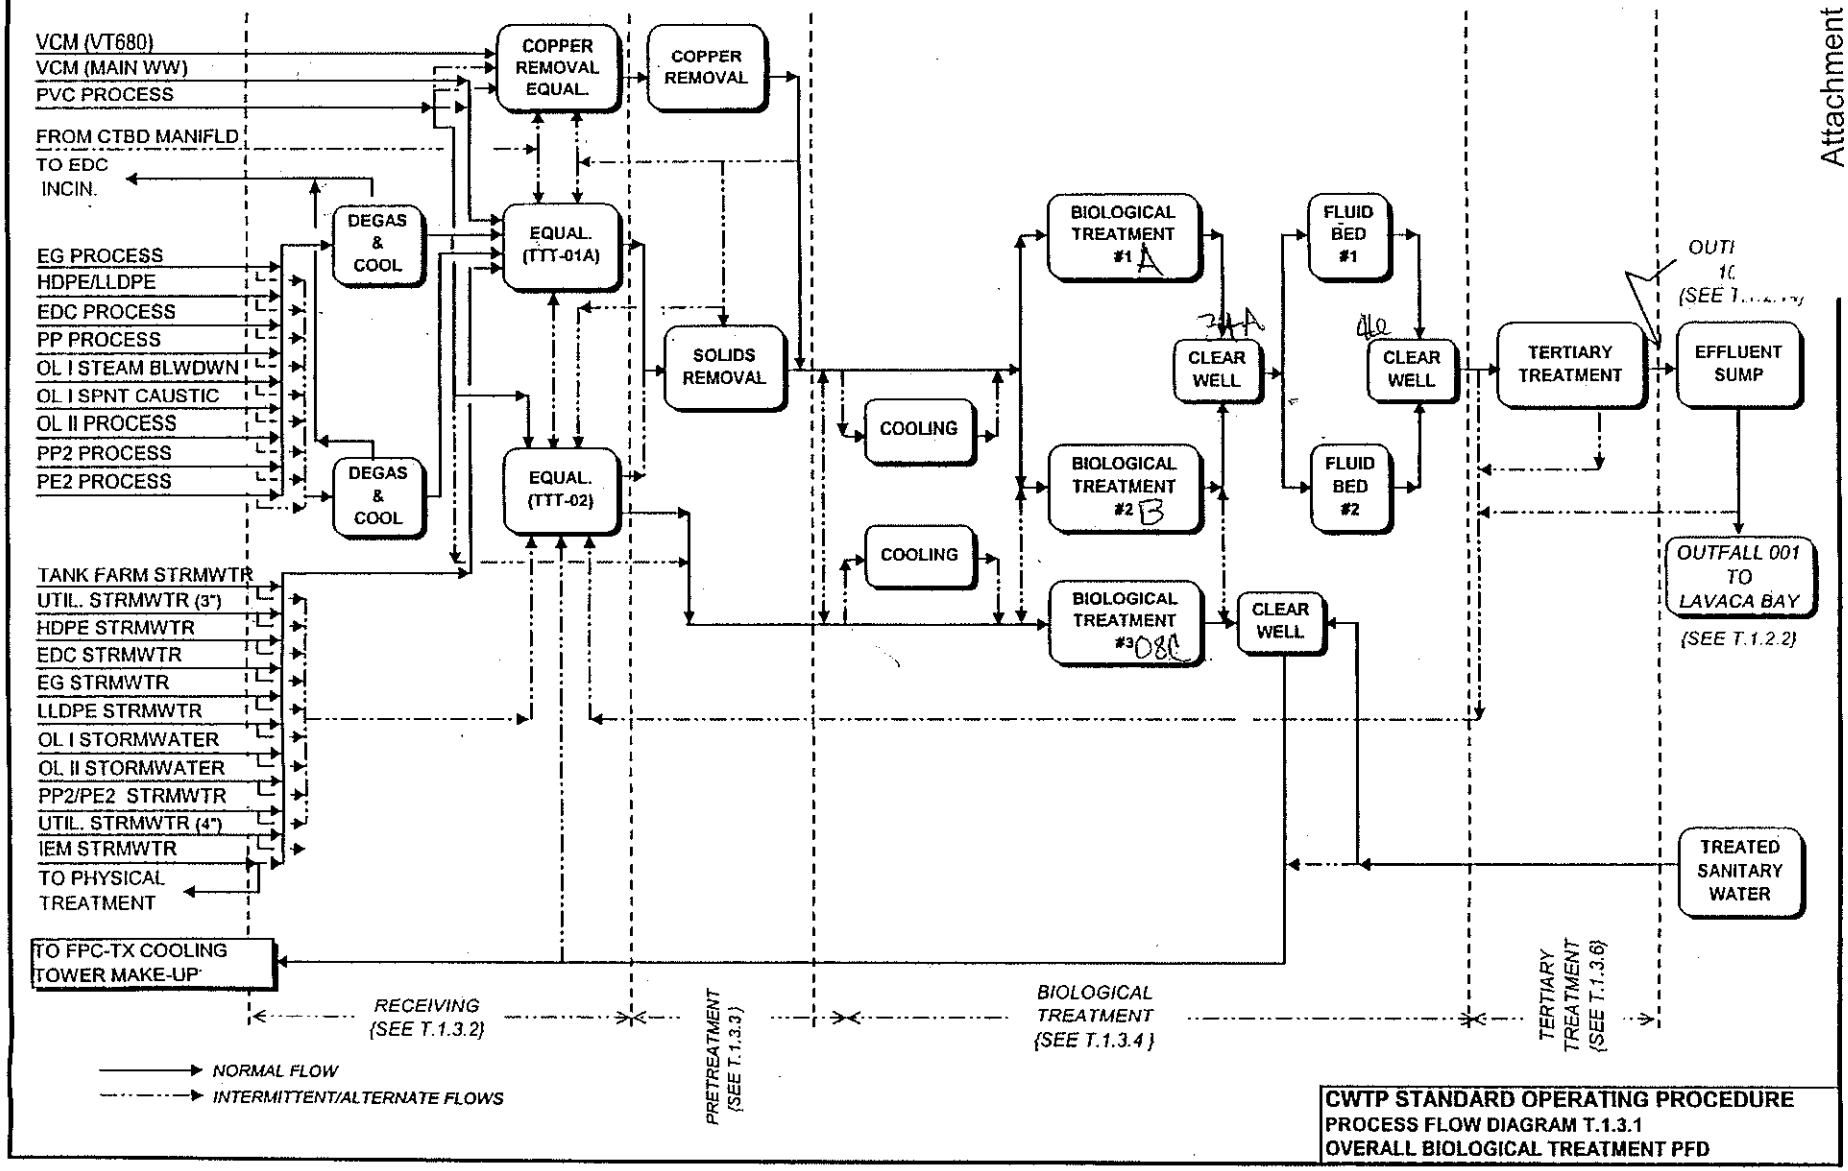
CWTP STANDARD OPERATING PROCEDURE
PROCESS FLOW DIAGRAM T.1.3.1
OVERALL BIOLOGICAL TREATMENT PFD

Effluent from Outfall 101 consists of process wastewater, storm water, and utility wastewater treated in two of the biological trains (A and B trains) of the CWTP. Effluent from Outfall 201 consists of utility and IEM wastewater streams treated in the physical treatment train of the CWTP. Treated domestic wastewater and treated process PVC wastewater from one of the biological trains (C-train) are recycled for use as cooling tower make-up water. Schematics of the biological treatment process and the physical treatment process are provided in this report in Attachments 3 and 4, respectively.
