INSPECTION REPORT

REPORT DATE: 1/22/2013 **INCIDENT NO:** 1162013-1

LOCATION: Flatonia, TX 78941
COUNTY: Bastrop County, Texas

MATERIAL SPILL: Brine/Oil
OWNER/OPERATOR: Warrior Resources INC. BARINA
Box 953
Mexia, TX 76667
SURFACE OWNER: Jay Absher.
PHONE: 432-940-1014

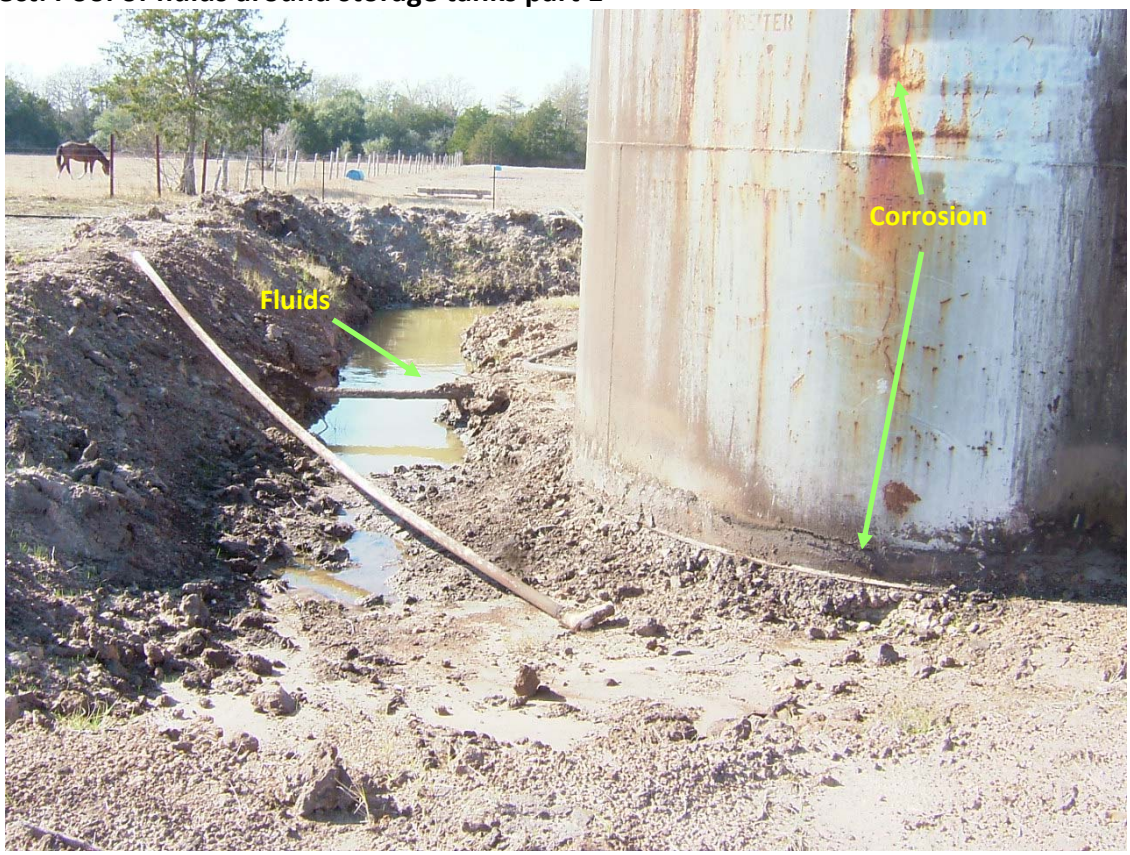
Warrior Resources INC. Barina Photo 3

Photo #3. **Facing North from Buckner's Creek. Observed accumulation of fluids around tanks. Fluids showed a green coloration and some oil sheens.**

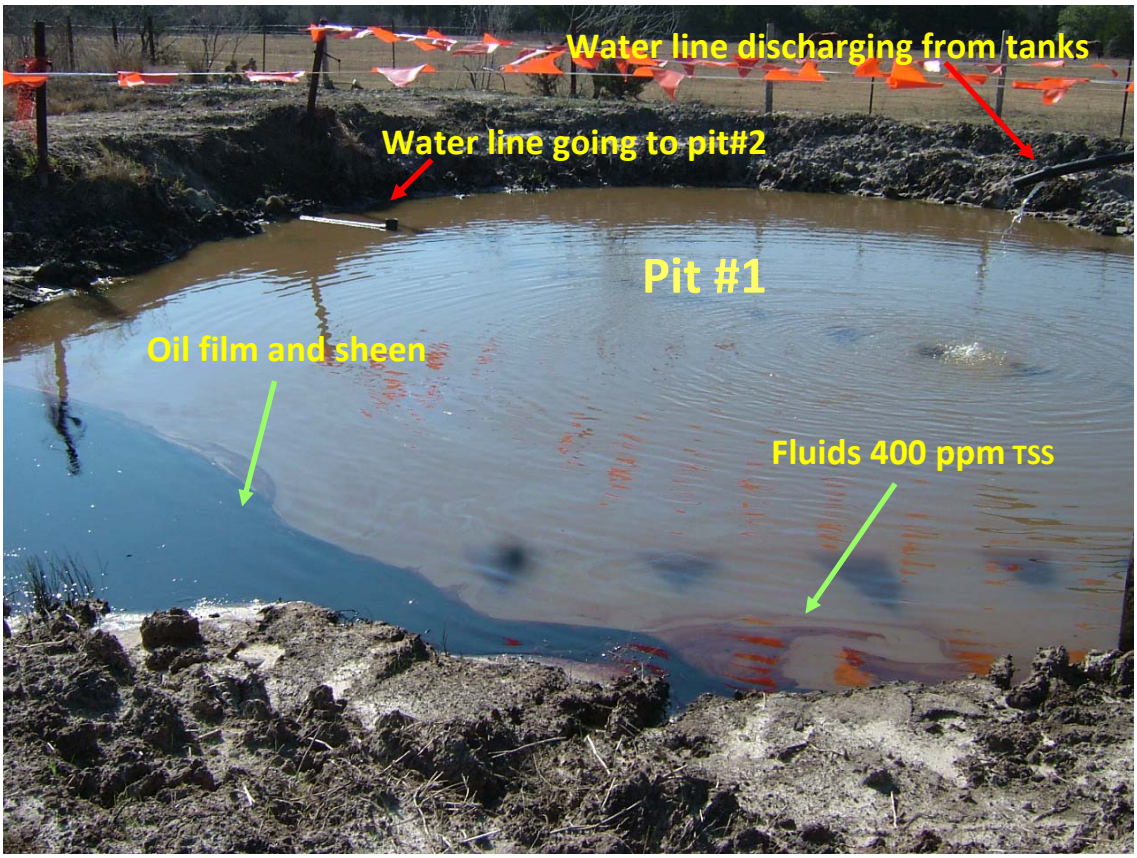
Warrior Resources INC. Barina Photo 7

Photo #7. **Facing southwest from storage tanks. Observed fluids (produced wastewater, oily film and sheen. Found a pipe line discharging in pit #1 and discharging out to pit #2.**

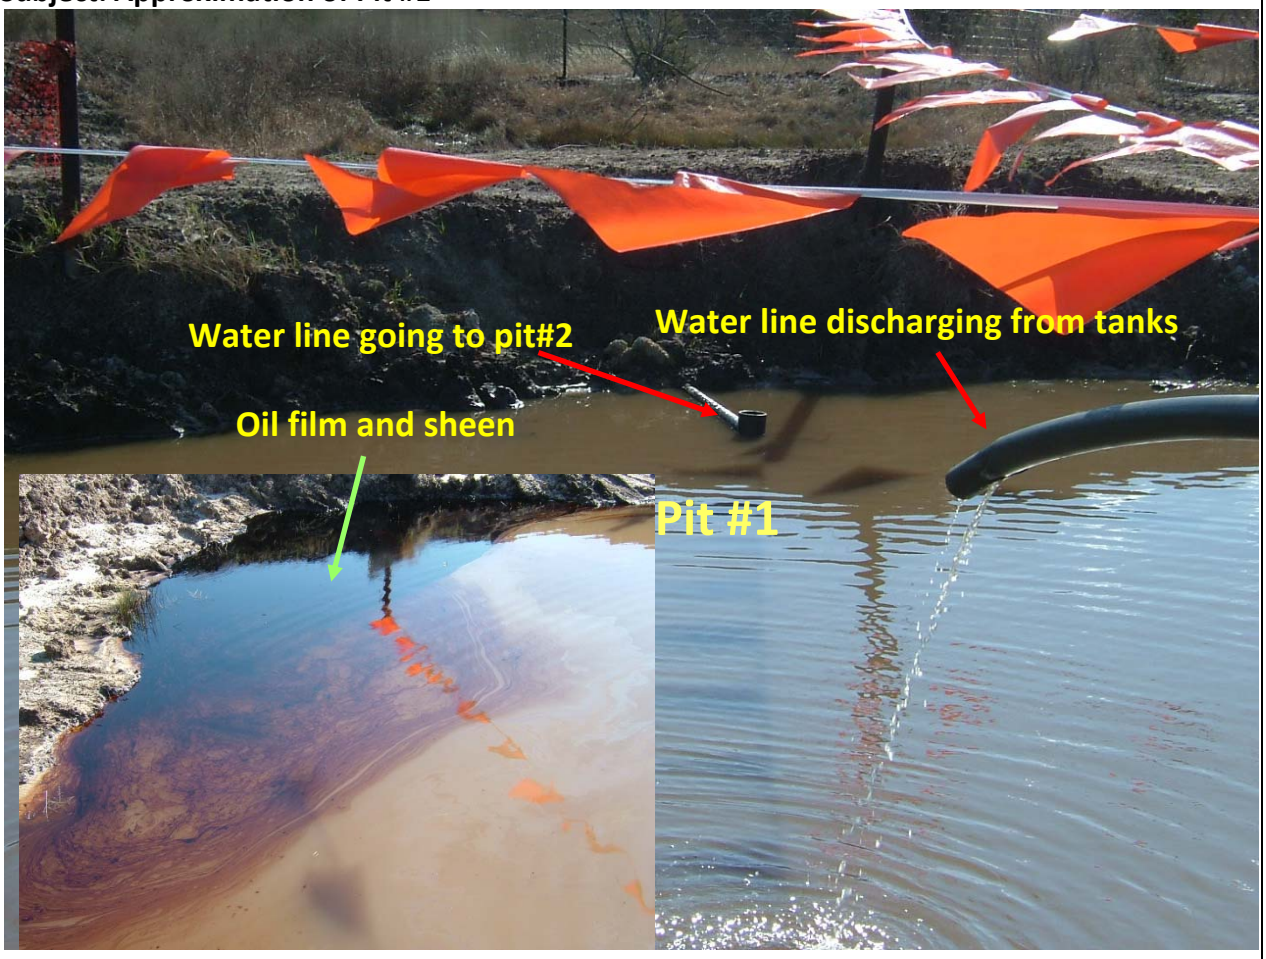
Warrior Resources INC. Barina Photo 8

Photo #8. Facing southwest from storage tanks. Observed fluids (produced wastewater, oily film and sheen. Found a pipe line discharging in the pit #1 and discharging out to pit #2.

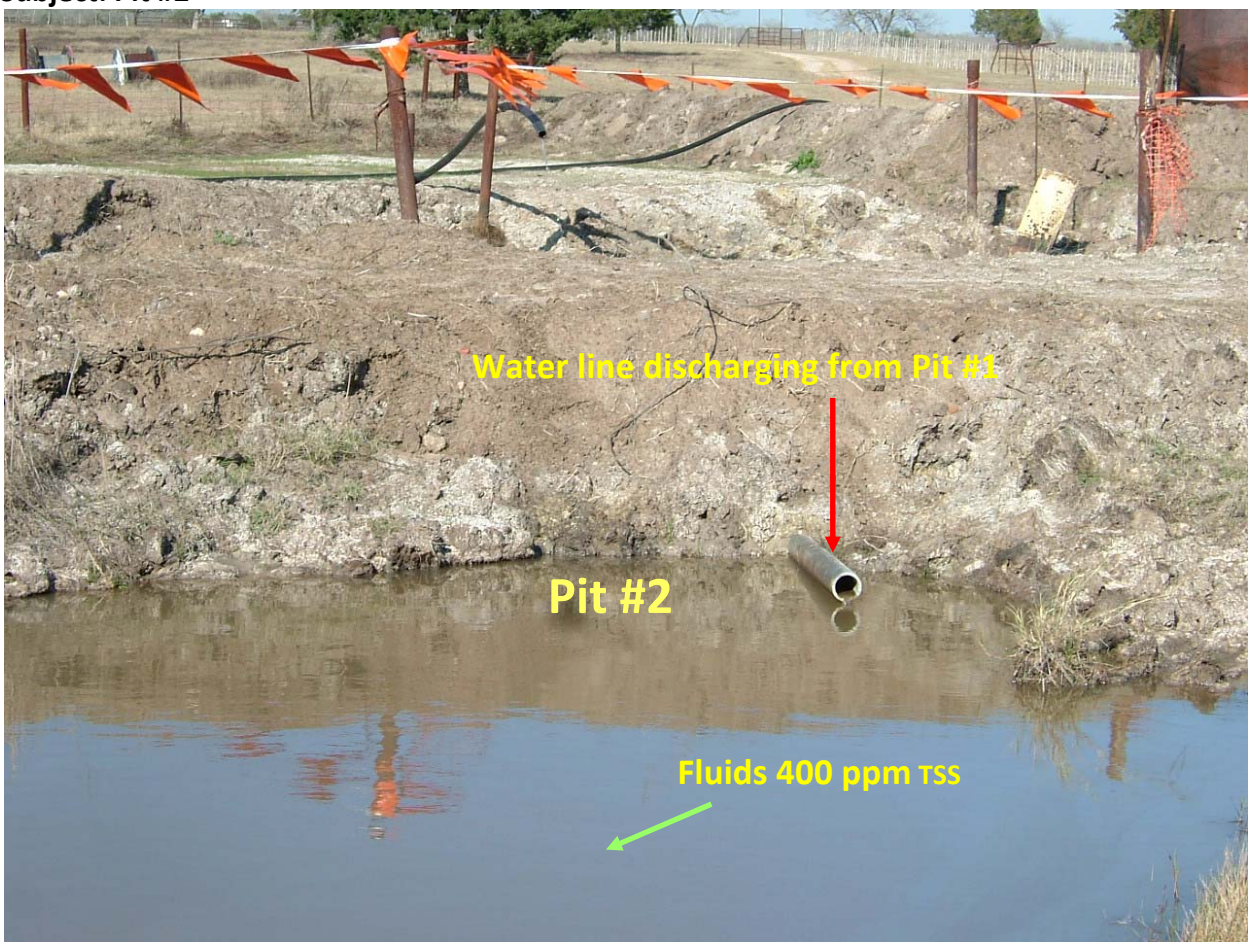
Warrior Resources INC. Barina Photo 9

Photo #9. Facing southwest from storage tanks. Observed fluids (produced wastewater, oily film and sheen. Found a pipe line (coming from pit #1) discharging inside pit #2.

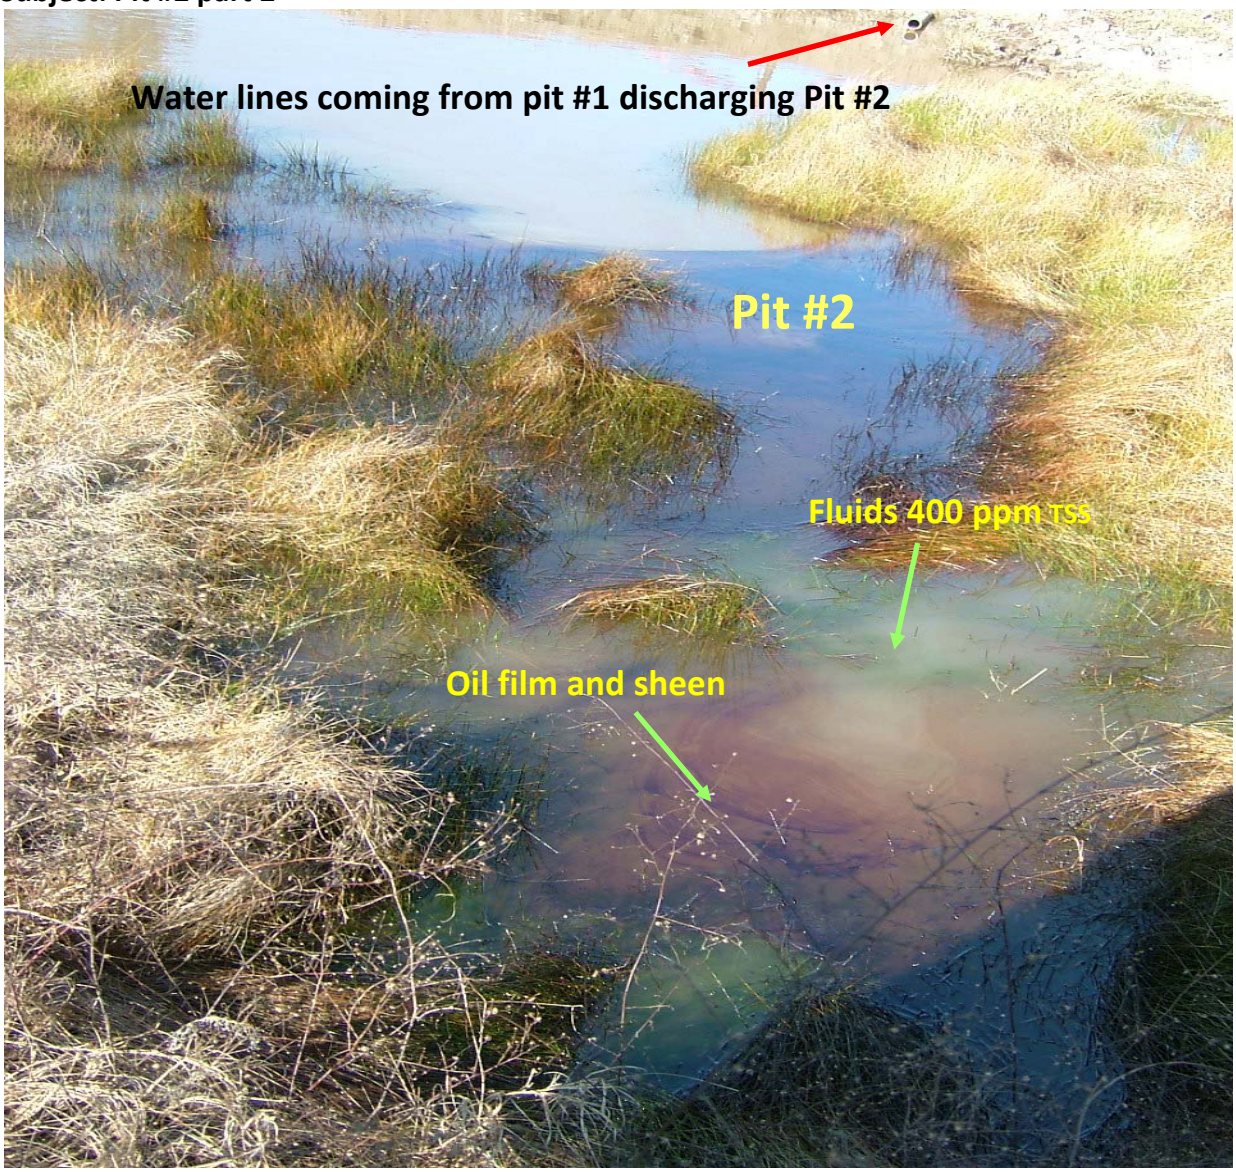
Warrior Resources INC. Barina Photo 10

Photo #10. **Facing southwest from storage tanks. Observed fluids (produced wastewater and oily film and sheen. Found a pipe line (coming from pit #1) discharging inside pit #2.** .

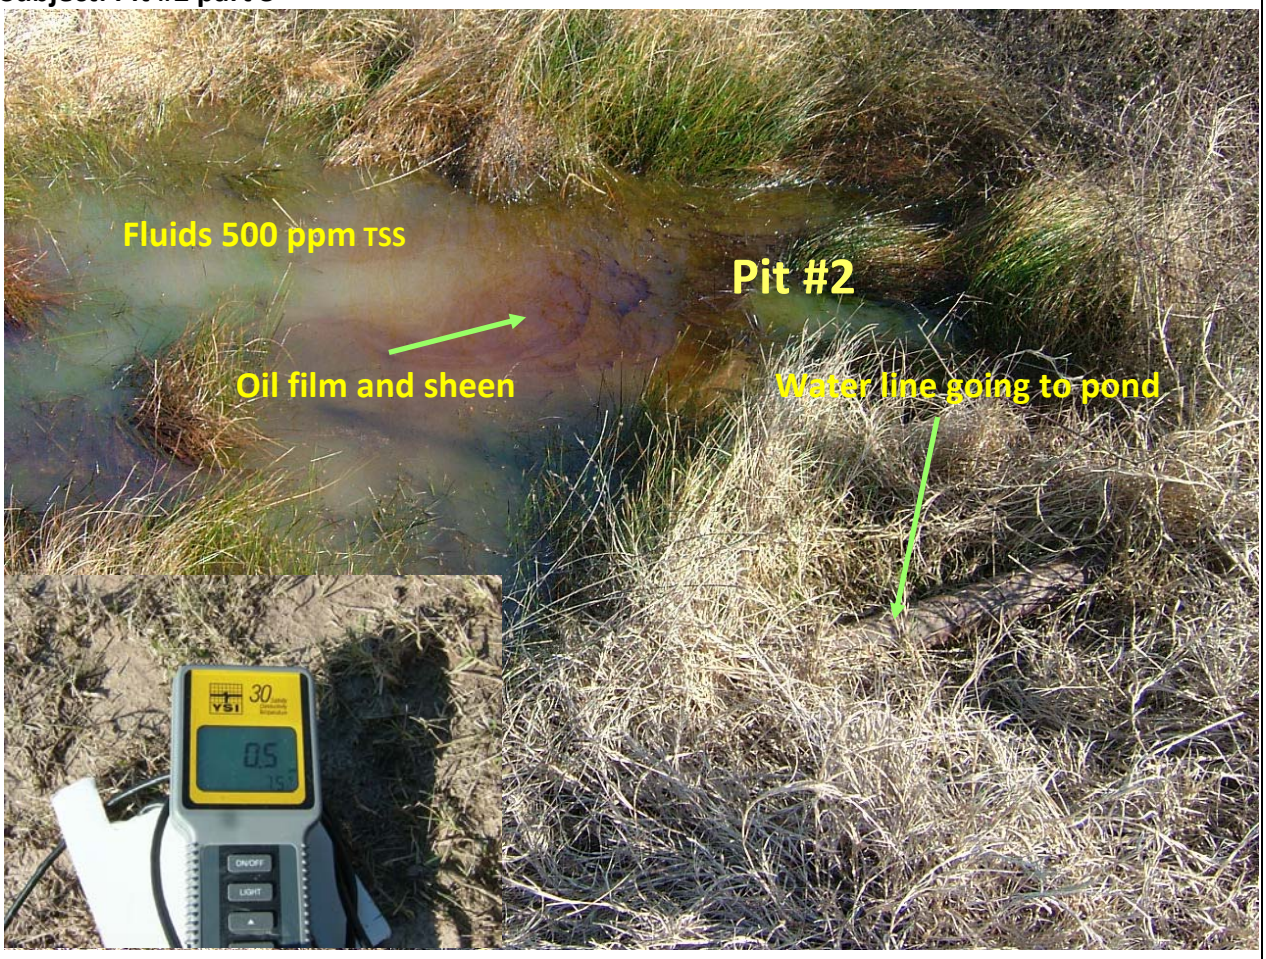
Warrior Resources INC. Barina Photo 11

Photo #11. **Facing southwest from storage tanks. Observed fluids (produced wastewater and oily film and sheen. Found a pipe line (coming from pit #2) discharging inside a pond. TSS was 500 ppm.**

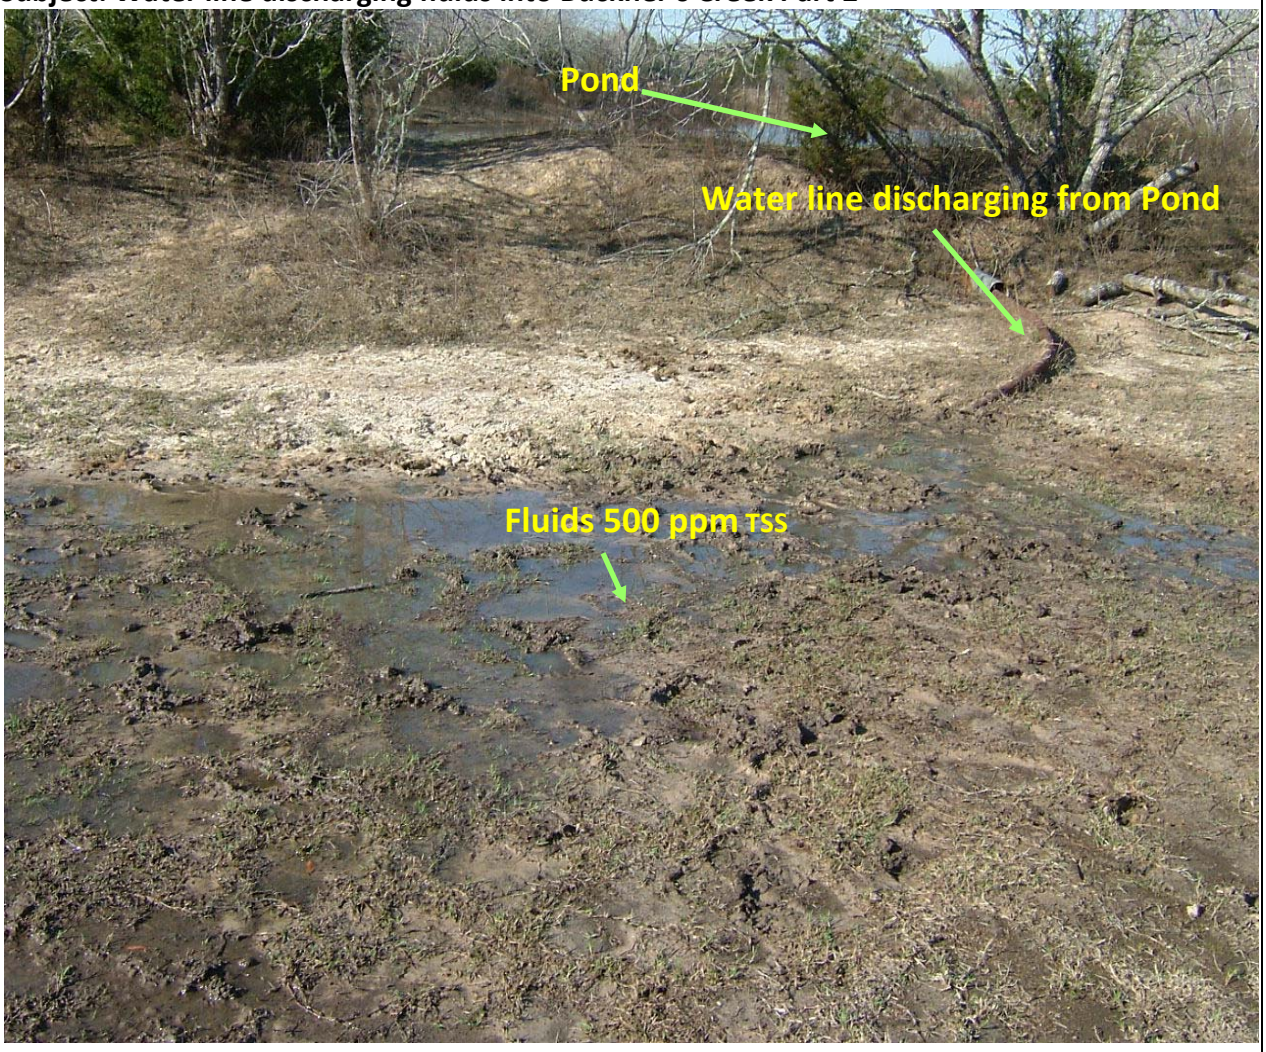
Warrior Resources INC. Barina Photo 14

Photo #14. Facing southwest from storage tanks. Observed an overflow flow path of fluids moving towards Buckner's Creek.
