INSPECTION REPORT

REPORT DATE: 9/20/2006 **INCIDENT NO:** 09192006-1

LOCATION: NW/4, Sec. 15, T 4S, 3W
COUNTY: Carter Co. OK
OWNER/OPERATOR: Citation Oil & Gas Corp.
8223 Willow Place South
Houston, TX 77070
281-517-7192

Citation Oil & Gas Corp.
NE-16-T3S-R4W Carter Co., OK
September 19, 2006

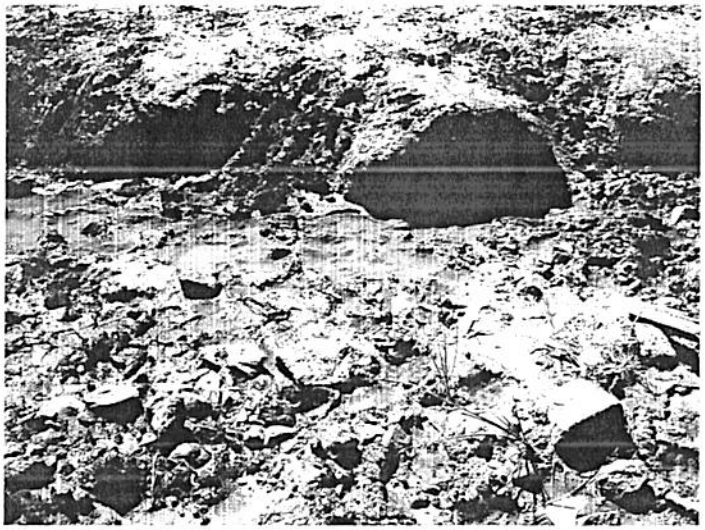
Photo 1. Taken west. Appears to be where fluids from the seep are entering into the tributary also point of entry where fluids from Pond 1's overflow pipe enters. Fluids here measured 7,200 ppm TSS.

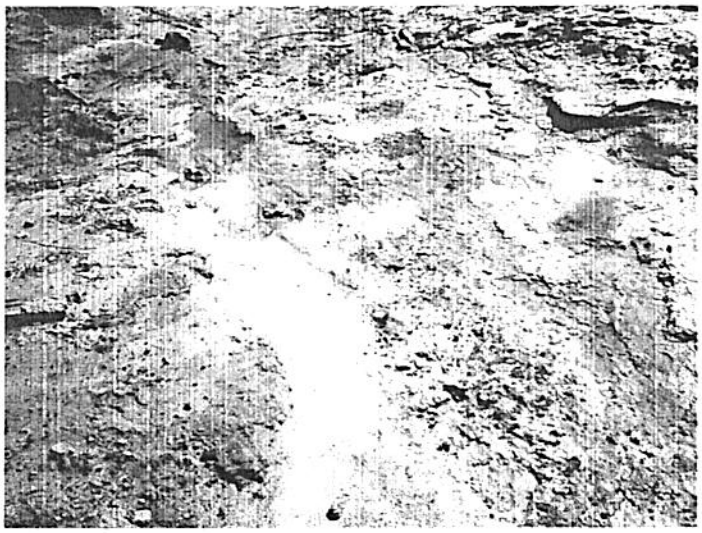
Photo 3. Taken south. Salt staining inside the tributary. Standing at 34 12.657N 97 30.621W.

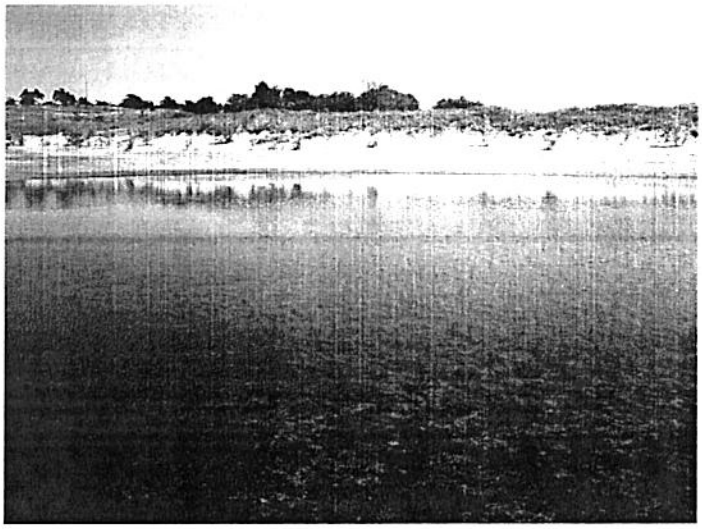
Photo 4. Taken east. Fluids located in Pond 1of the inspection report. Fluids in this pond measured 12,500 ppm TSS.

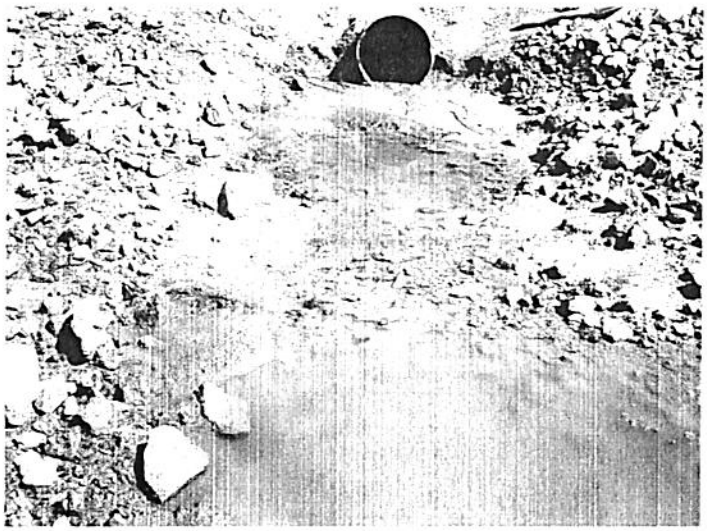
Photo 6. Taken east. Overflow pipe on west side of Pond 1. Standing at 34 12.731N 97 30.558W. Fluids pictured here measured 6,000 ppm TSS.

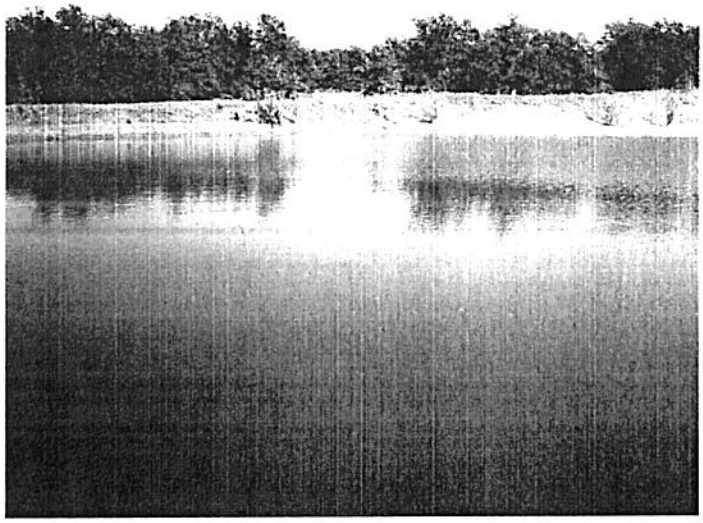
Photo 8. Taken east. Pond 2 of the inspection report. Fluids in this pond measured 1,500 ppm TSS.

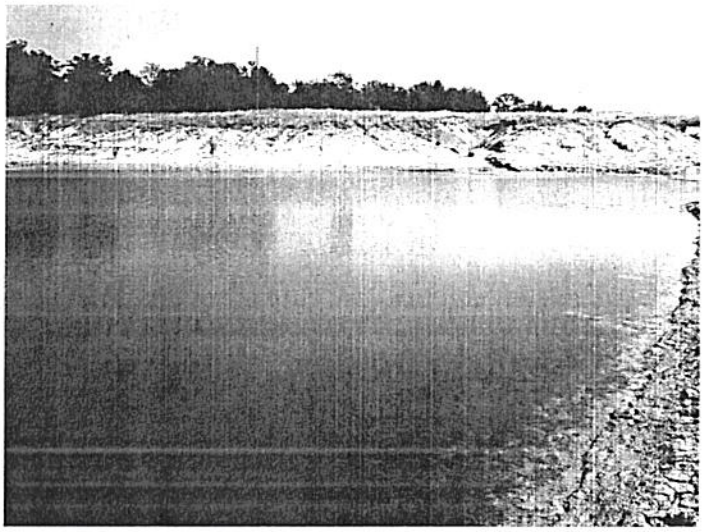
Photo 9. Taken south. Pond 2 of the inspection report.

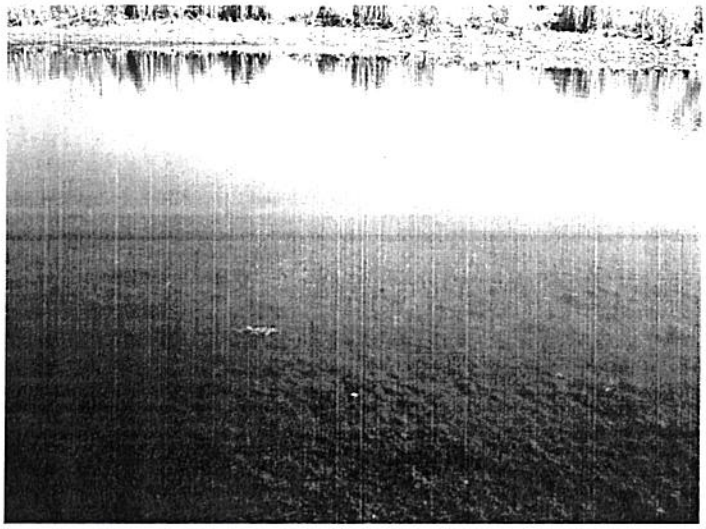
Photo 10. Taken east. Pond 3 of the inspection report. Fluids here measured 3,900 ppm TSS.

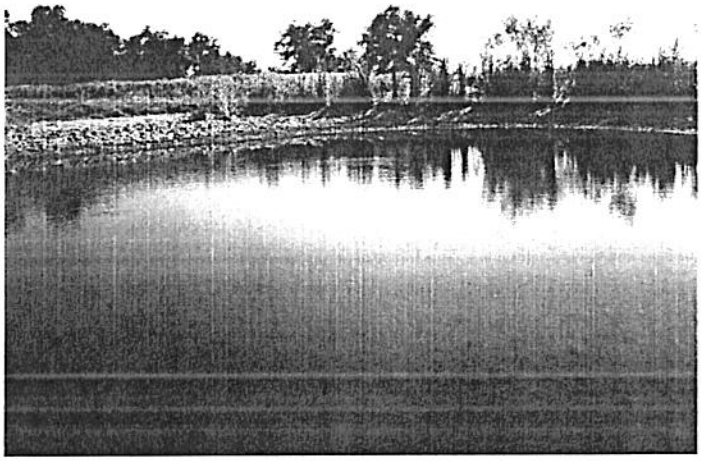
Photo 11. Taken south. Pond 3 of the inspection report.

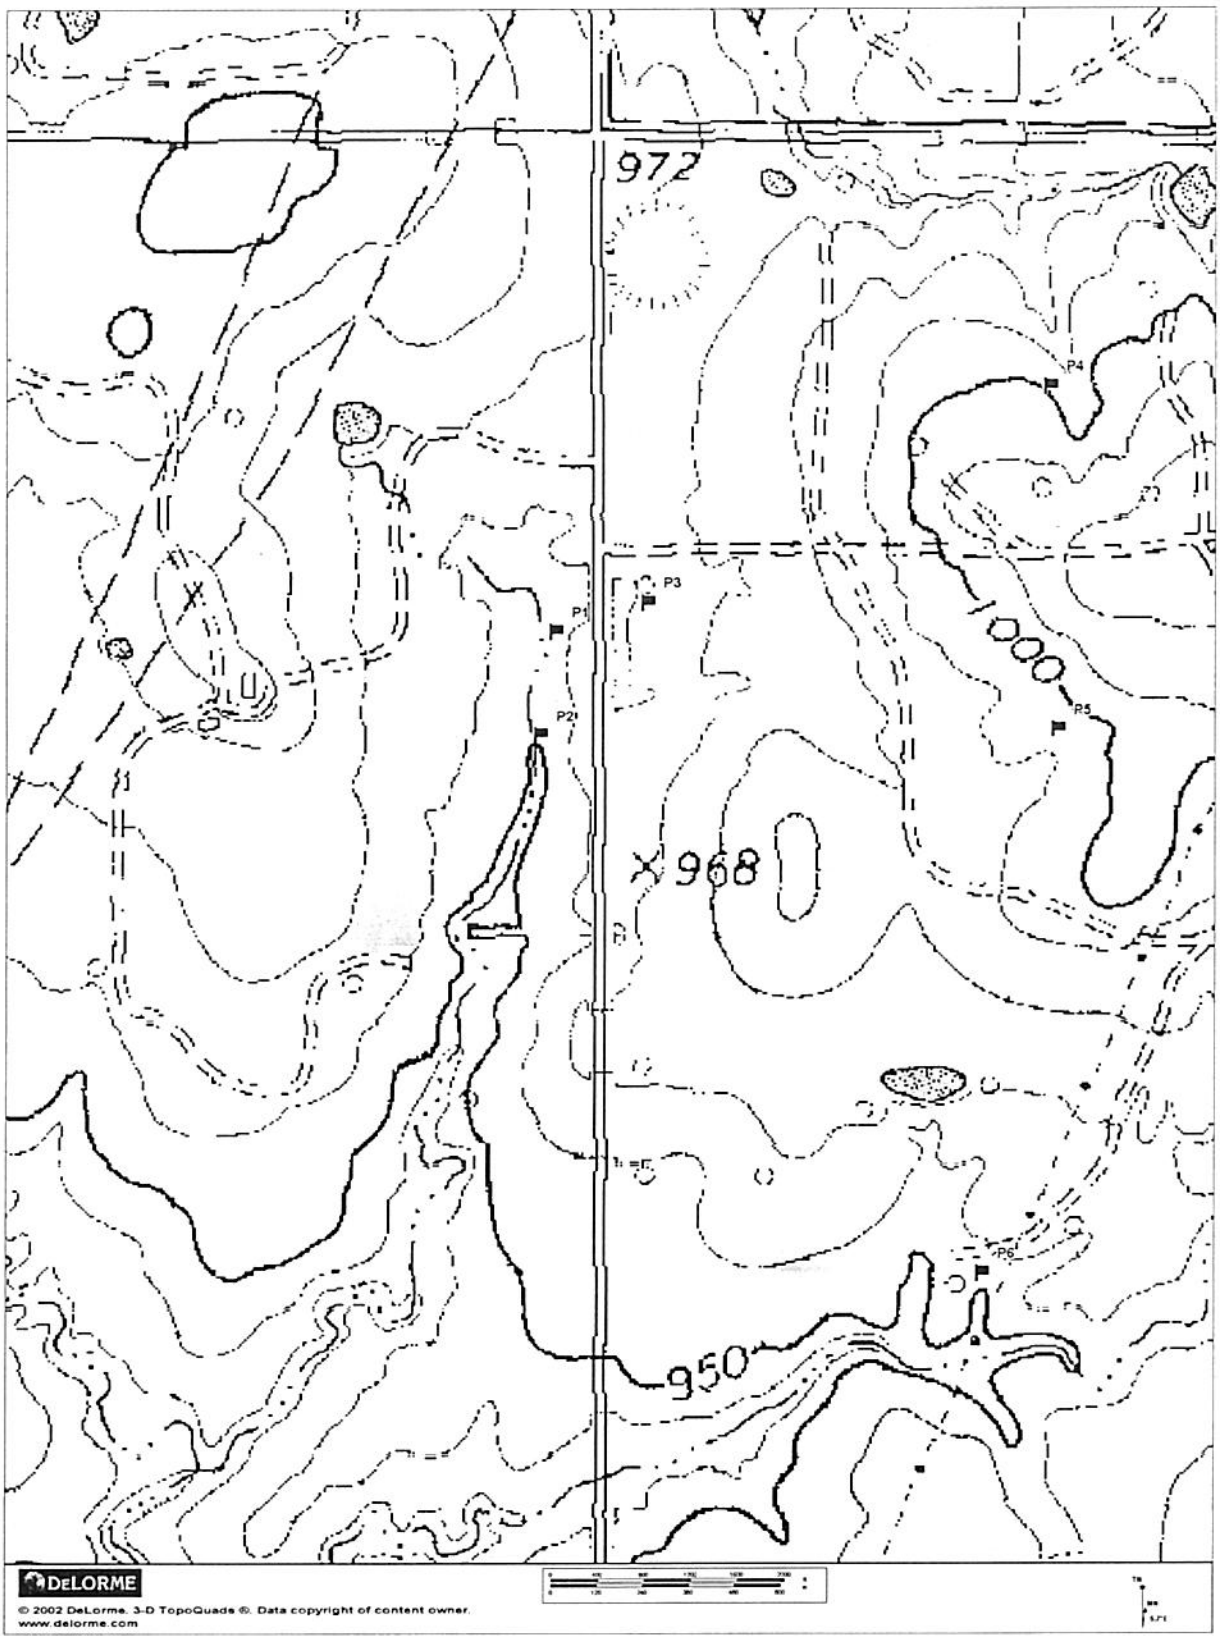
P1: This is where fluids were seeping into the tributary. Fluids here measured 7,200 ppm TSS.
P2: Inside the tributary approximately 360 ft downstream of P1. Fluids here measured 6,800 ppm TSS.
P3: Pond 1 of the inspection report. Fluids located inside Pond 1 measured 12,500 ppm TSS.
P4: Pond 2 of the inspection report. Fluids located inside Pond 2 measured 3,900 ppm TSS.
P5: Pond 3 of the inspection report. Fluids located inside Pond 3 measured 1,500 ppm TSS.
P6: Pond 4 of the inspection report. Fluids located inside Pond 4 measured 800 ppm TSS.
