Down-hole Camera of EPA Pavillion Monitoring Well MW-02 Conducted on May 2, 2012 Prior to Redevelopment by the USGS

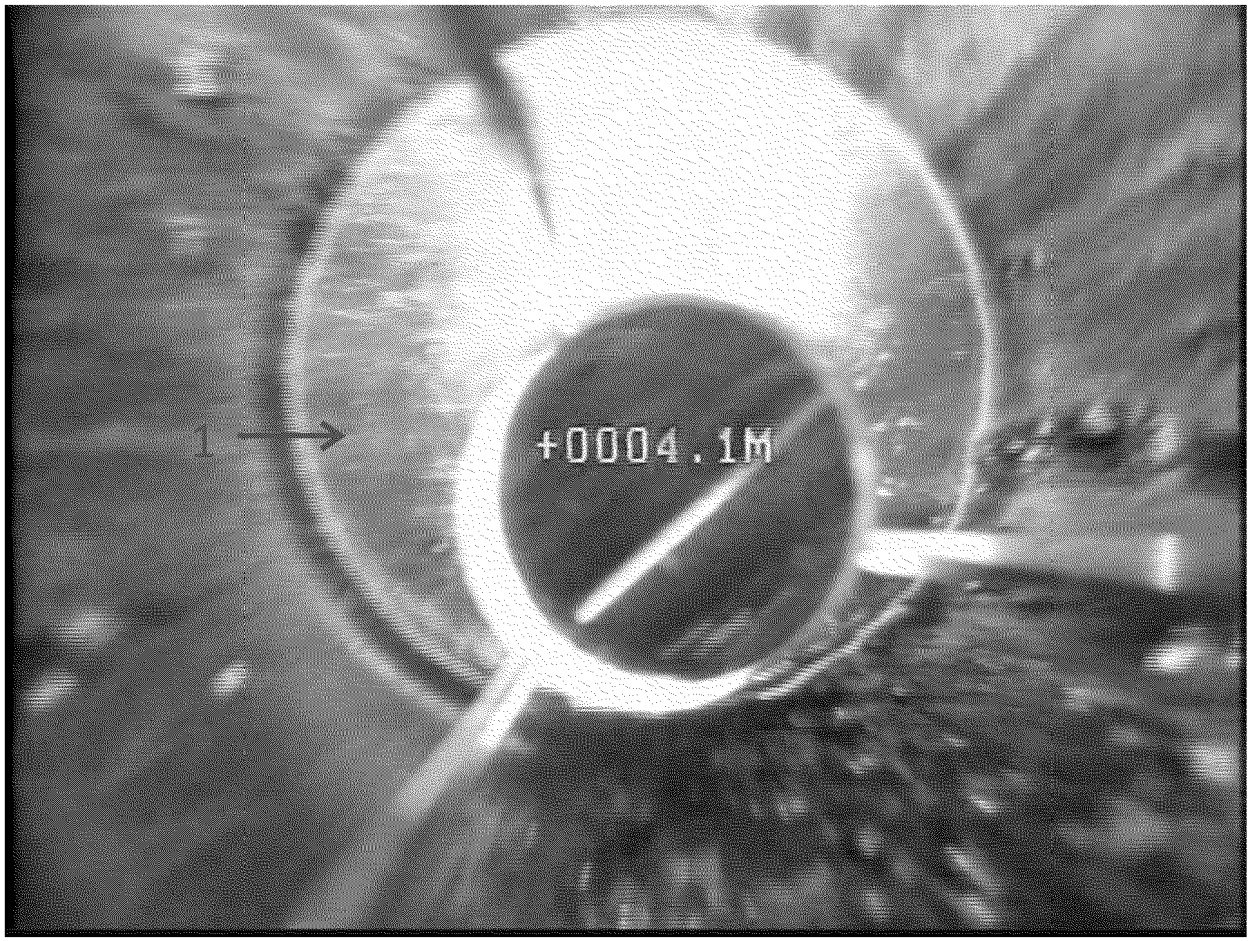
VTS_02.1.VOB at 0:07:54

Water surface (1) encountered at approximately 173-ft below top of casing (btoc).

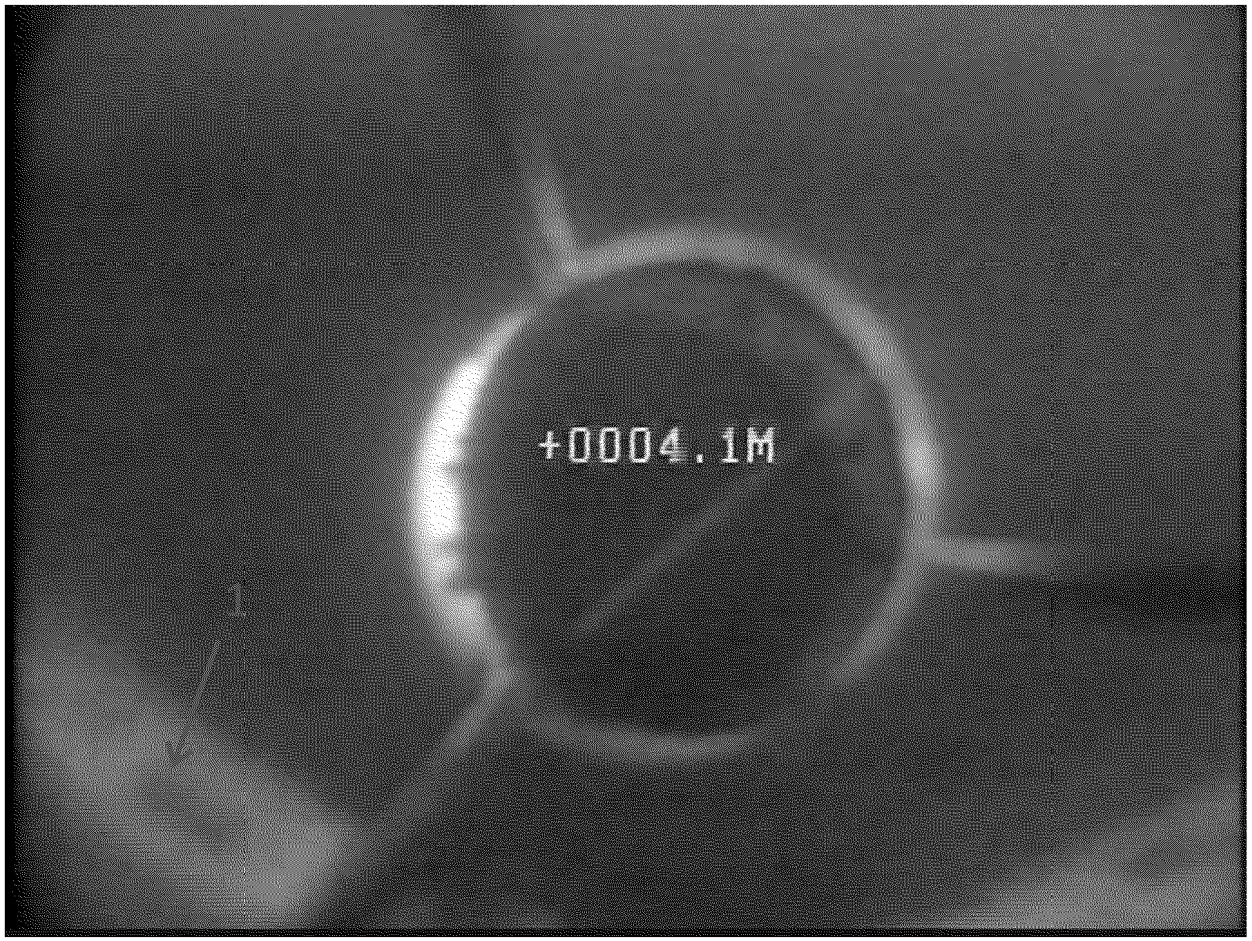
VTS_02_1.VOB at 0:11:37

Visible threaded casing joint below water surface (1), and example of water clarity.

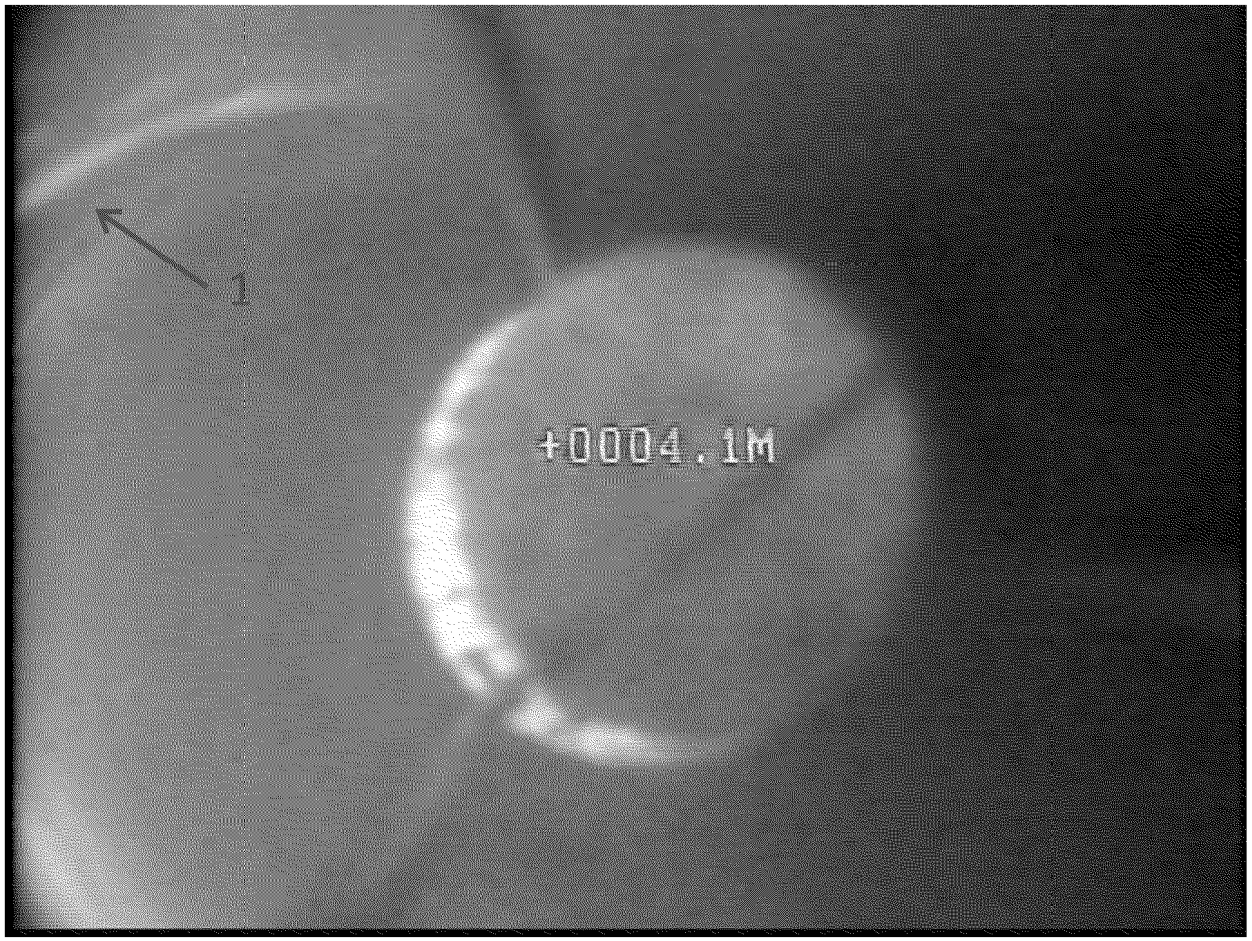
VTS_02_3.VOB at 0:10:29

Water clarity is sufficient again to see threaded casing joints (1).

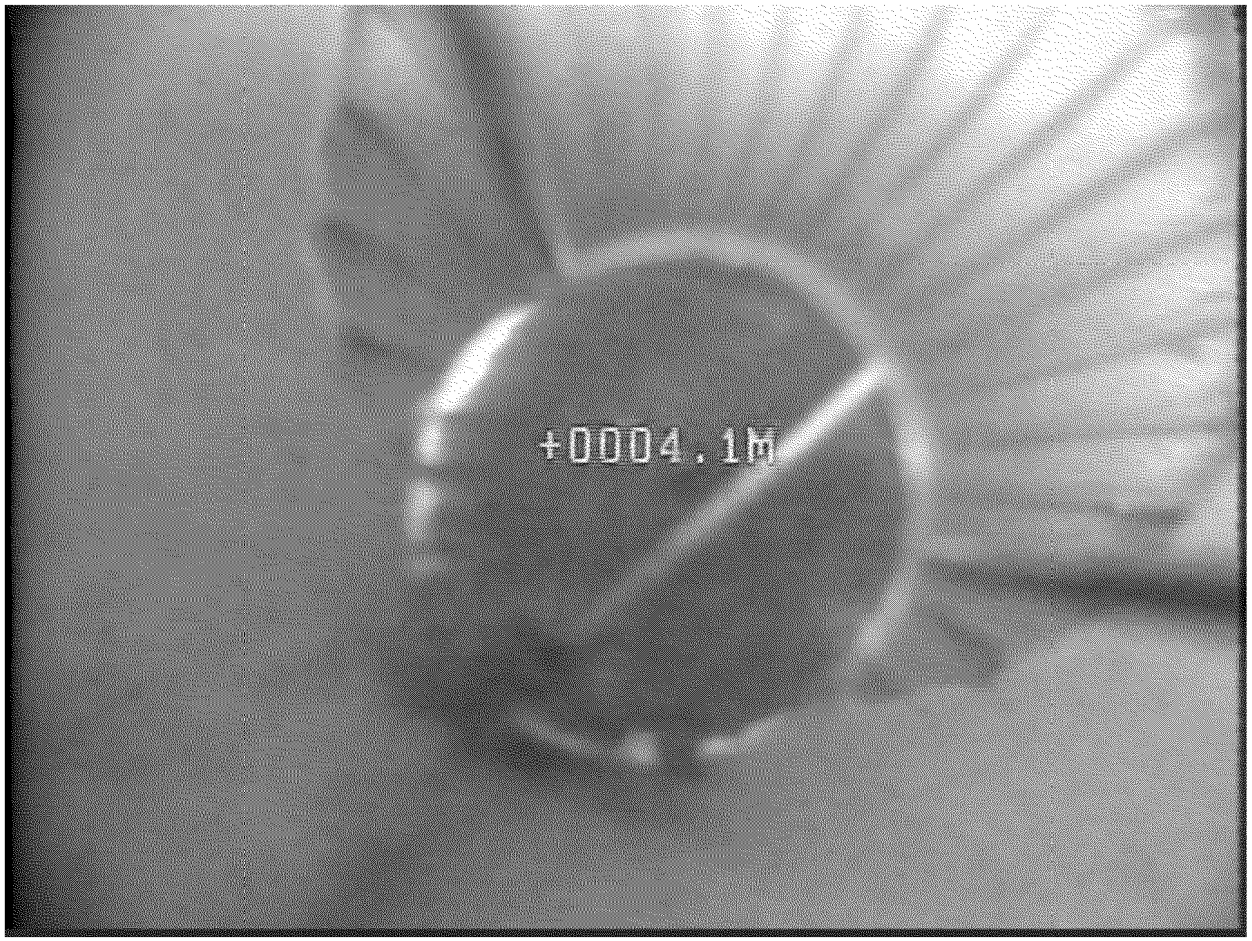
VST_02_4.VOB at 0:06:46

Top of screened interval, encountered at approximately 973-ft btoc.

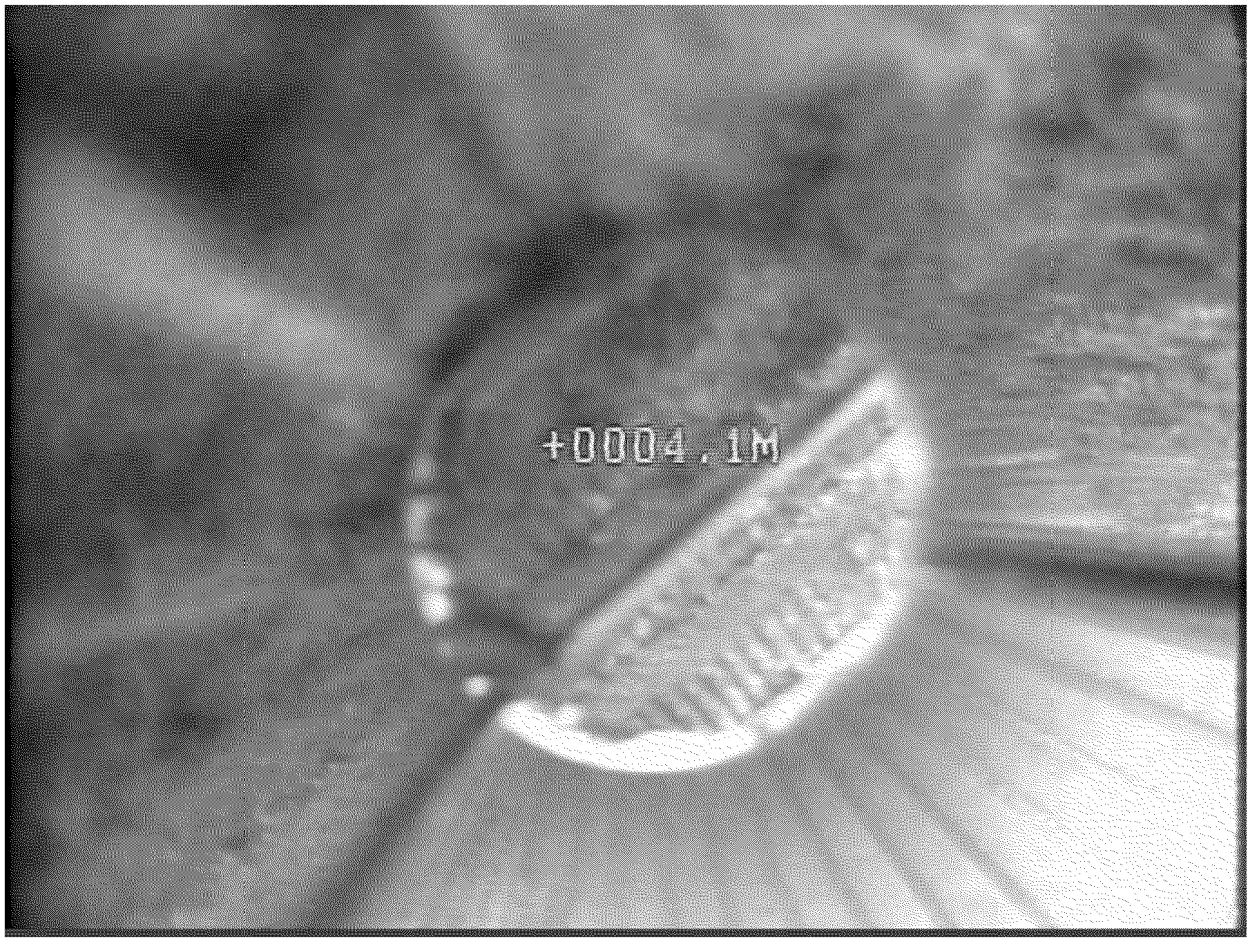
VST_02_4.VOB at 0:10:24

Material on well screen.

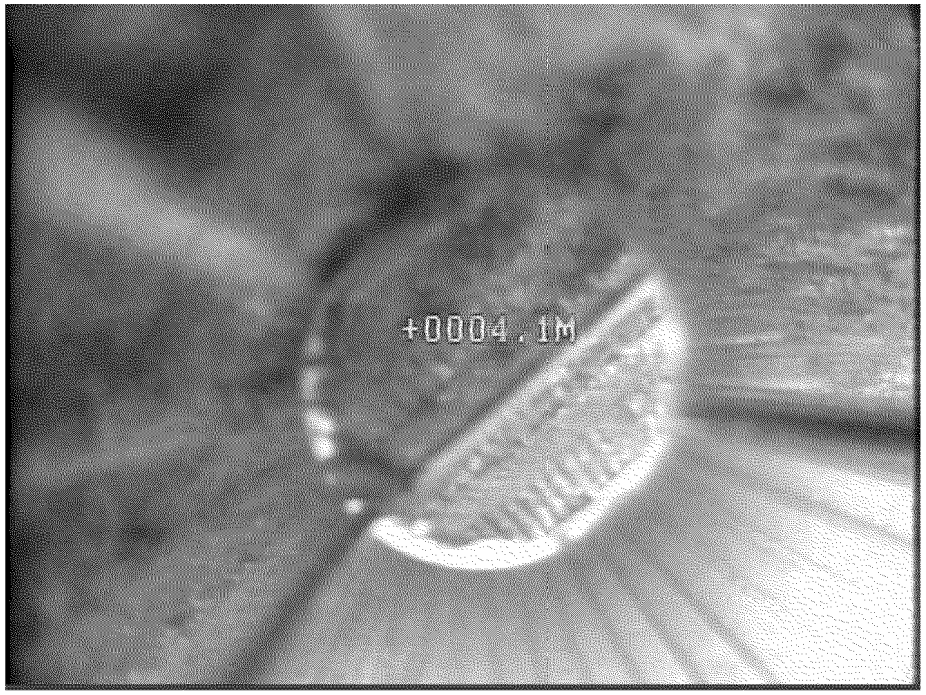
VST_02_4.VOB at 0:10:24

EPA MW02 Well Screen

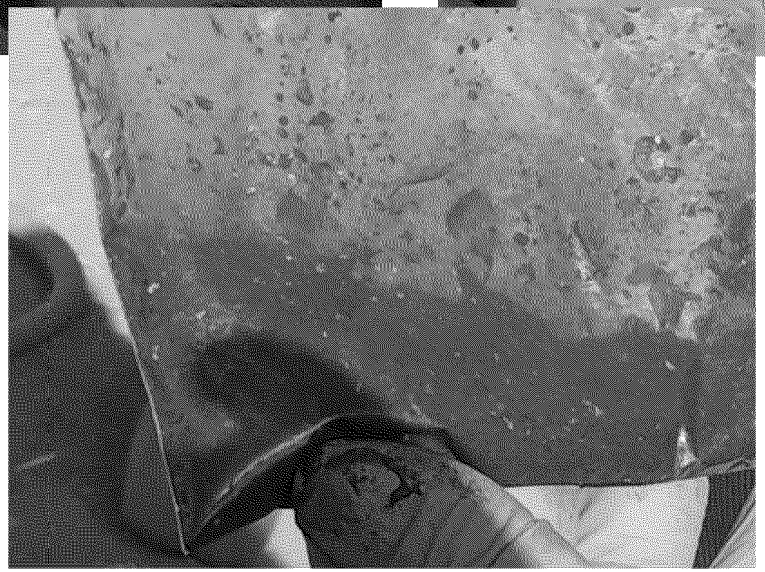
Material removed from MW02 during redevelopment of well by USGS, May 2012
