Subject: Sky Valley Education Center
PCB air and wipe sampling in Annex Building
EHSI Project 10816-01

Monroe School No. 103 District
Sky Valley Education Center
Collection and Analysis of PCBs in Air & Wipe Sample

January 15, 2016
EHSI Project 10816-01

POLYCHLORINATED BIPHENYLS (PCBs) AIR & WIPE SAMPLING
SKY VALLEY EDUCATION CENTER
MONROE, WASHINGTON

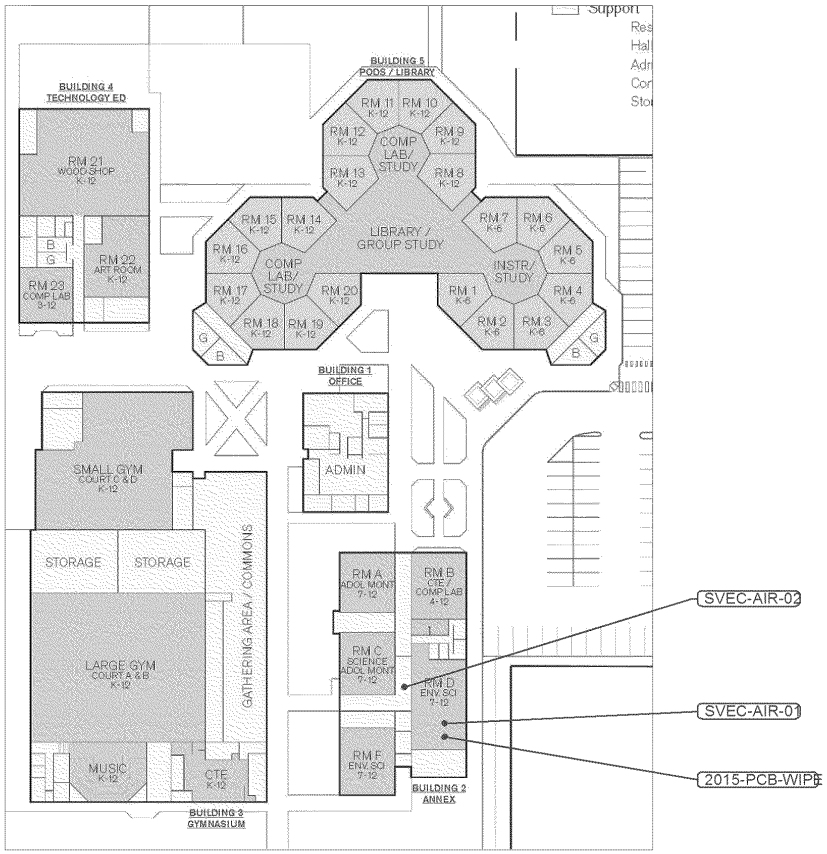
SL-1

Air samples were collected over a twenty-four (24) hour period using low flow Gilian sampling pumps calibrated to an airflow of 1.0 liter per minute (LPM). Samples were collected on 13 millimeter (mm) GFF Swinnex cassettes. A sample was collected from the room in which the ballast recently failed and an additional, comparator sample was collected from a "non-affected" area within the same annex building. Sample collection began on at 8:34am on December 23rd and concluded at 8:40am on December 24th, 2015. A wipe sample was also collected from the vinyl floor tile where the ballast oil had leaked onto the carpet. The carpet in the affected area was removed prior to this assessment. A wipe sample was taken from a 100 square centimeter (cm^2) area. Sampling locations are denoted on the floor plans provided in Appendix A of this report.
