Investigation Report
Department of Health
Clean Water Branch

I D #: PA0991A Date of investigation: 12/23/2010

Permit/File/WQC No: R50A533 Island: Oahu Facility: City and County of Honolulu

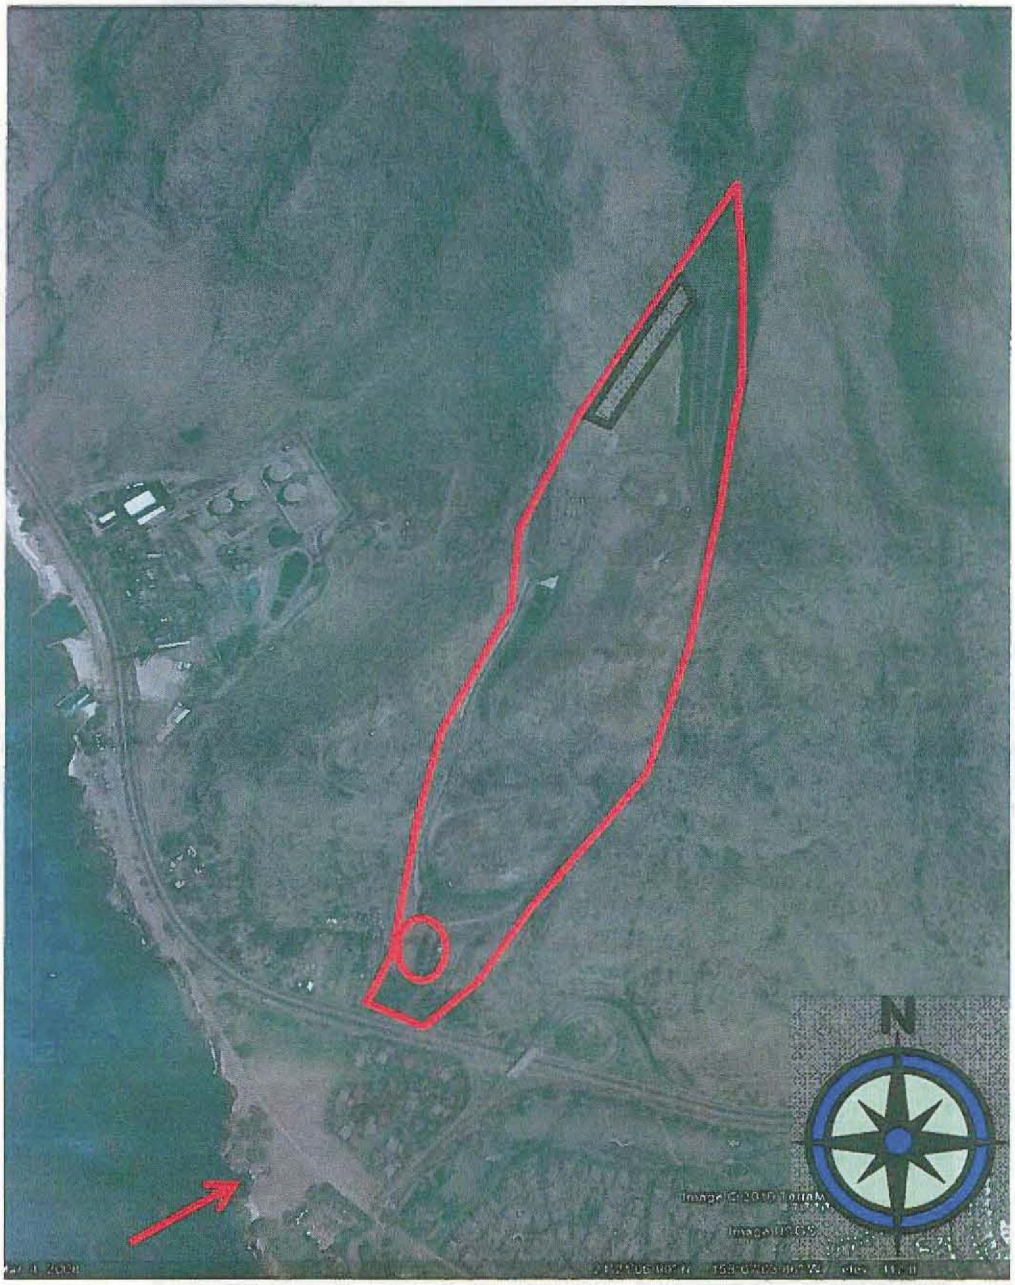
Image 1

Description: View of the Landfill (Red Outline). The E6 cell (Black Outline) was observed at the time of inspection. An earthen berm traversed the E6 cell. Discharges from the Landfill's storm water detention basin (Red Circle) enter into the Pacific Ocean at a shoreline outfall (Red Arrow) north of Ko Olina.
