SUBJECT: Supplemental Asbestos and Lead-Based Paint Report
Former Livingston Memorial Hospital
504 South 13th Street, Livingston, Montana
Tetra Tech Project Number: 117-8292002

Asbestos Inspection
ACM Locations
SMDC - Former Livingston Hospital - Main Level
504 South 13th Street
Livingston, Montana

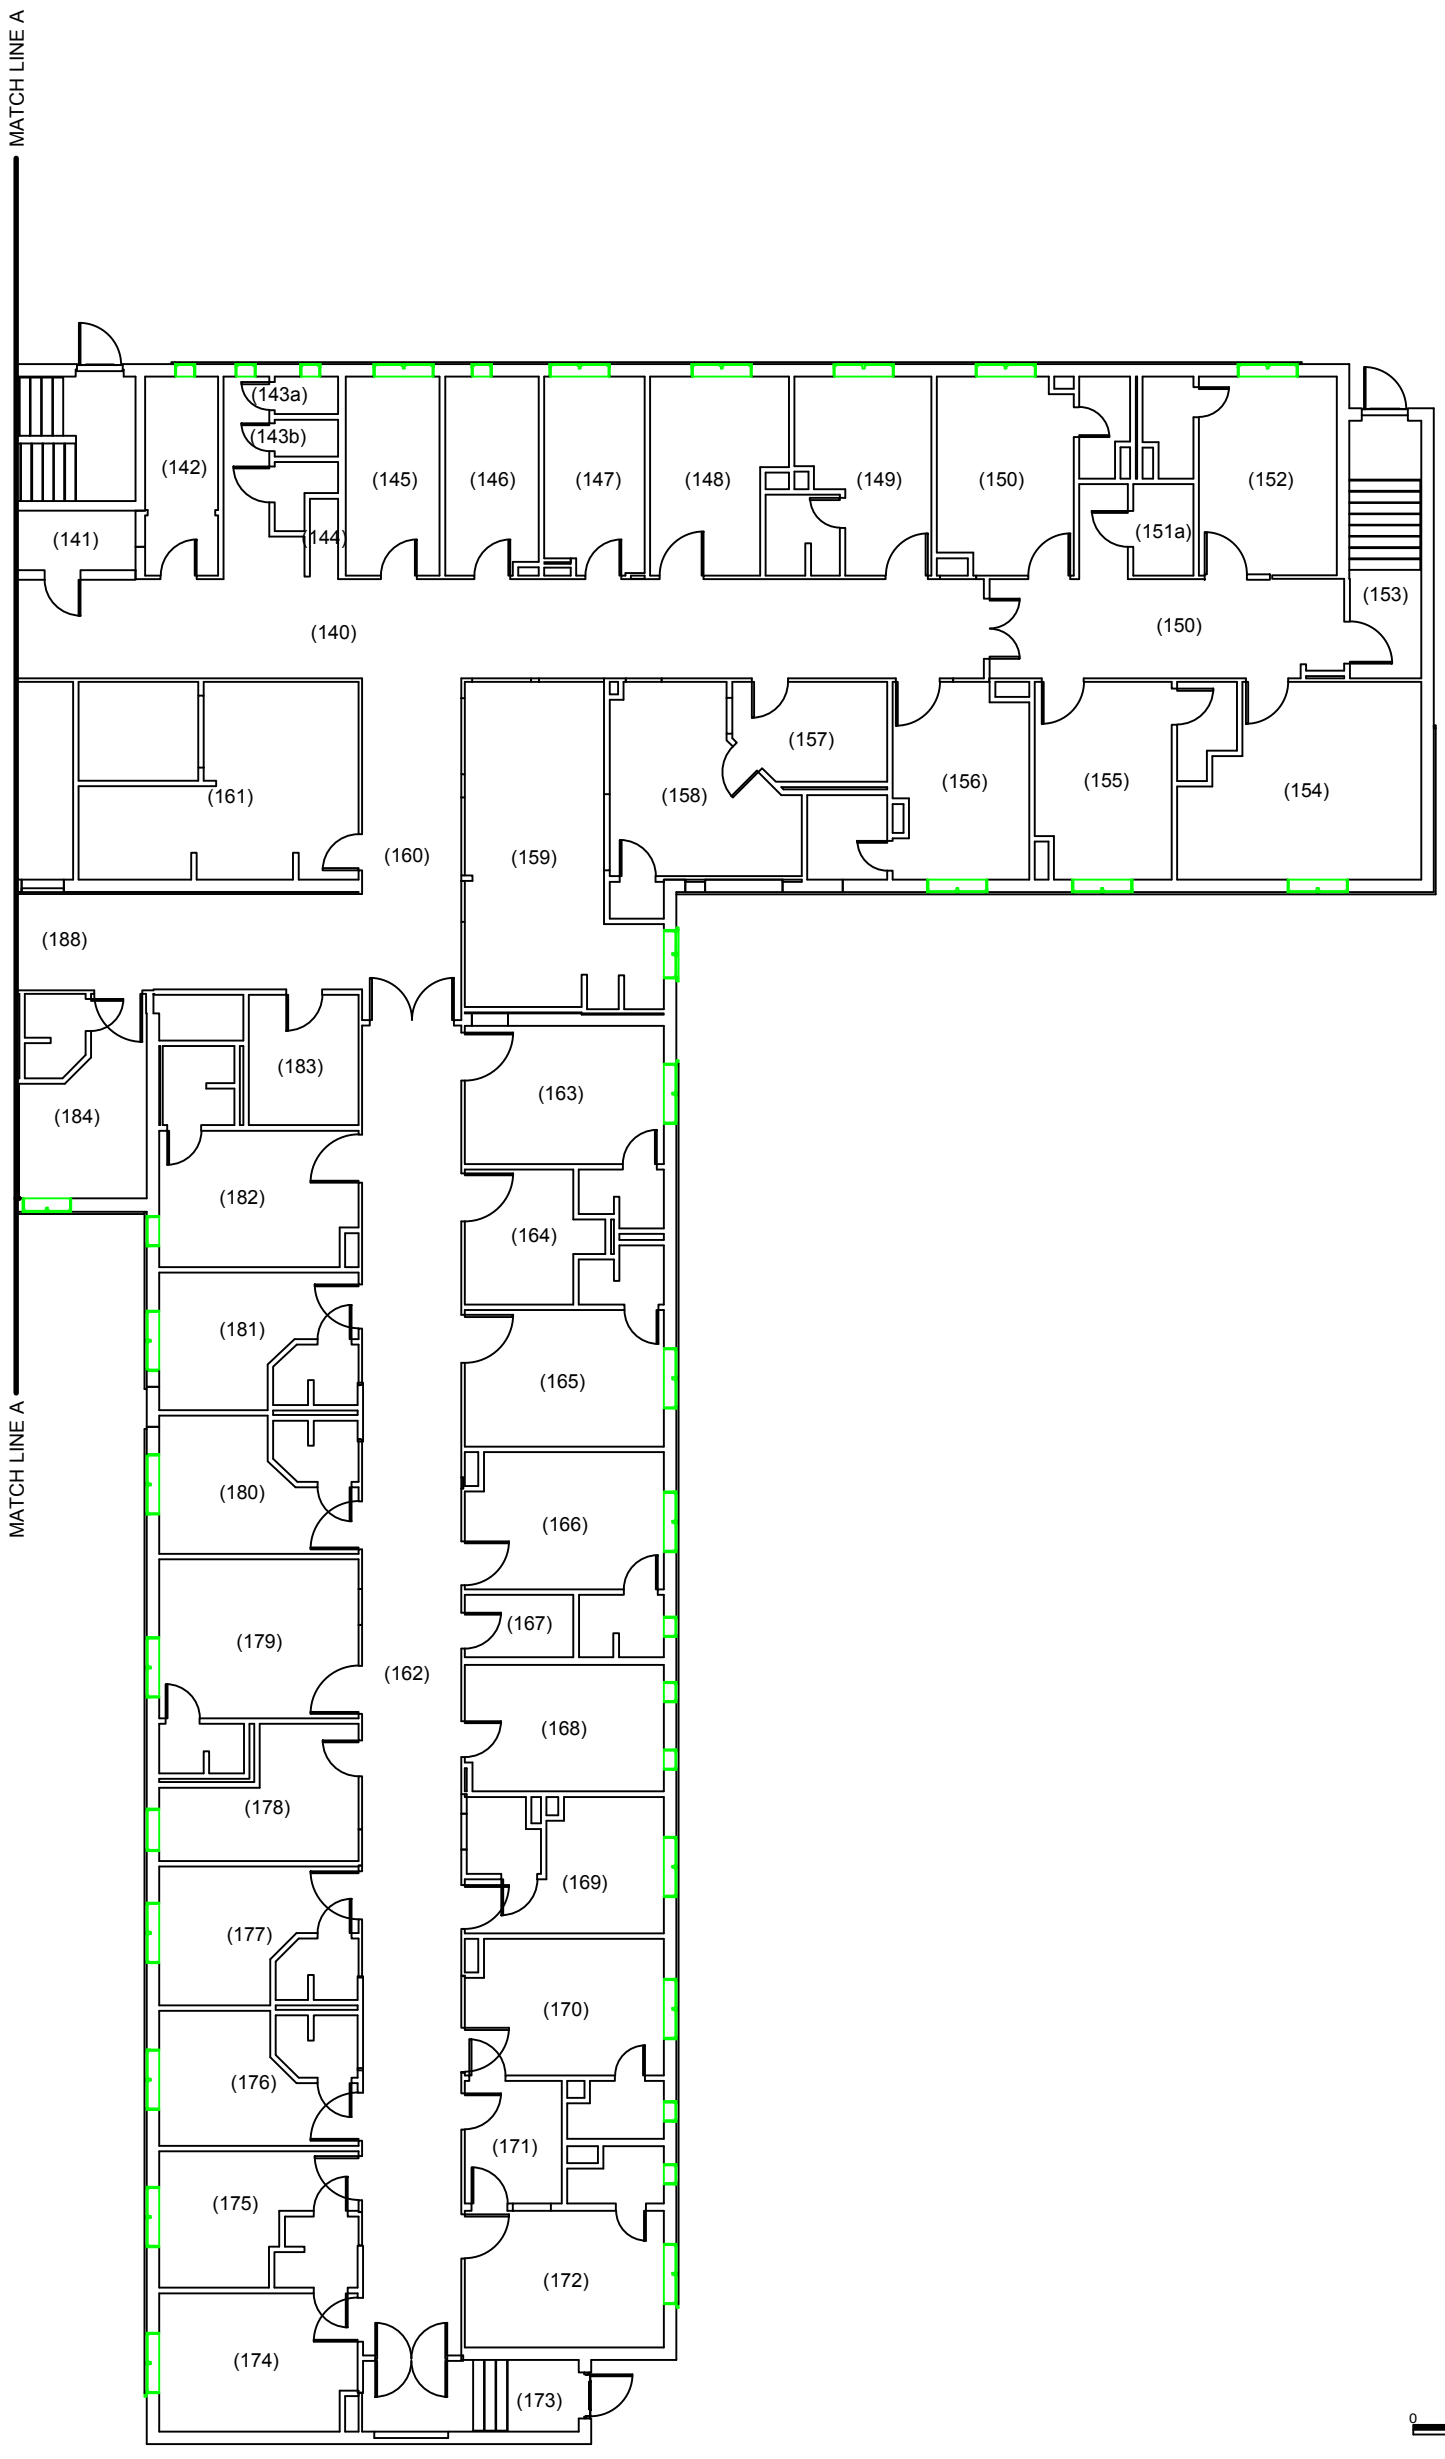
DATE: 01/31/2019	DRAWN BY: DLL
REVIEWED: RH	APPROX. SCALE: 1" = 16'
PROJ. NO. 117-8292002	FIGURE NO. 1

A summary of the ACMs identified to contain greater than 1% asbestos that remains on the project site are presented in Table 1. Approximate ACM locations are presented on Figures 1 through 4.

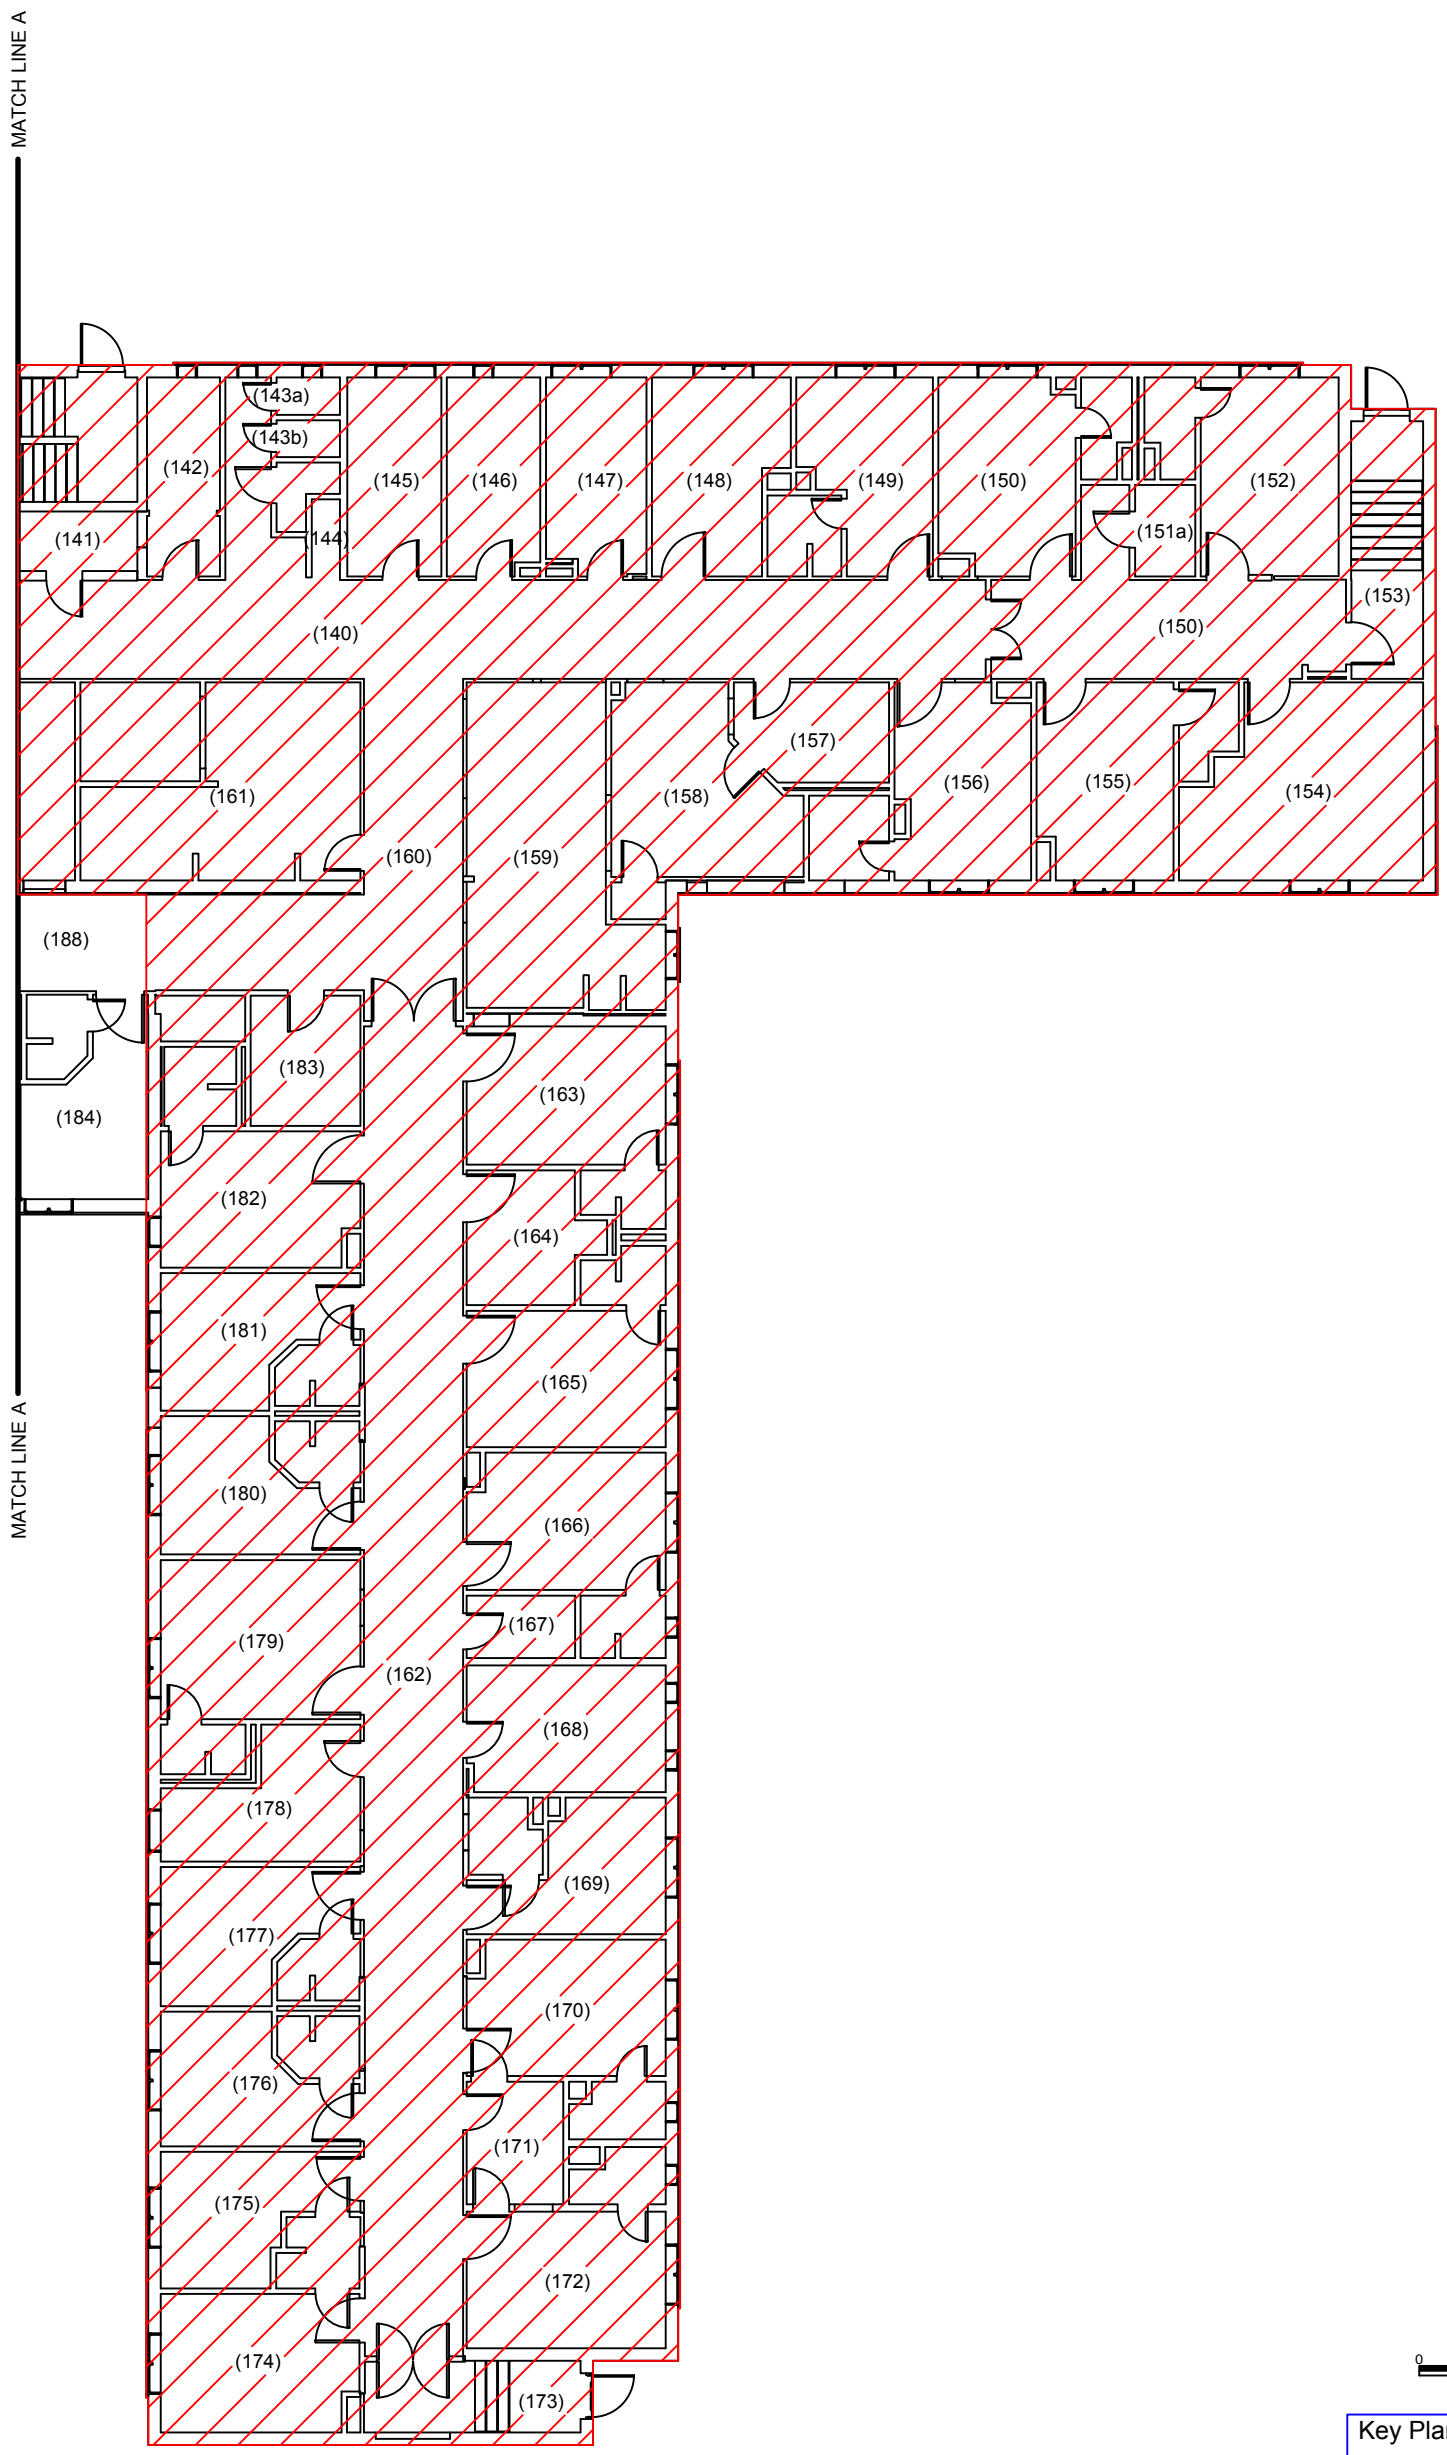
DATE: 01/31/2019	DRAWN BY: DLL
REVIEWED: RH	APPROX. SCALE: 1" = 16'
PROJ. NO. 117-8292002	FIGURE NO. 3

Asbestos Inspection
ACM Locations
SMDC - Former Livingston Hospital - Main Level
504 South 13th Street
Livingston, Montana

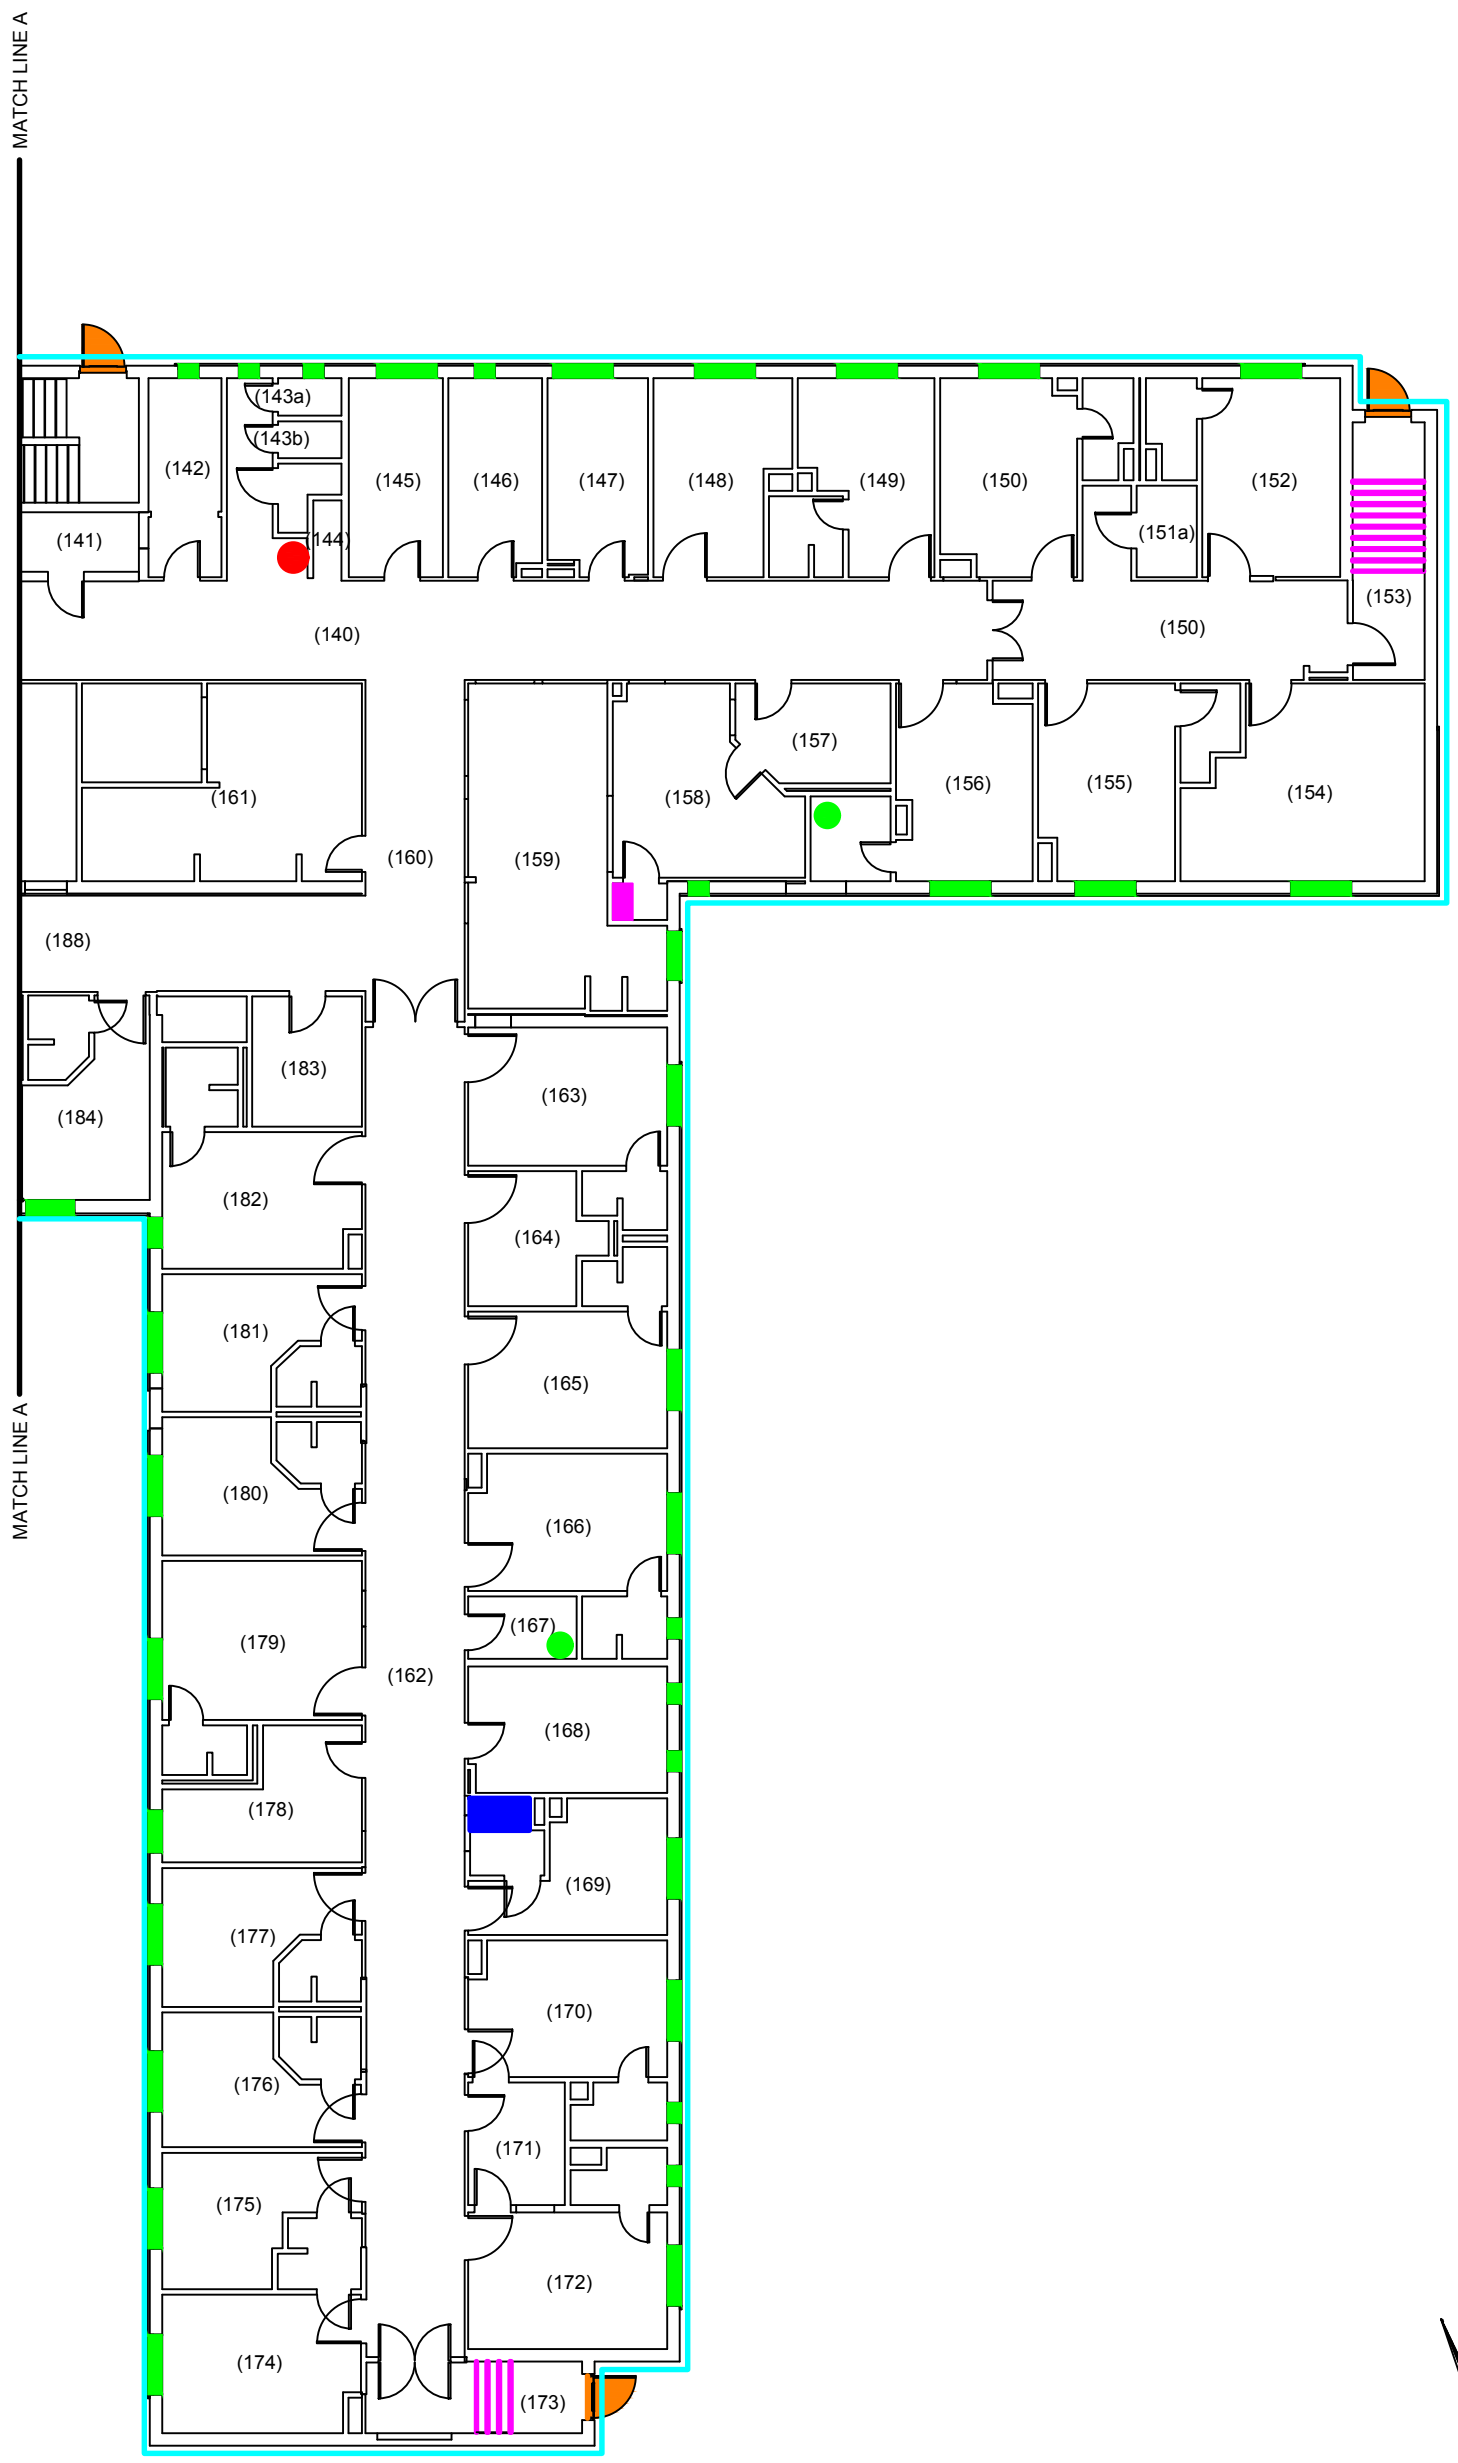
DATE: 02/01/2019	DRAWN BY: DLL
REVIEWED: RH	APPROX. SCALE: 1" = 16'
PROJ. NO. 117-8292002	FIGURE NO. 5

Component and General Description	Observed Condition	Highest Lead Concentration mg/cm²
Yellow Painted Wood Trim	Good	2.9
Yellow Painted Wood Fascia	Good	3.4
Yellow Painted Metal Window and Door Frame Headers	Good	10.1
Yellow Painted Wood Soffit	Good	4.3
Brown Painted Door Kickplate	Good	11.1

Lead-Based Paint Inspection
LBP Locations
SMDC - Former Livingston Hospital - Main Level
504 South 13th Street
Livingston, Montana

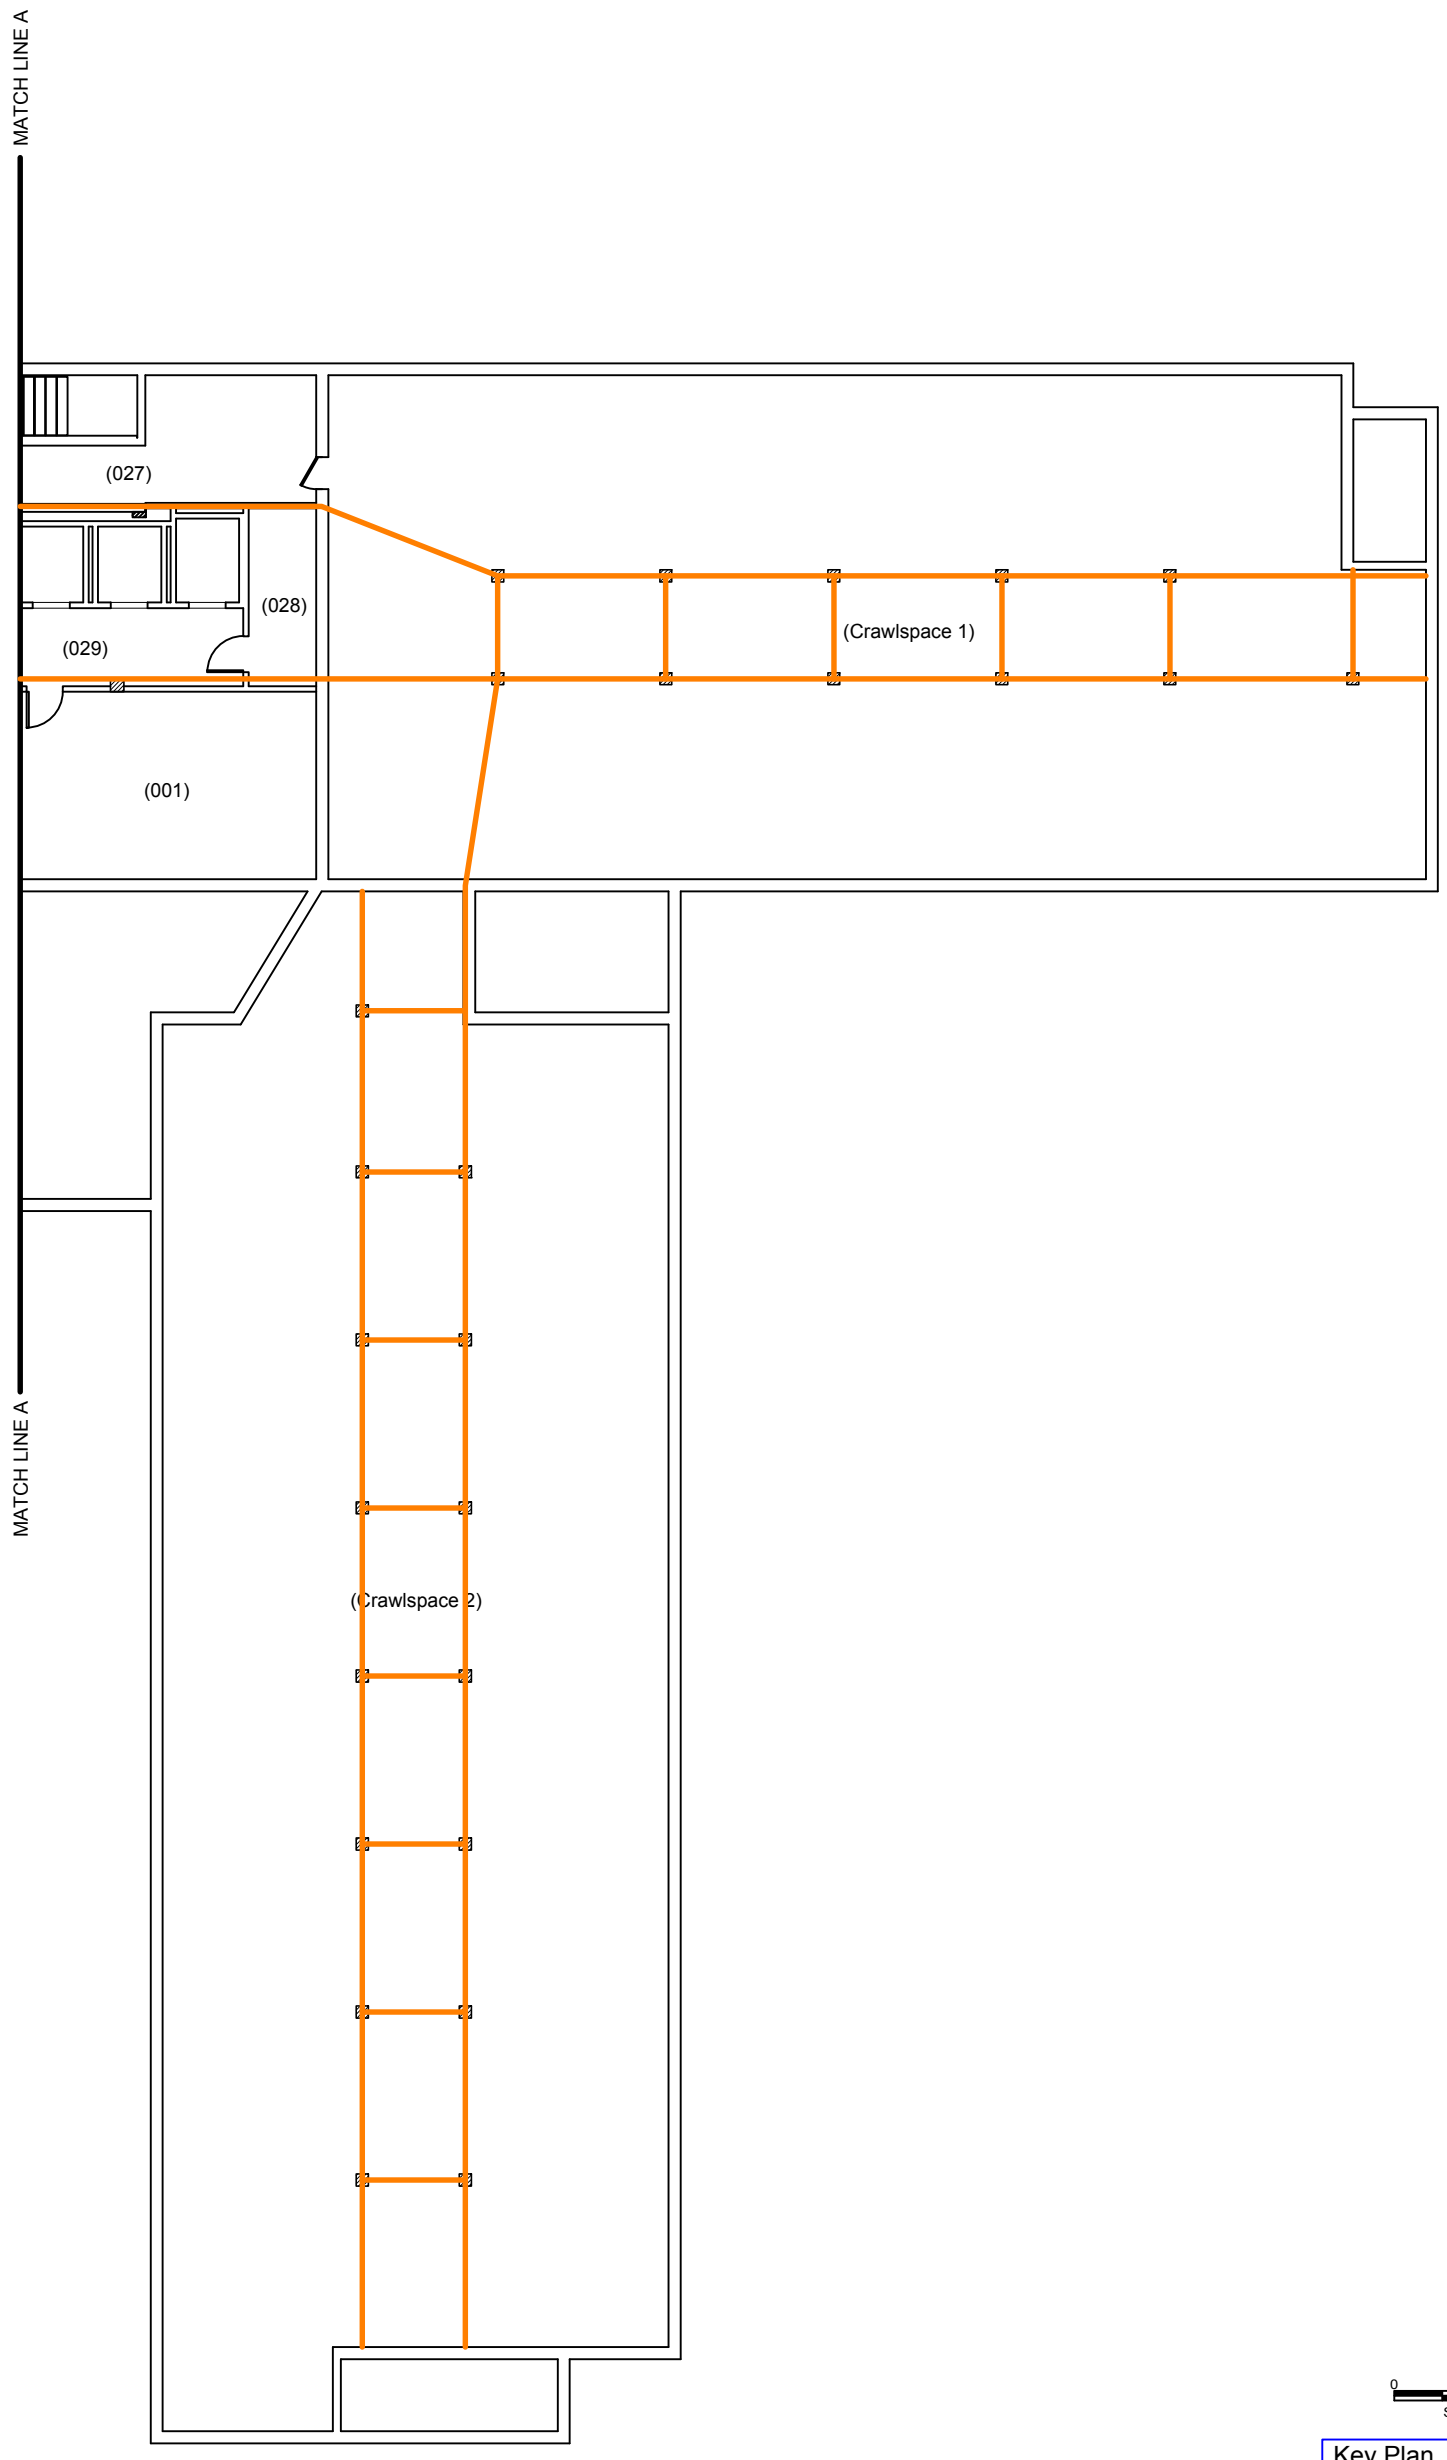
DATE: 02/01/2019	DRAWN BY: DLL
REVIEWED: RH	APPROX. SCALE: 1" = 16'
PROJ. NO. 117-8292002	FIGURE NO. 7

Lead-Based Paint Inspection
LBP Locations
SMDC - Former Livingston Hospital - Basement
504 South 13th Street
Livingston, Montana

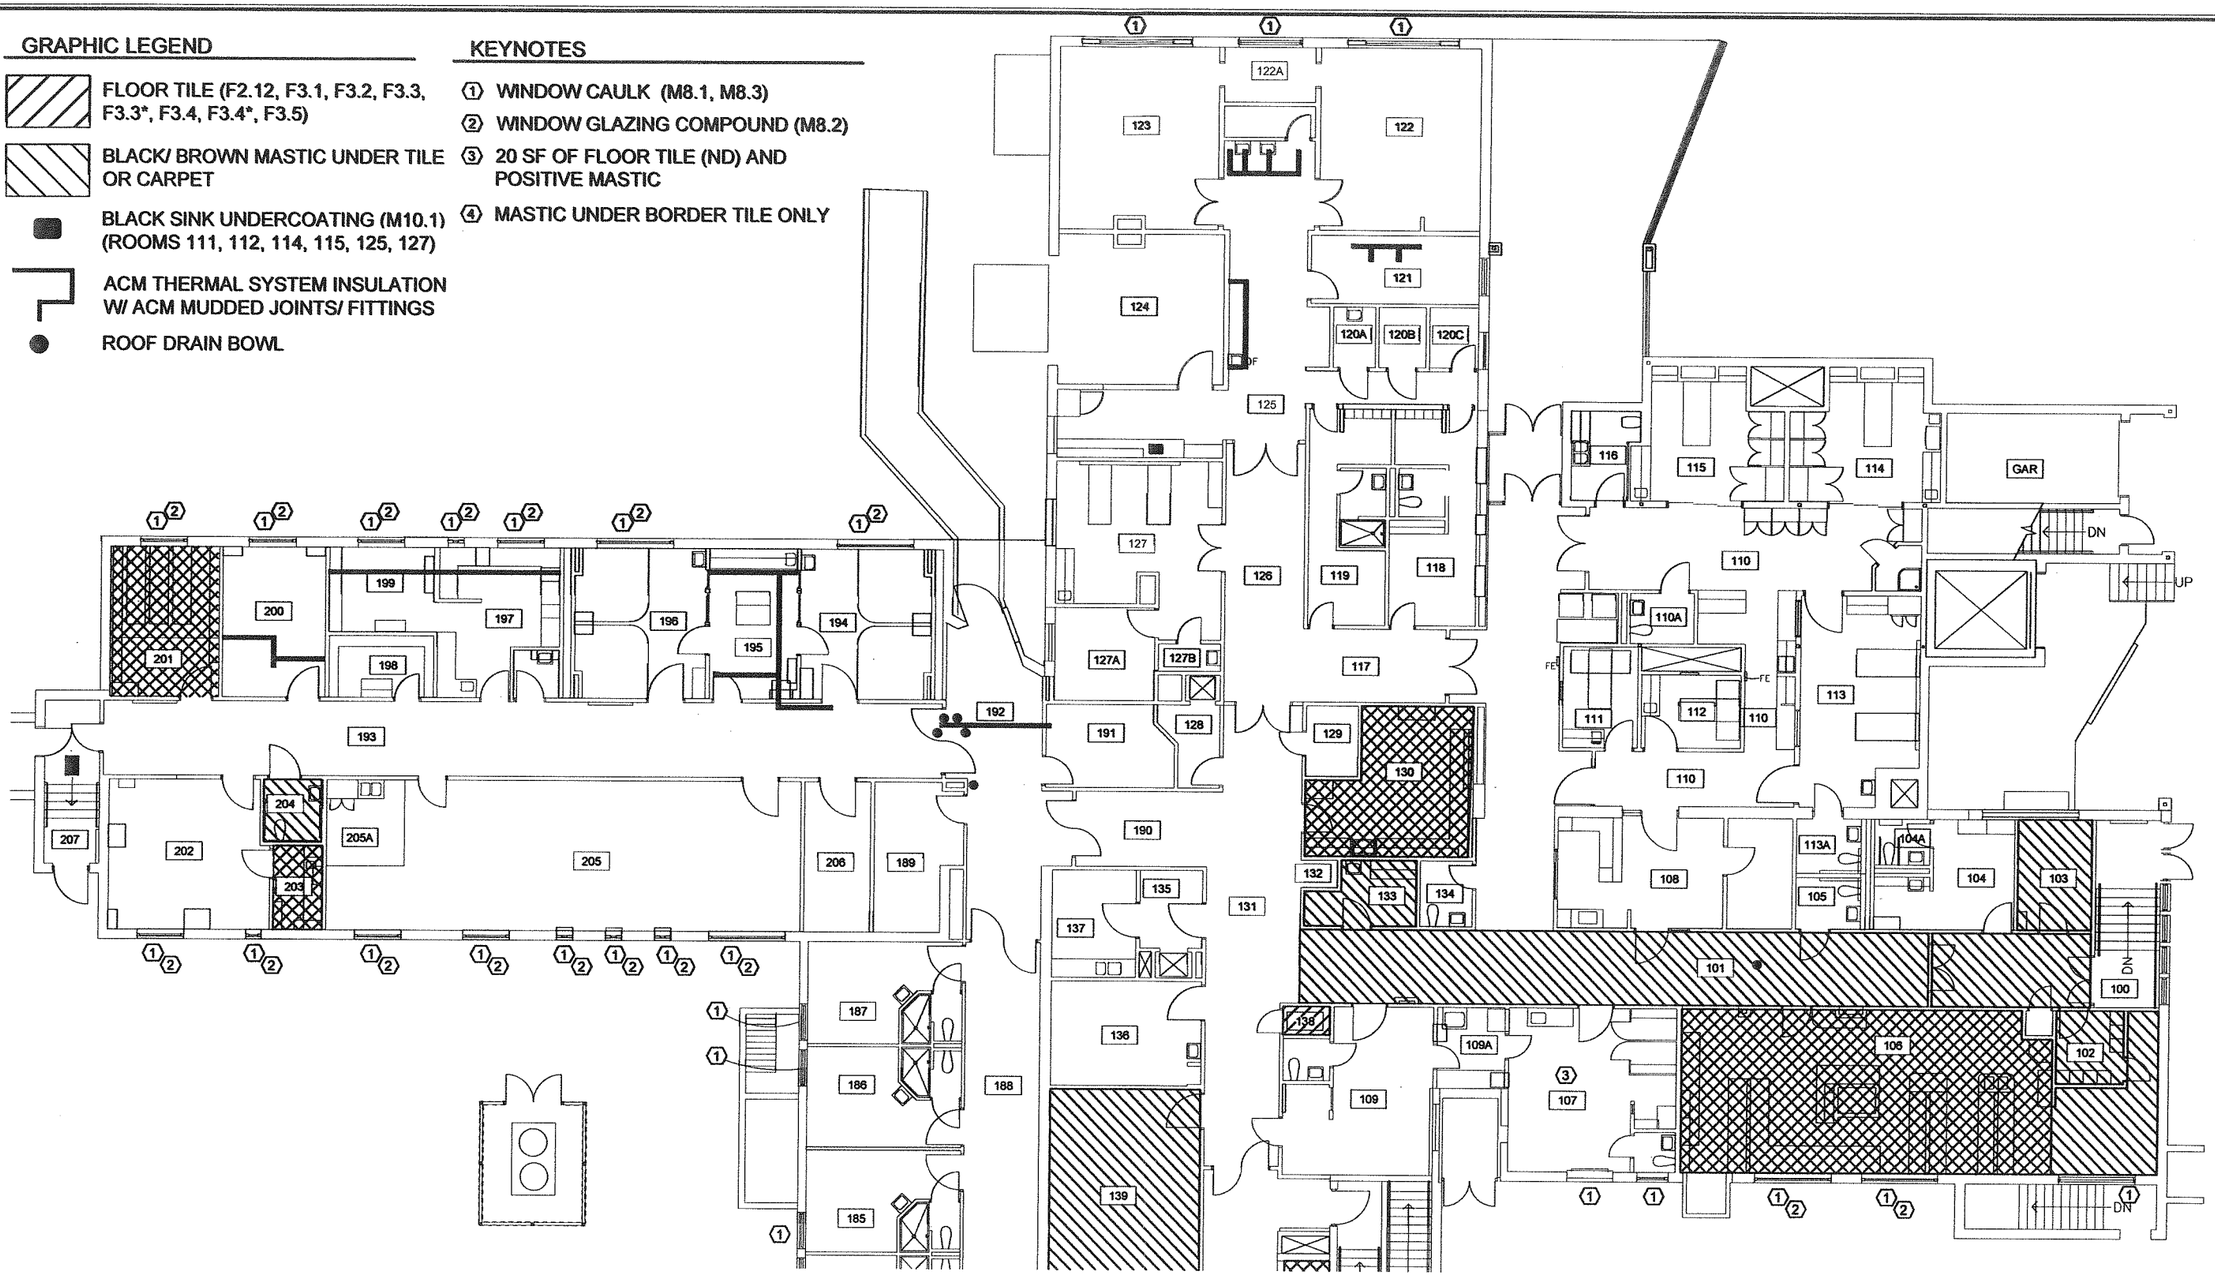
NORTH WING MATERIAL LOCATION PLAN

1. WINDOW CAULK (M8.1, M8.3)
2. WINDOW GLAZING COMPOUND (M8.2)
3. 20 SF OF FLOOR TILE (ND) AND POSITIVE MASTIC
4. MASTIC UNDER BORDER TILE ONLY

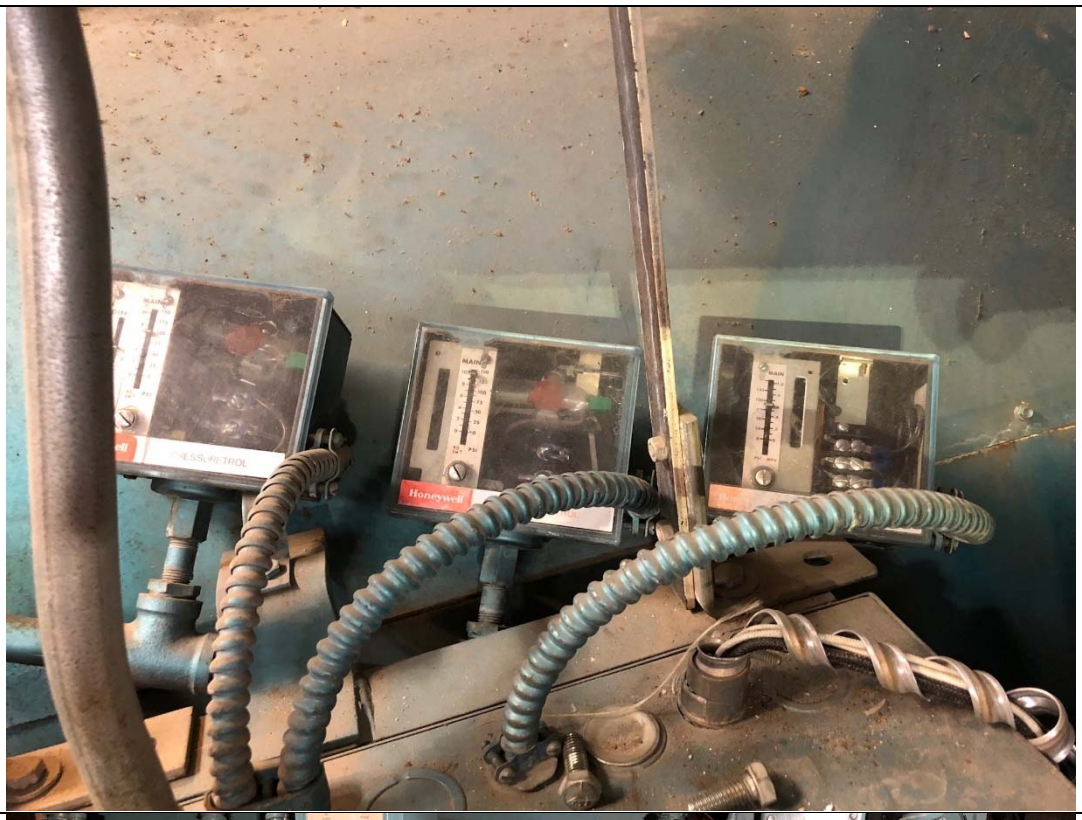
Photo No.	Date:
2	04/17/2018

Two mercury ampules observed on the boiler in the hospital.

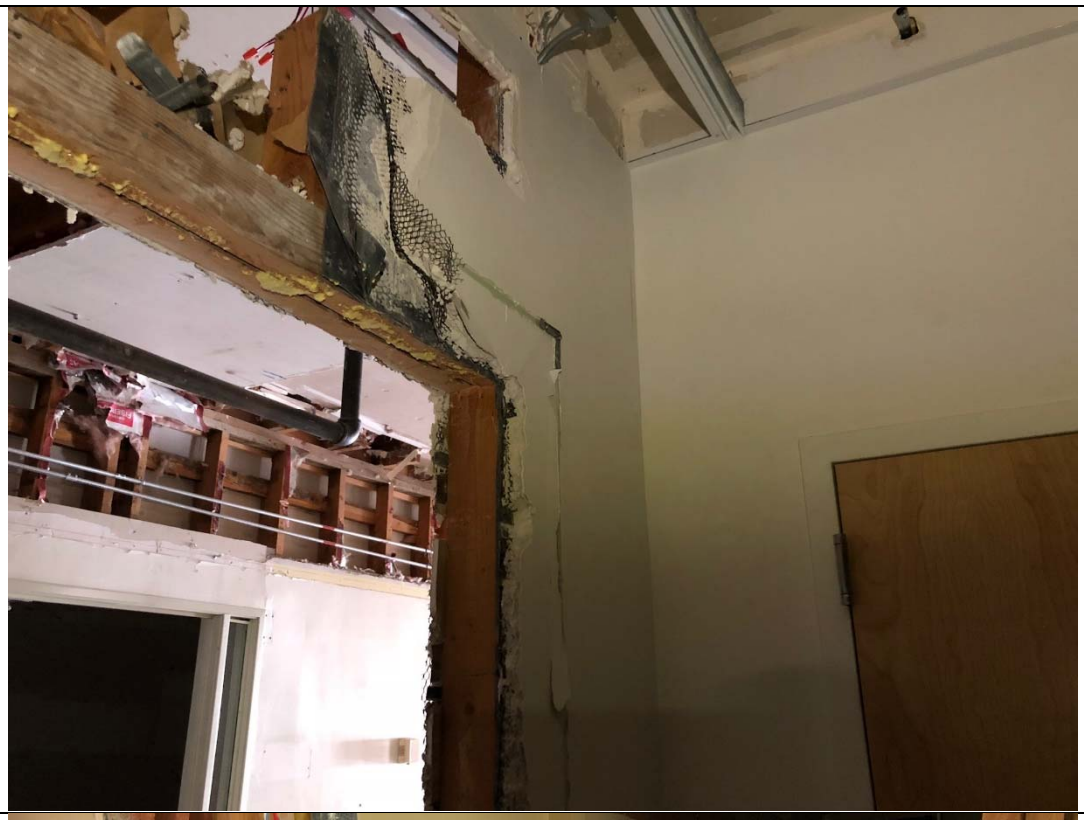
Photo No. 11	Date: 04/17/2018
Photo Coordinates	
Lat	45.649464
Long	-110.569192
Direction Photo Taken: 9.33245844269466	
Description: Lead sheet metal in walls of the hospital building.

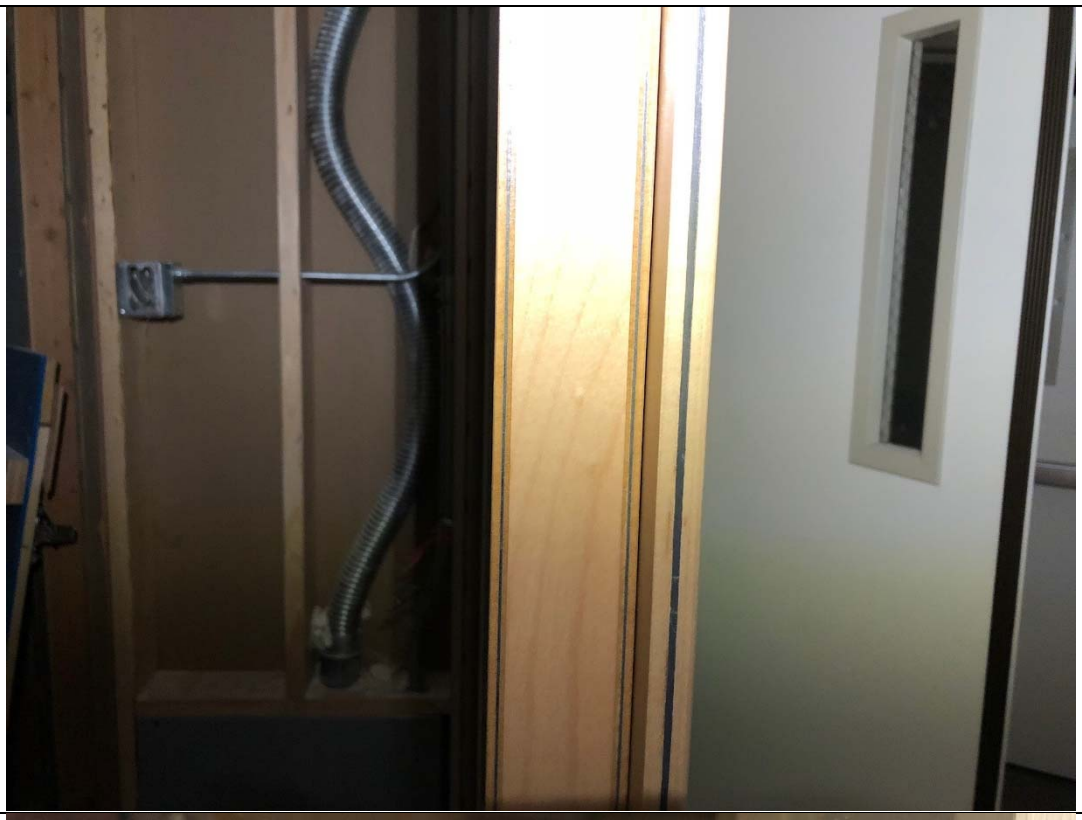
Photo No.	Date:
22	04/18/2018

Lead-lined door observed in the hospital.

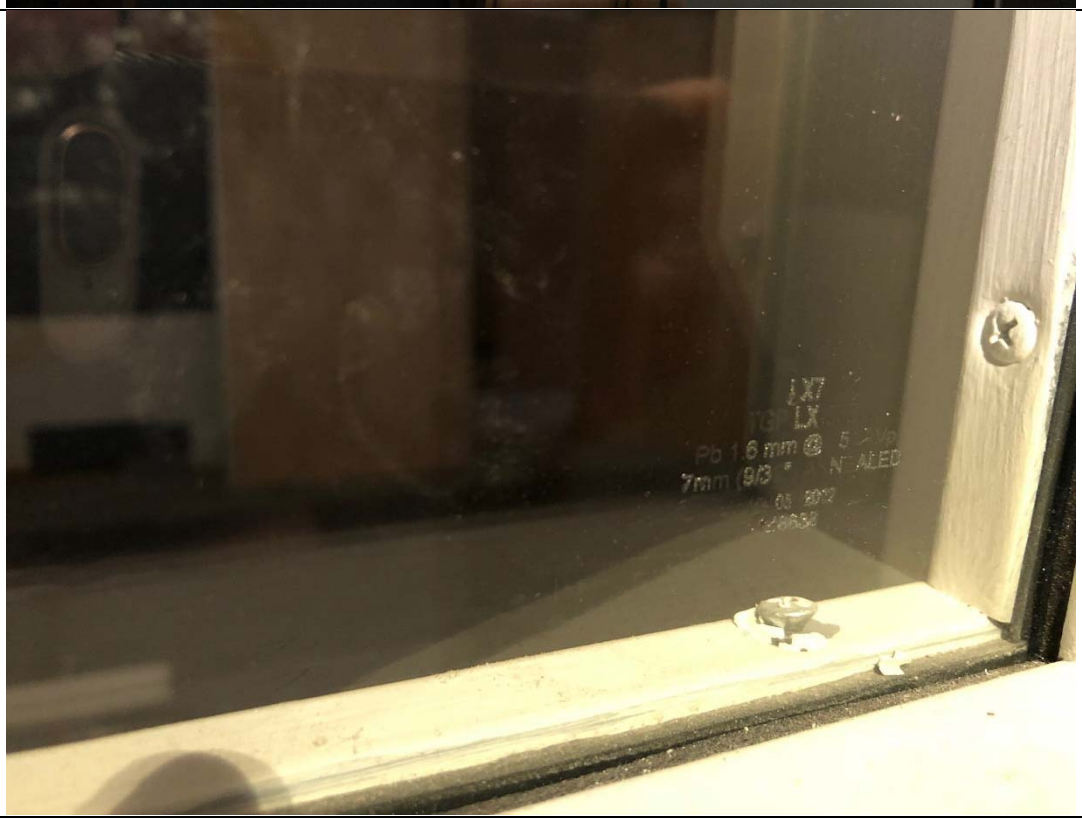
Leaded glass observed in the hospital.

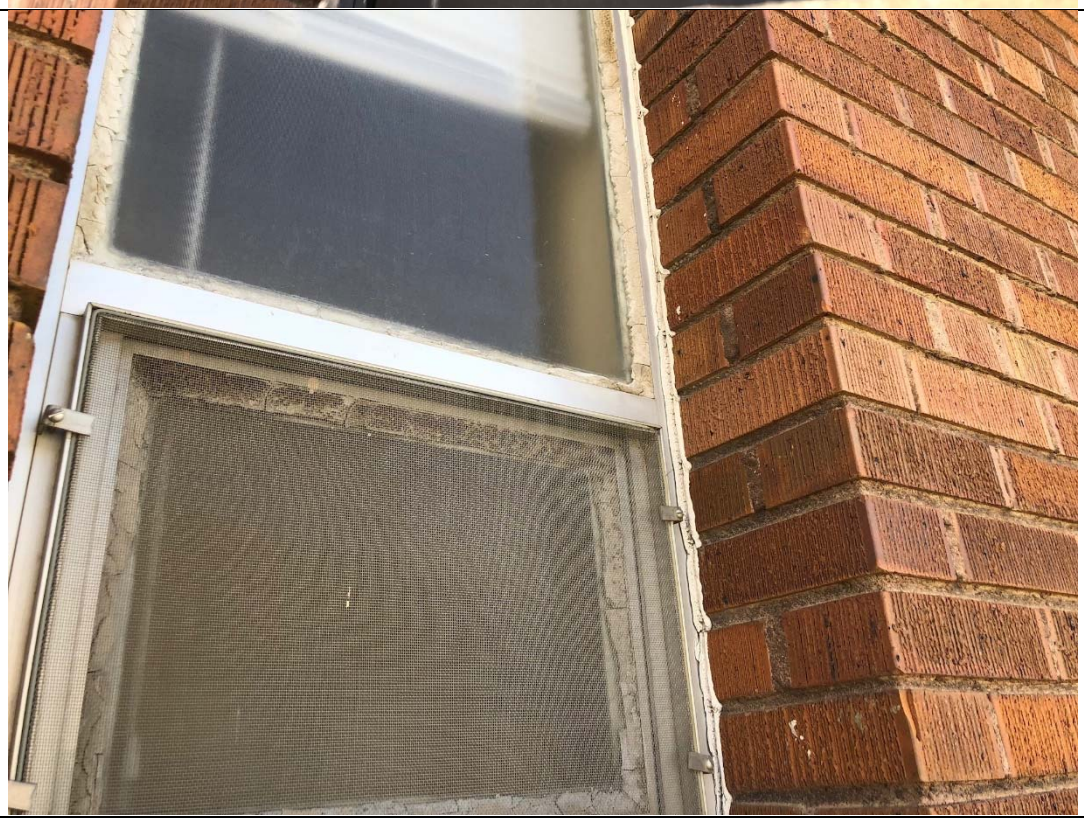
White asbestos window caulking and glazing.
