Transfer Station 2

Post 2012 Remediation
Surface Gamma Activity

Cove, Apache
County, Arizona

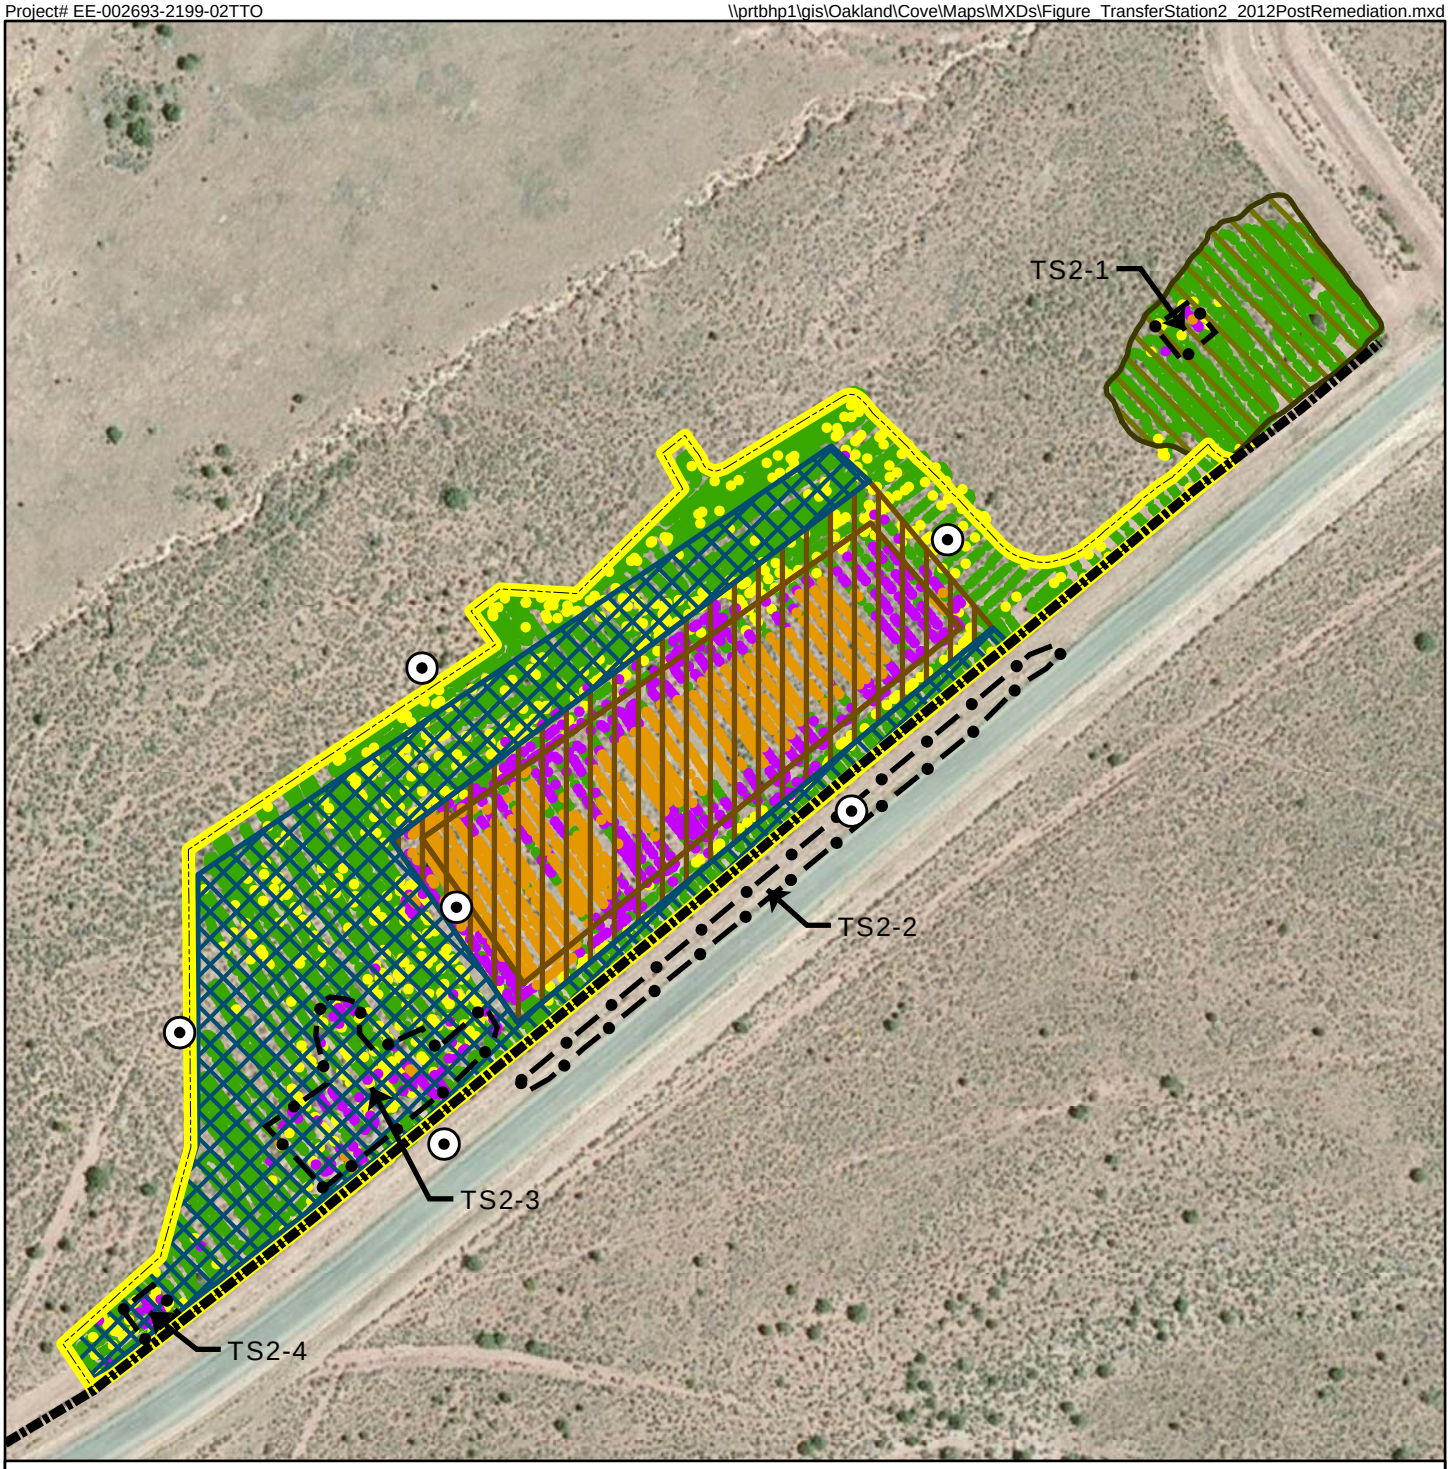
(a) Surface gamma activity post excavation October and November 2012.
