Final Phase II Environmental Site Assessment Report
Targeted Brownfields Assessment
Brownfields Site B
Former Landfill Parcels
907 North Airport Drive
Weslaco, Texas

November 2009

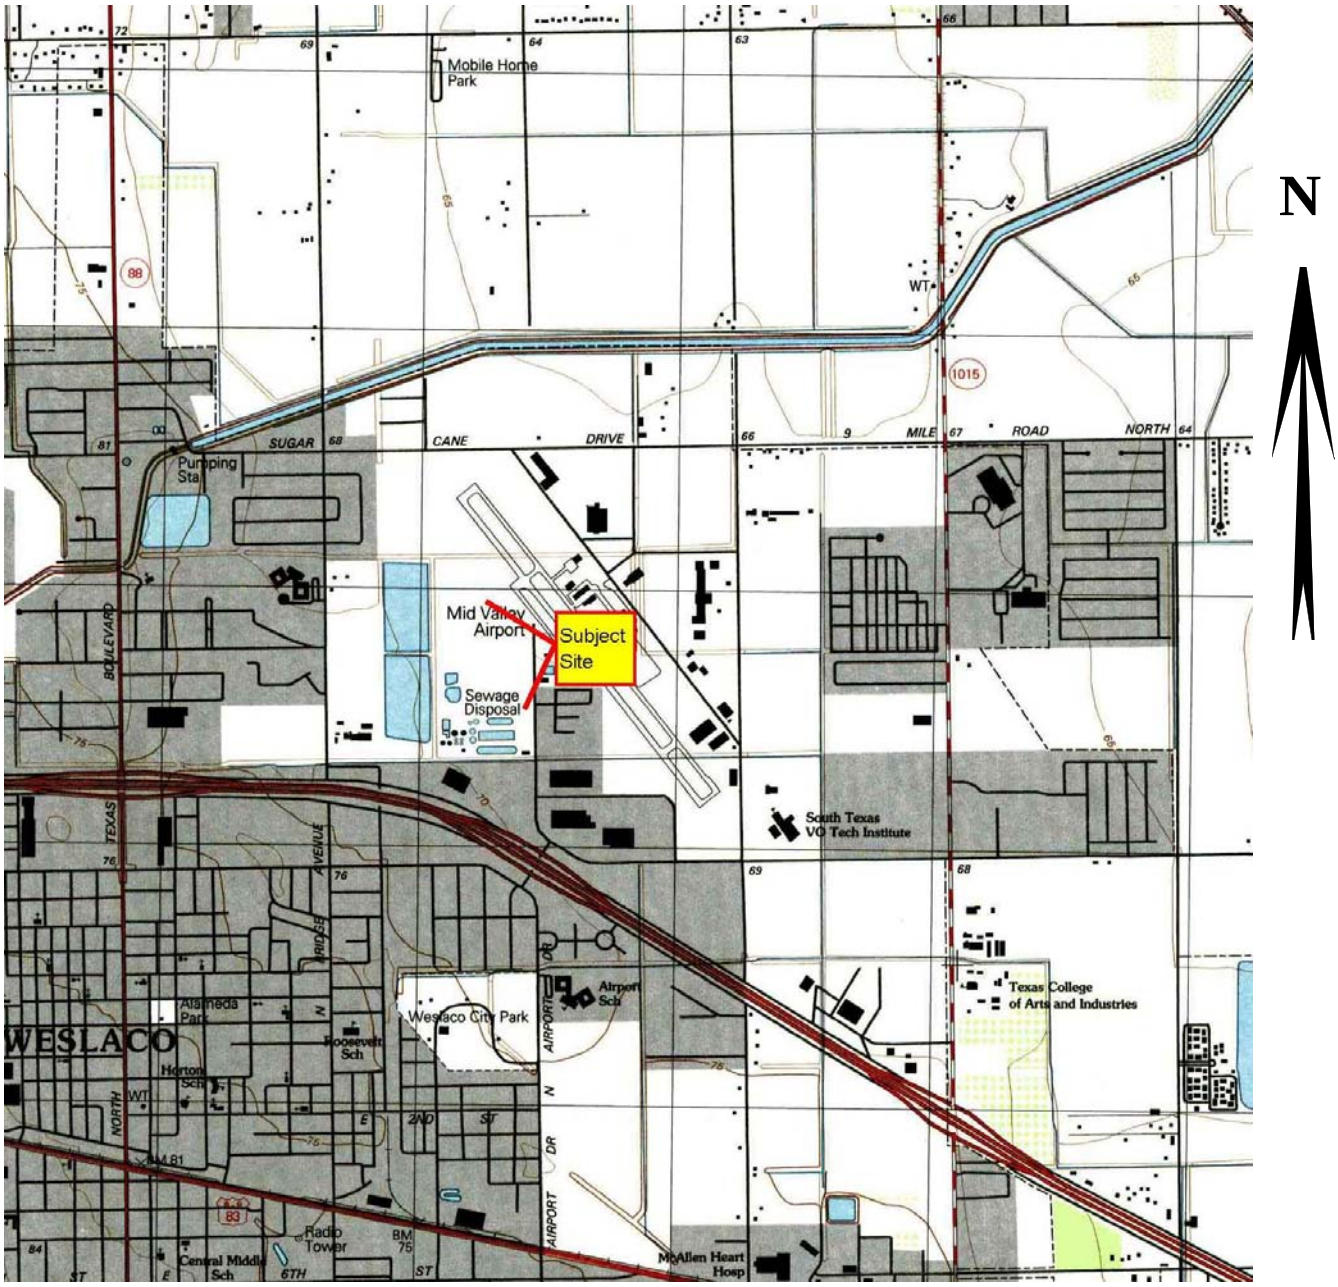
FIGURE 1: U.S.G.S. (7.5 MINUTE 2002) MERCEDES, TEXAS QUADRANGLE SHOWING TOPOGRAPHY, AND DRAINAGE IN THE VICINITY OF THE TWO FORMER LANDFILL PARCELS ASSOCIATED WITH SUBJECT SITE; 907 NORTH AIRPORT DRIVE, WESLACO, TEXAS.

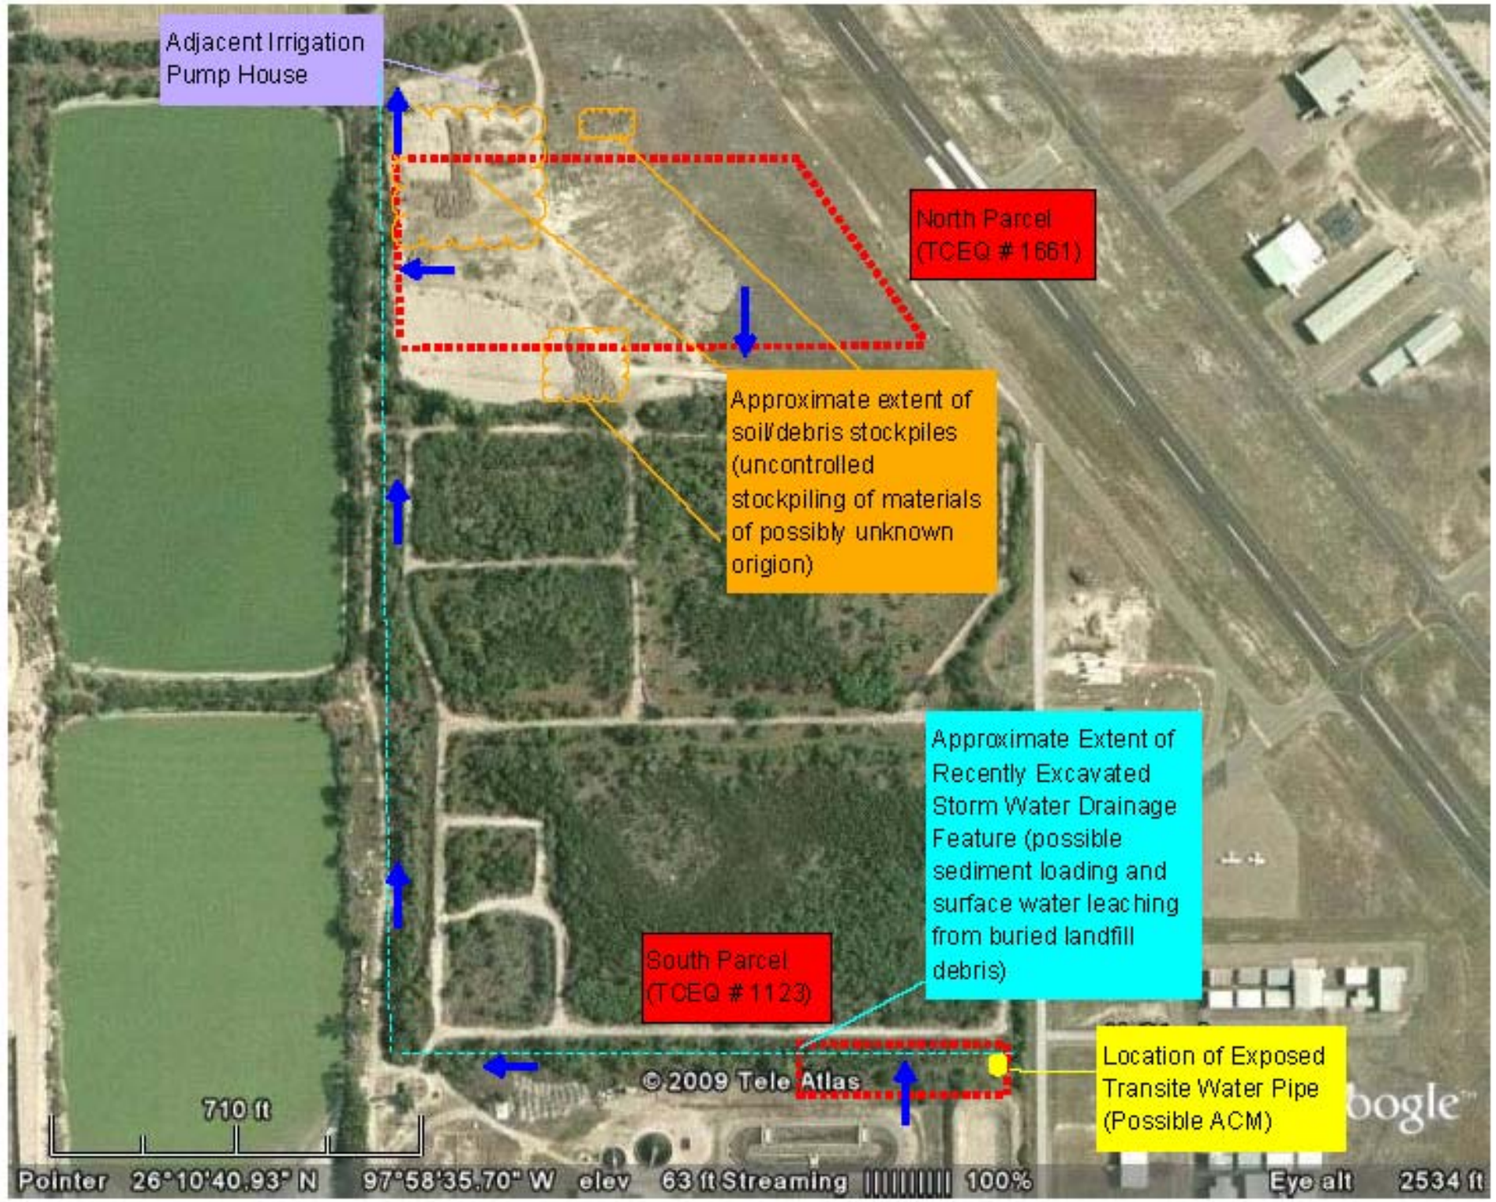
FIGURE 2: Former Landfill Parcels Site Map Illustrating Approximate Boundaries, Site Features, and RECS Identified During March 2009 Phase I ESA.

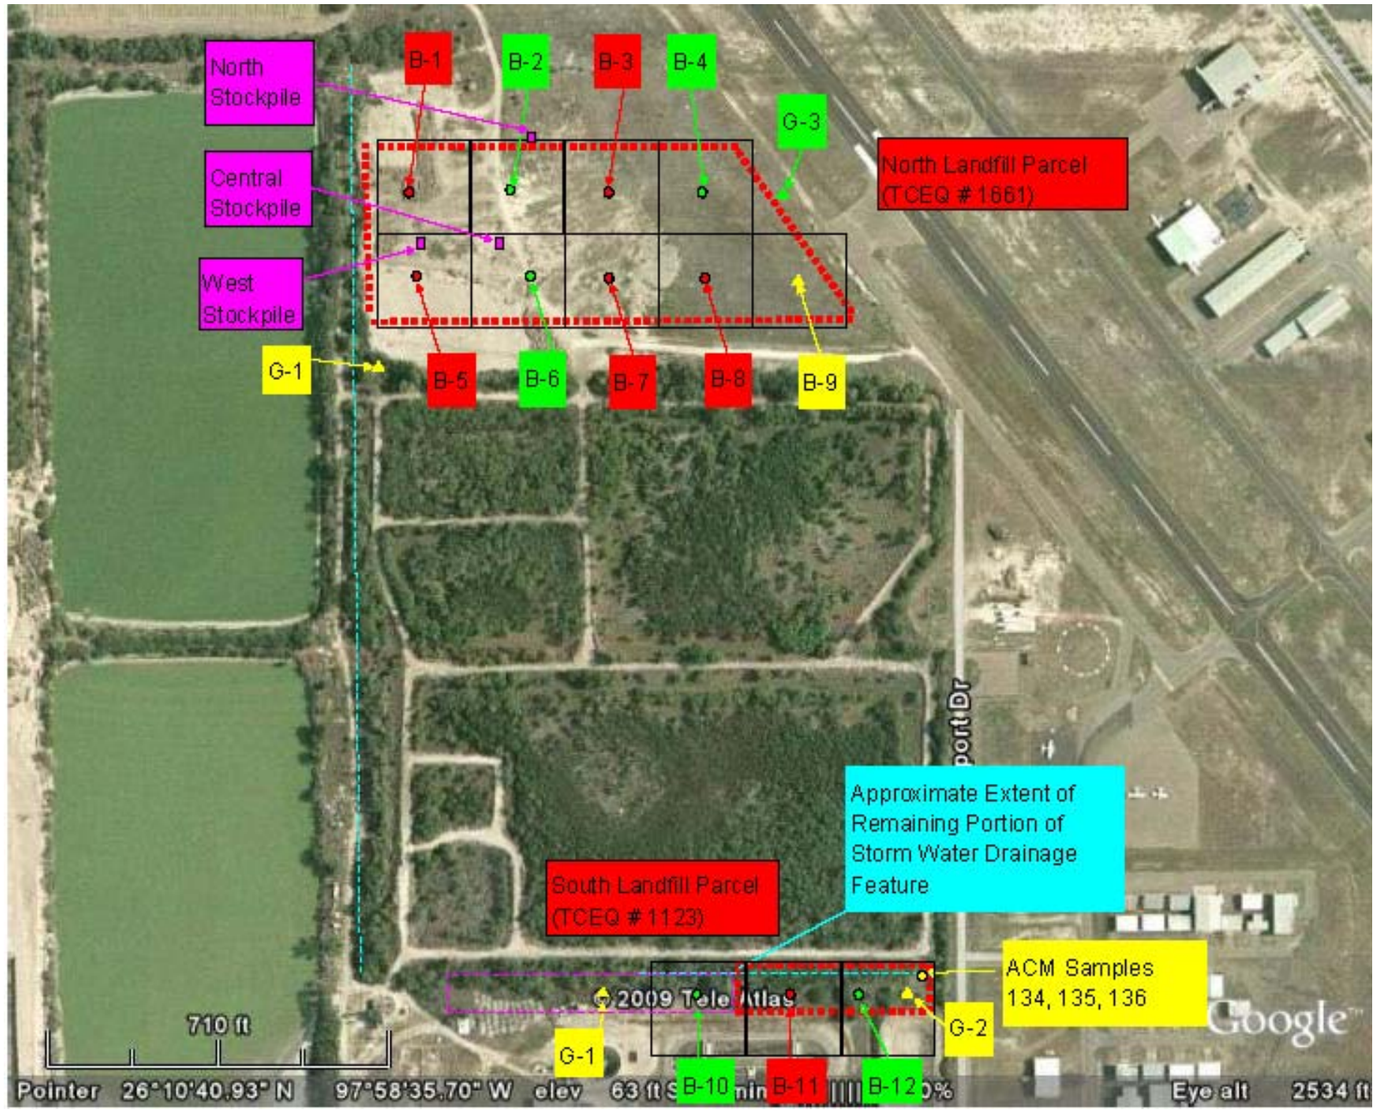
The DPT boring locations are illustrated on **Figure 3 (Appendix B)**. Per the July 2009 QAPP/SAP, borings B-1 through B-12 were installed at these locations in order to be representative of a one-acre grid system established for each of the landfill parcels, while boring locations for borings G-1 through G-4 were originally proposed/intended for use as temporary ground water monitoring wells. Based on a change in site conditions, boring G-3 was converted into a temporary landfill leachate well due to encountering landfill debris at this location. In addition, boring B-9 was converted into a temporary ground water monitor well due to it being outside the footprint of landfill debris.

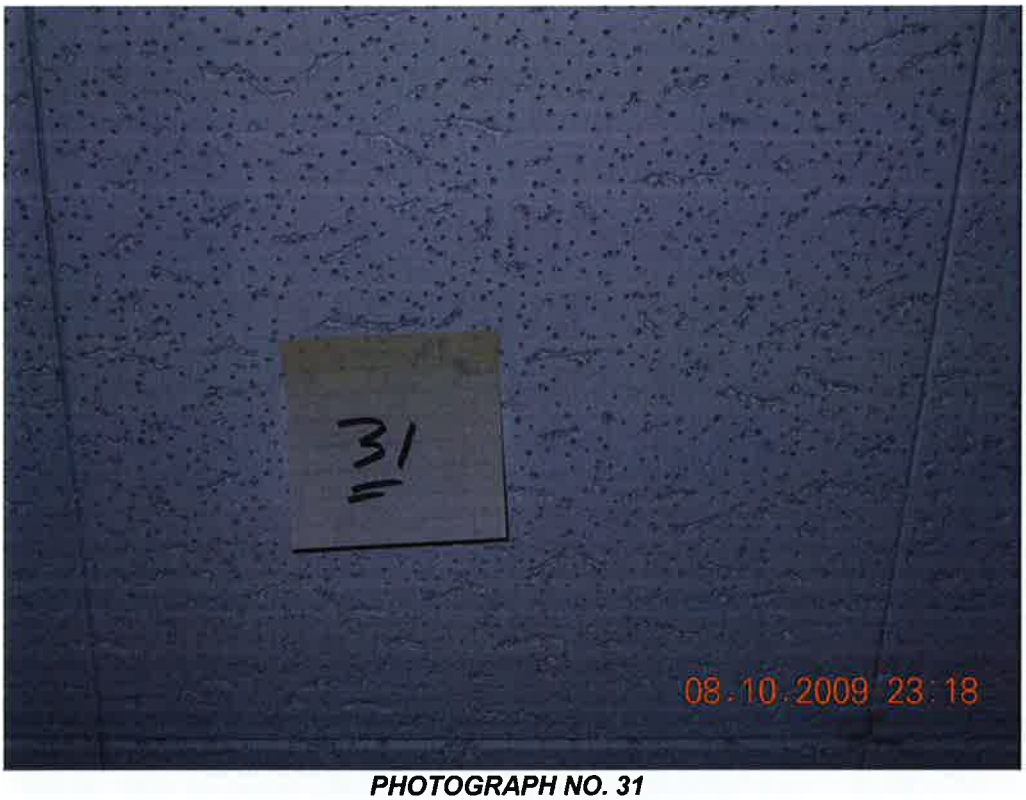
PHOTOGRAPH NO. 31
12" CEILING TILE IN OFFICE AREAS.
PHOTOGRAPH TAKEN BY R-K ON 8/10/09.

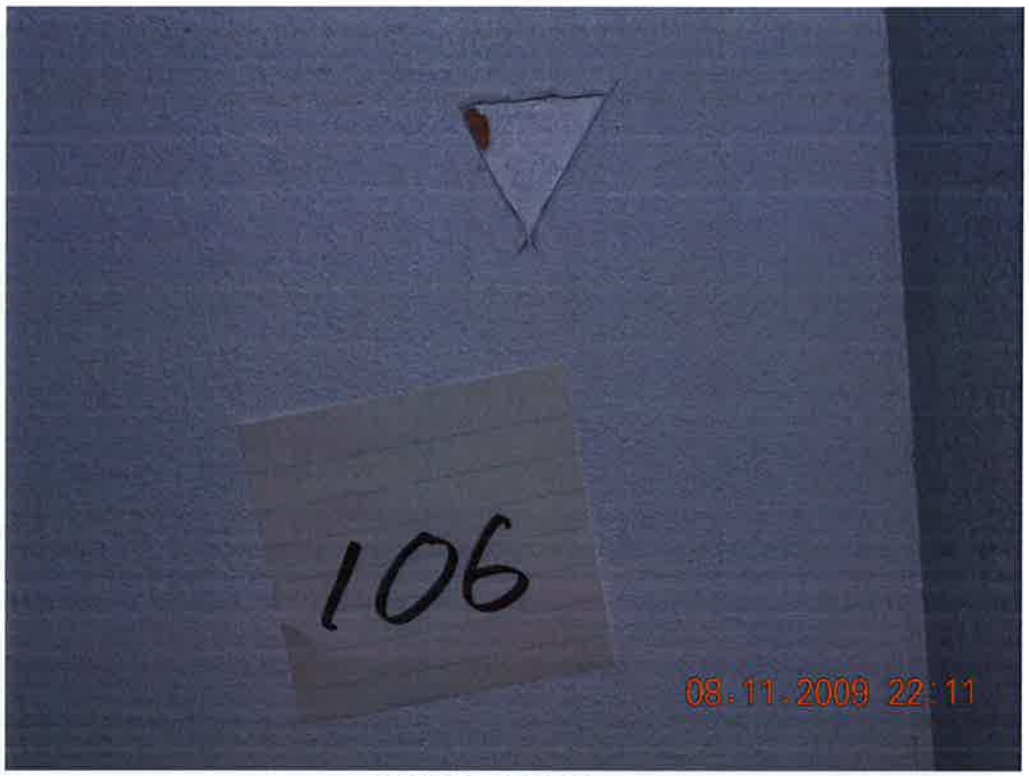
PHOTOGRAPH NO. 106
WALLBOARD, JOINT COMPOUND, AND TEXTURE IN SECOND STORY OLD ENGINEERING DEPARTMENT OFFICE. PHOTOGRAPH TAKEN BY R-K ON 8/11/09.

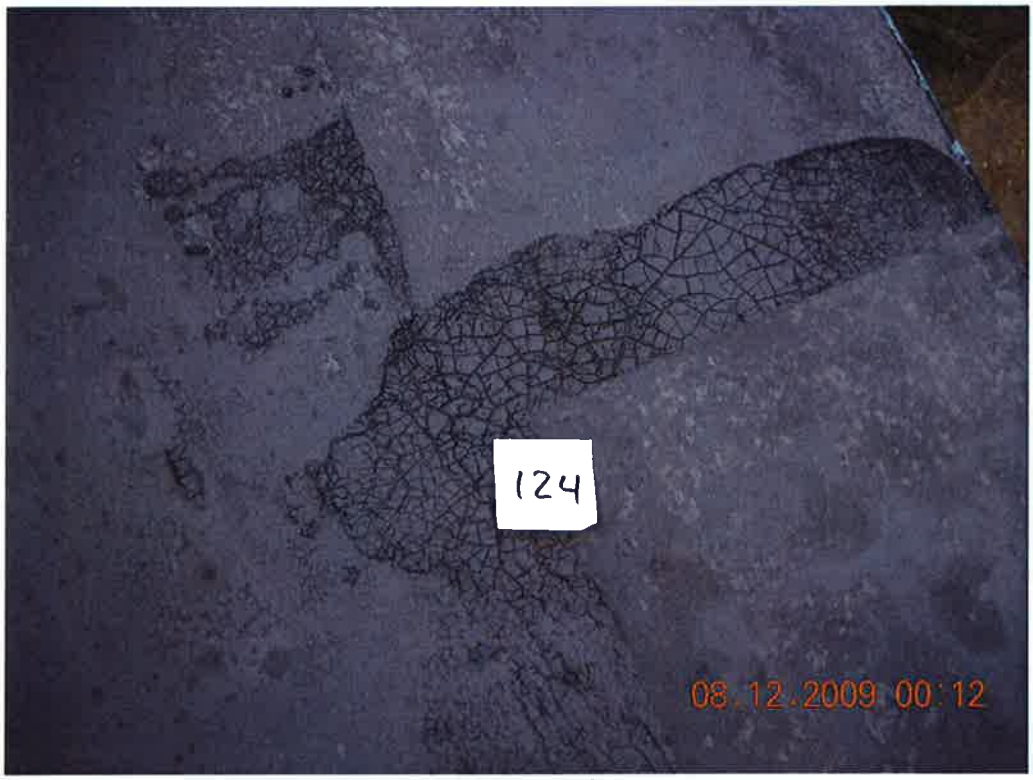
PHOTOGRAPH NO. 124
NORTHEAST METER SHOP ROOM WITH ASPHALT ROOFING PAPER AND BLACK MASTIC.
PHOTOGRAPH TAKEN BY R-K ON 8/12/09.
