FINAL
PHASE II INVESTIGATION
TARGETED BROWNFIELDS ASSESSMENT REPORT

Former Lincoln Heights Jail
401 North Avenue 19
Los Angeles, Los Angeles County, California

Prepared for:
U.S. Environmental Protection Agency
Region 9

February 2018

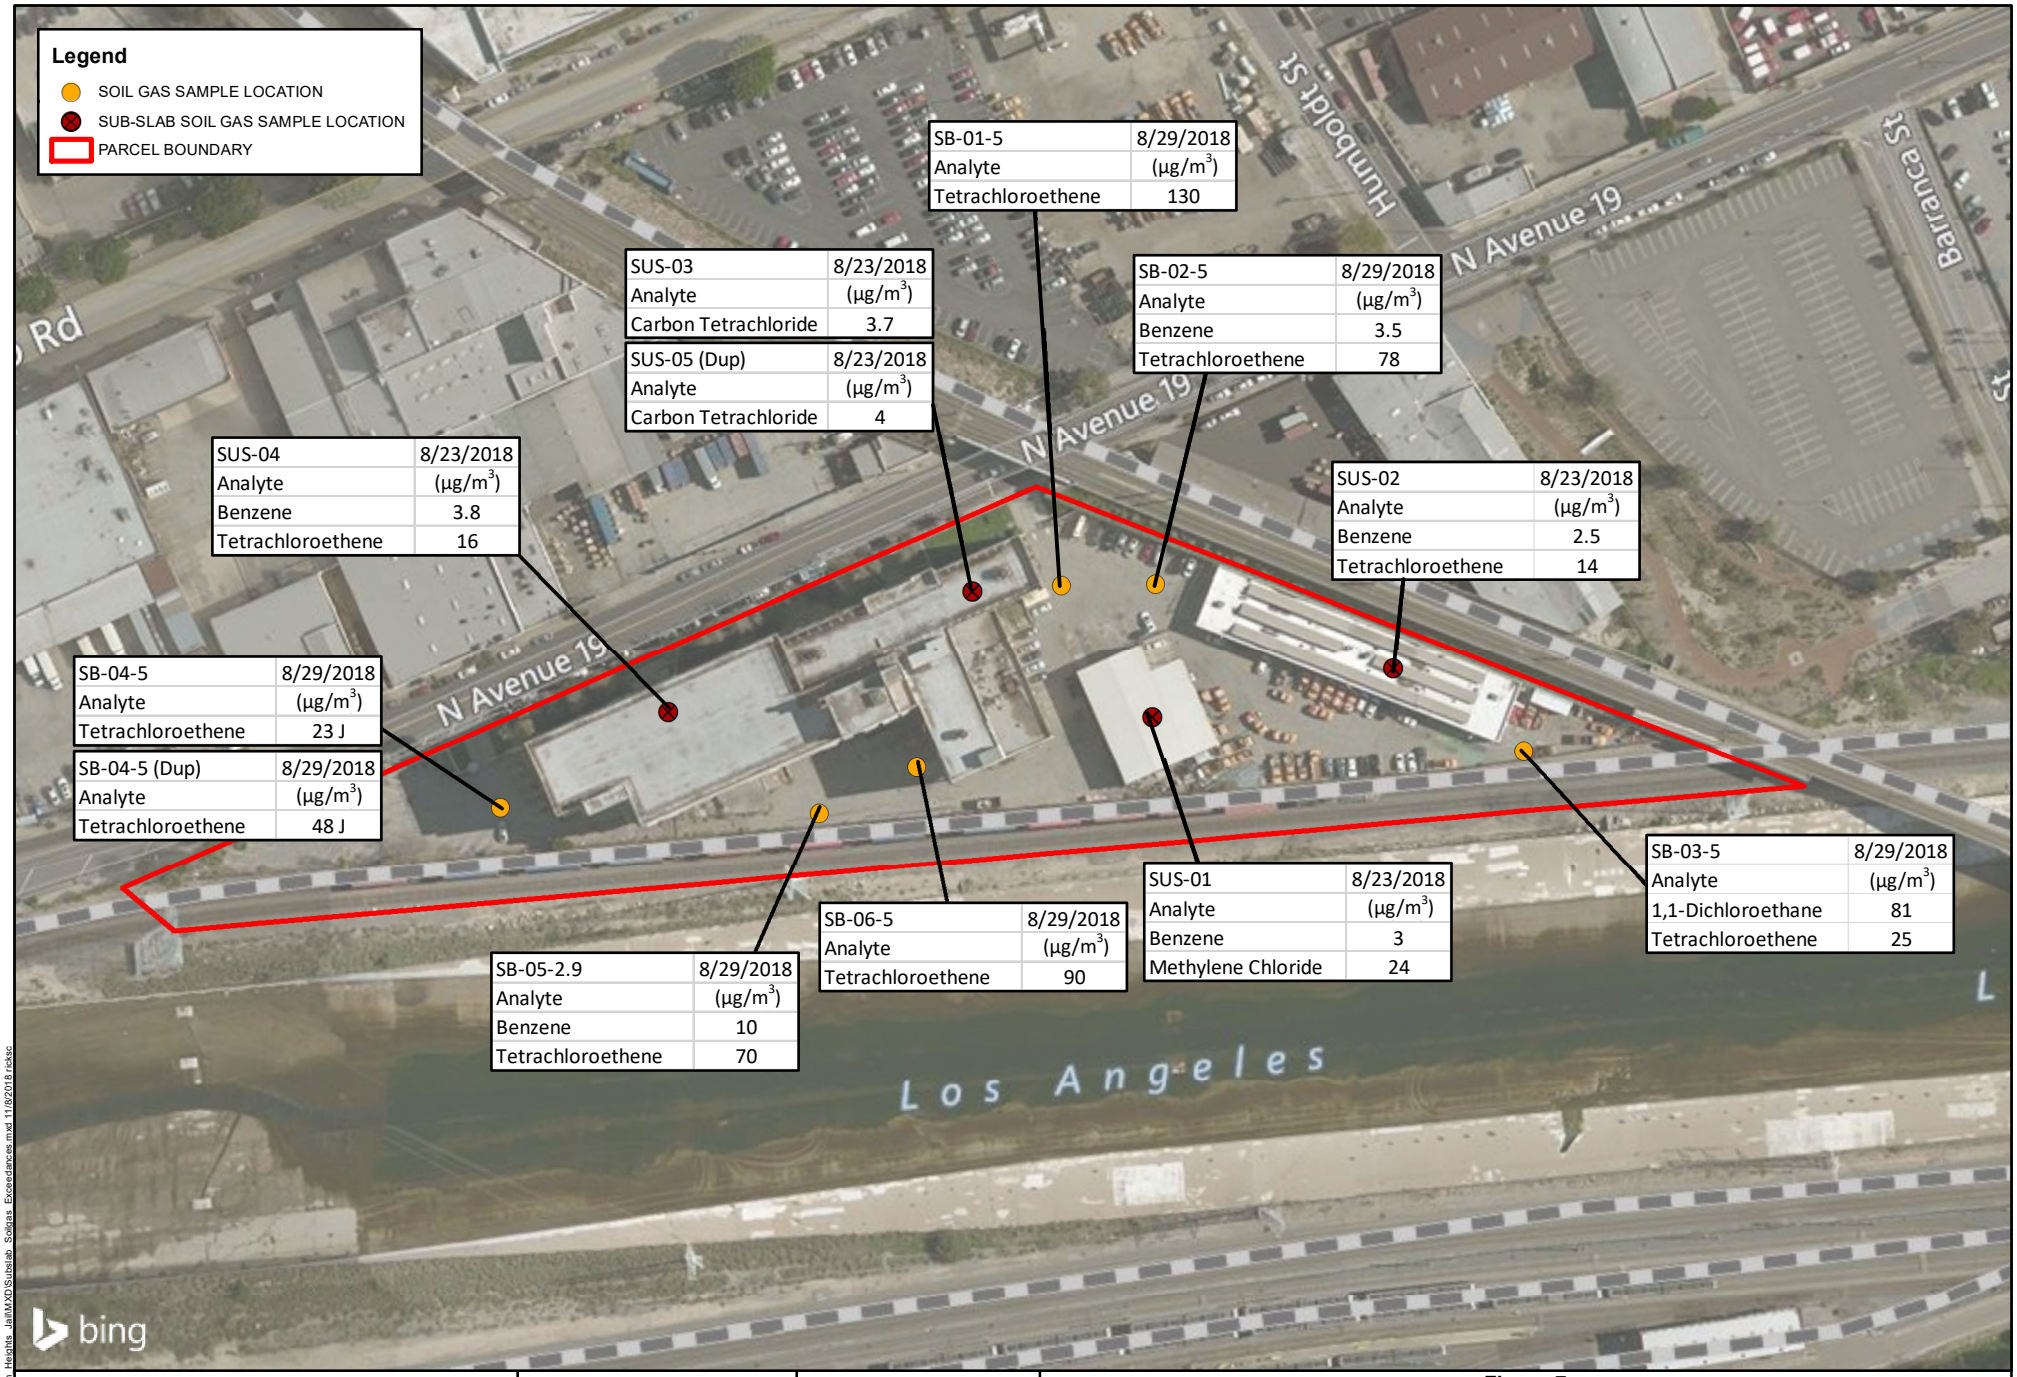
Figure 7
SUB-SLAB SOIL GAS AND SOIL GAS RESULTS-
EXCEEDANCES OF SCREENING LEVELS
Los Angeles - Former Lincoln Heights Jail
Targeted Brownsfields Assessment
Los Angeles, Los Angeles County, California

Sub-slab sample locations are shown on Figure 4. As shown, sub-slab samples were collected at four locations. Laboratory results for VOCs in sub-slab soil gas samples are presented in Table 10. One or more VOCs exceeded a DTSC-SL for sub-slab soil gas in all five sub-slab soil gas samples, including one duplicate. Because the boring met refusal at approximately 3 feet bgs, soil gas sample SB-05-2.9 was collected at 2.9 feet bgs. All other soil gas samples were collected at 5 feet bgs.

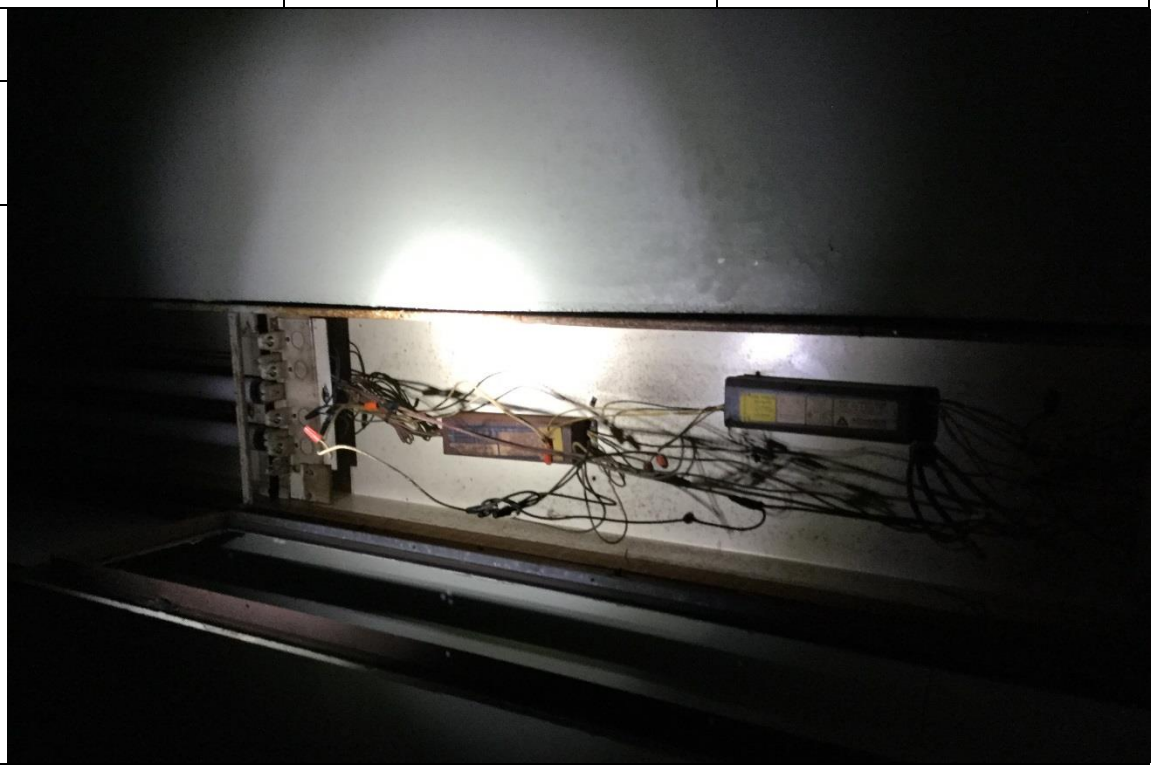
View of light ballast likely to contain PCBs.

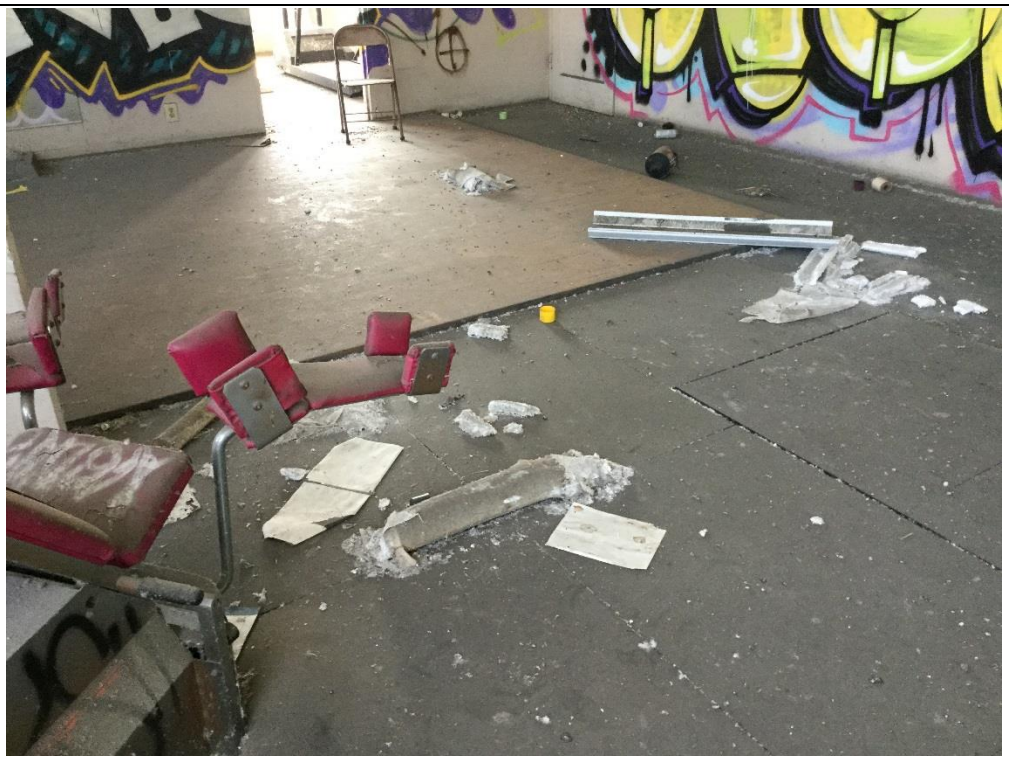
Photo No.	Date:
4	7/26/16

Friable TSI Pipe Insulation with ACM on 4th Floor. Note objects in the room must be cleaned or they will require disposal as ACM.

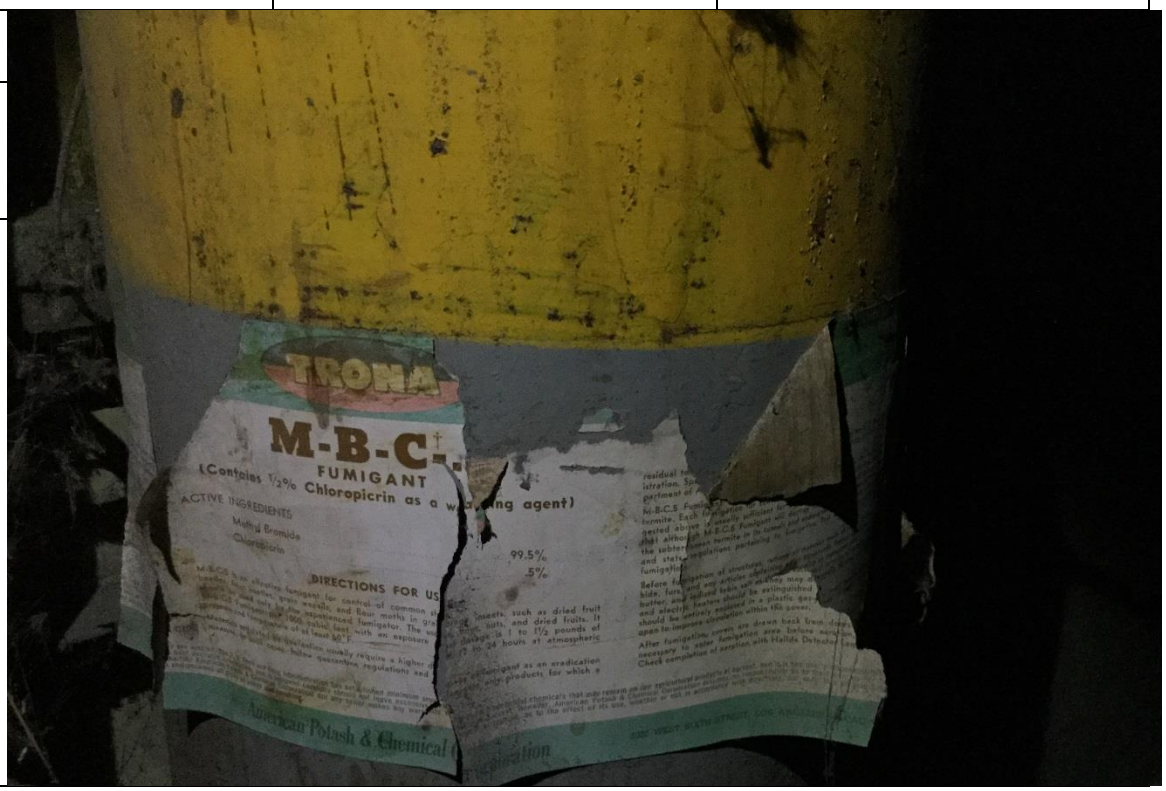
View of label from 1 of 3 bottled gas cylinders containing 99.5% methyl bromide and 0.5% chloropicrin in laundry room area of basement. Gas appeared to have been used to fumigate clothes and or bedding. Cylinders were safely removed in July 2018.

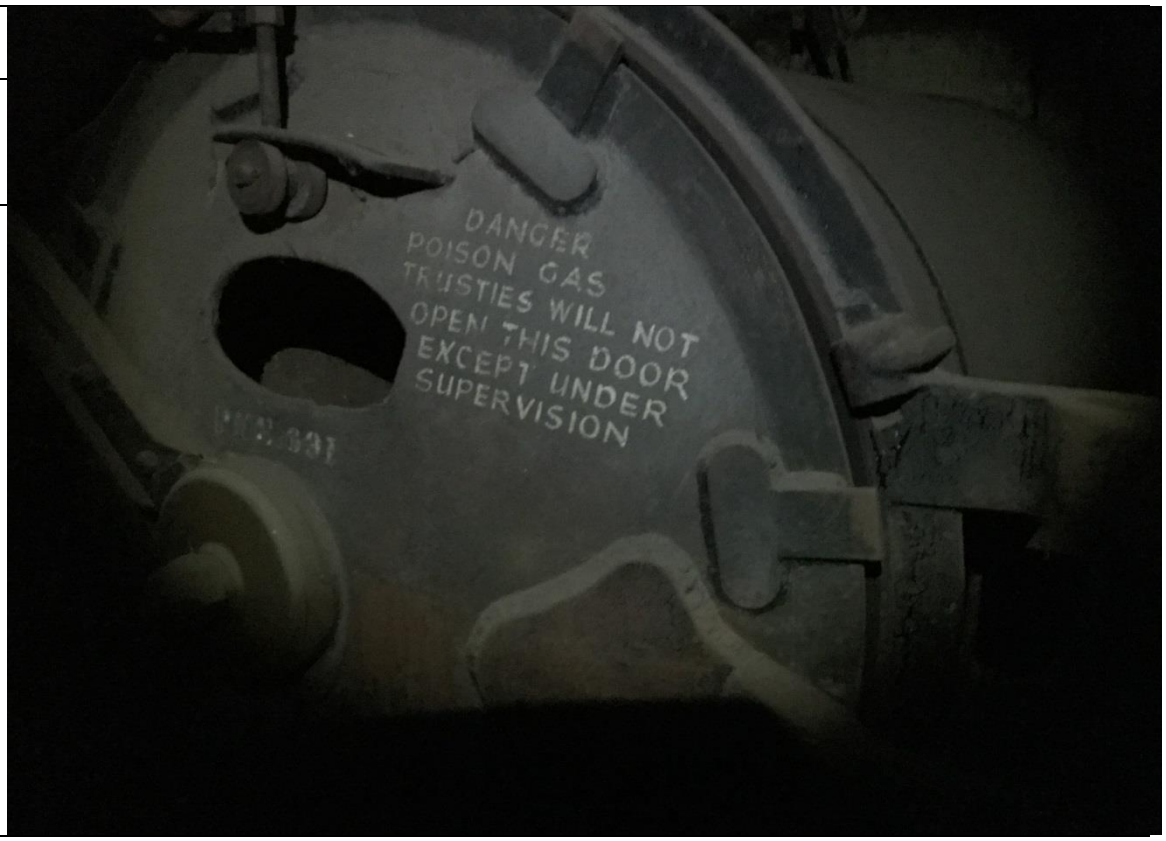
Photo No.	Date:
12	7/16/16

View of label on 1 of 4 apparent fumigation units in laundry area of basement. Bottled ethyl bromide/chloropicrin gas was plumbed to all 4 units.

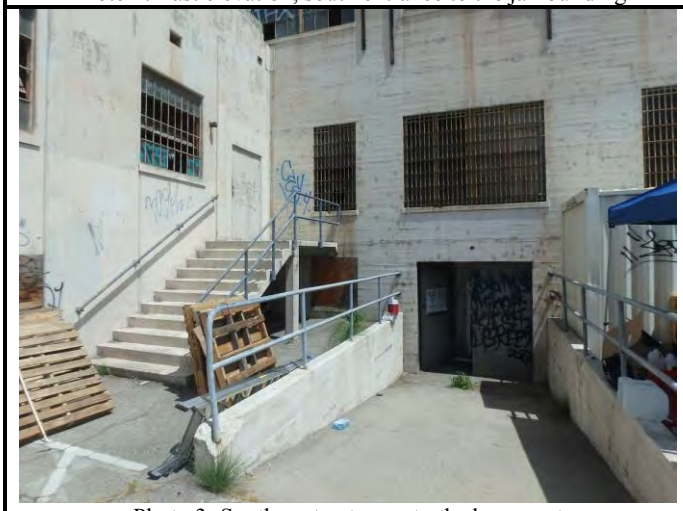
Photo 3: Southwest entrance to the basement

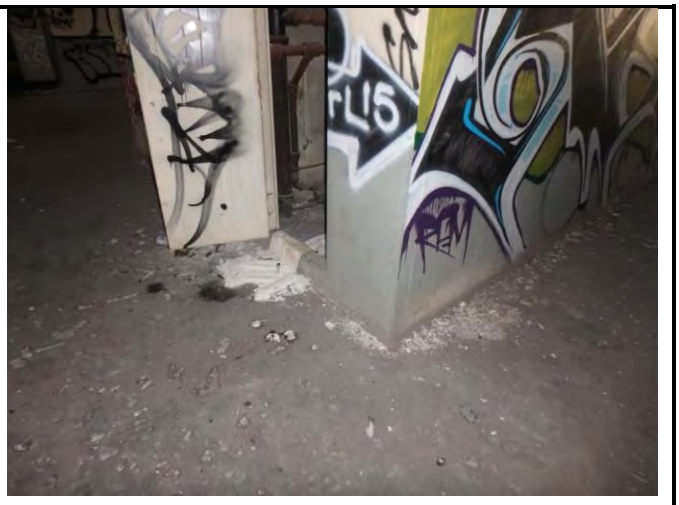
Photo 24: Typical interior contaminated with TSI debris, bird droppings and LBP debris

Photo 25: TSI debris
