OPS Briefing

January 13, 2014

Air Monitoring Location/Data Map - 1/12/14 - 14;20 hours
Charleston, WV Chemical Leak - Etowah, West Virginia

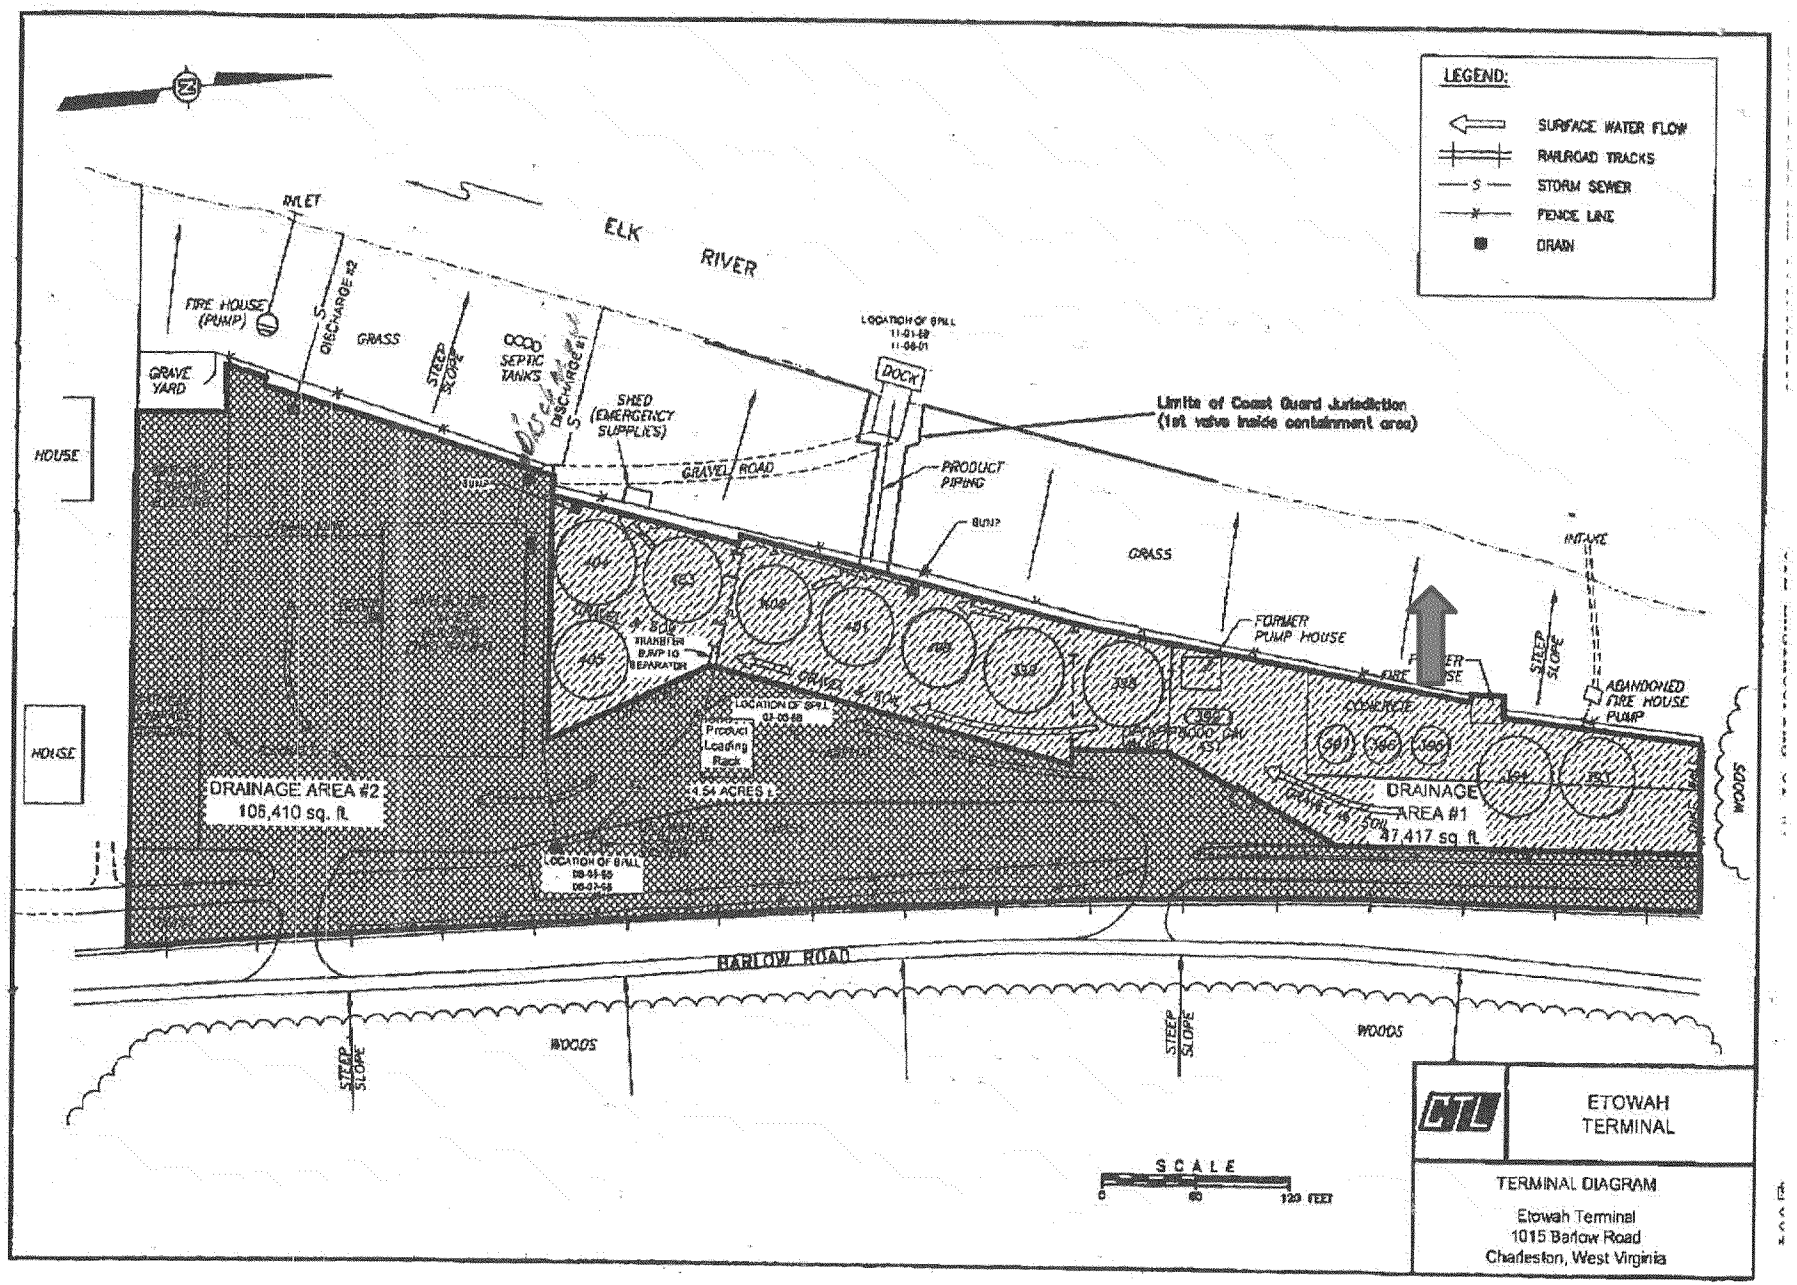
Storm drain below the second containment of tank farm
