FIELD BOOK

UNITED STATES ENVIRONMENTAL PROTECTION AGENCY
61 FORSYTH STREET, SW
ATLANTA, GEORGIA 30303

NAME: Bobby Glover Site - Jasper County, SC.

Project ID: Glover Date: 6/27/2016 Page 1 of 6

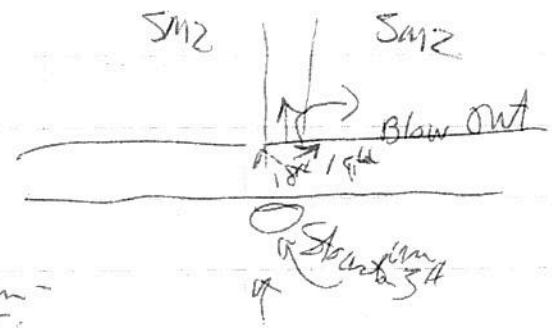
3RD Structure -
Same as other Two

18th of Downstream Run -
Clogged with Silt & trees - / SMZ

19th of Blow out on East side of channel

20th of 5th Branch for Structure

eroding around pipe on downstream pipe

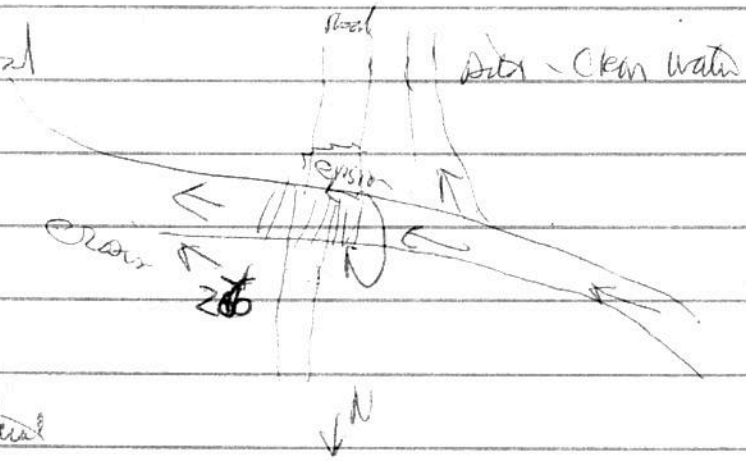
North End of Road

pic 21 - 3rd Structure - 2.5 to 3 Bench of Water Backed up - (Note in pic)

pic 22 - Strictly North along Road - good erosion control

23 - Strictly South along Road - " " "

pic 24 - Sandy Material

placed on top of Clay Base → Road

25 of new Road fill on top of Clay - Ruler

26 - of Erosion on west Side of Road

Noted Significant Erosion gullies in Road
