GUILFORD HIGH SCHOOL
605 NEW ENGLAND ROAD
GUILFORD, CONNECTICUT

TABLE 1
SUMMARY OF SOURCE AND SUBSTRATE MATERIALS
PCB INVESTIGATION
GUILFORD HIGH SCHOOL

TABLE 2
SUMMARY OF SOURCE AND SUBSTRATE MATERIAL REMOVAL REQUIREMENTS
PCB INVESTIGATION
GUILFORD HIGH SCHOOL

TABLE 3
Summary of Asphalt and Soil Data
PCB Investigation
Guilford High School

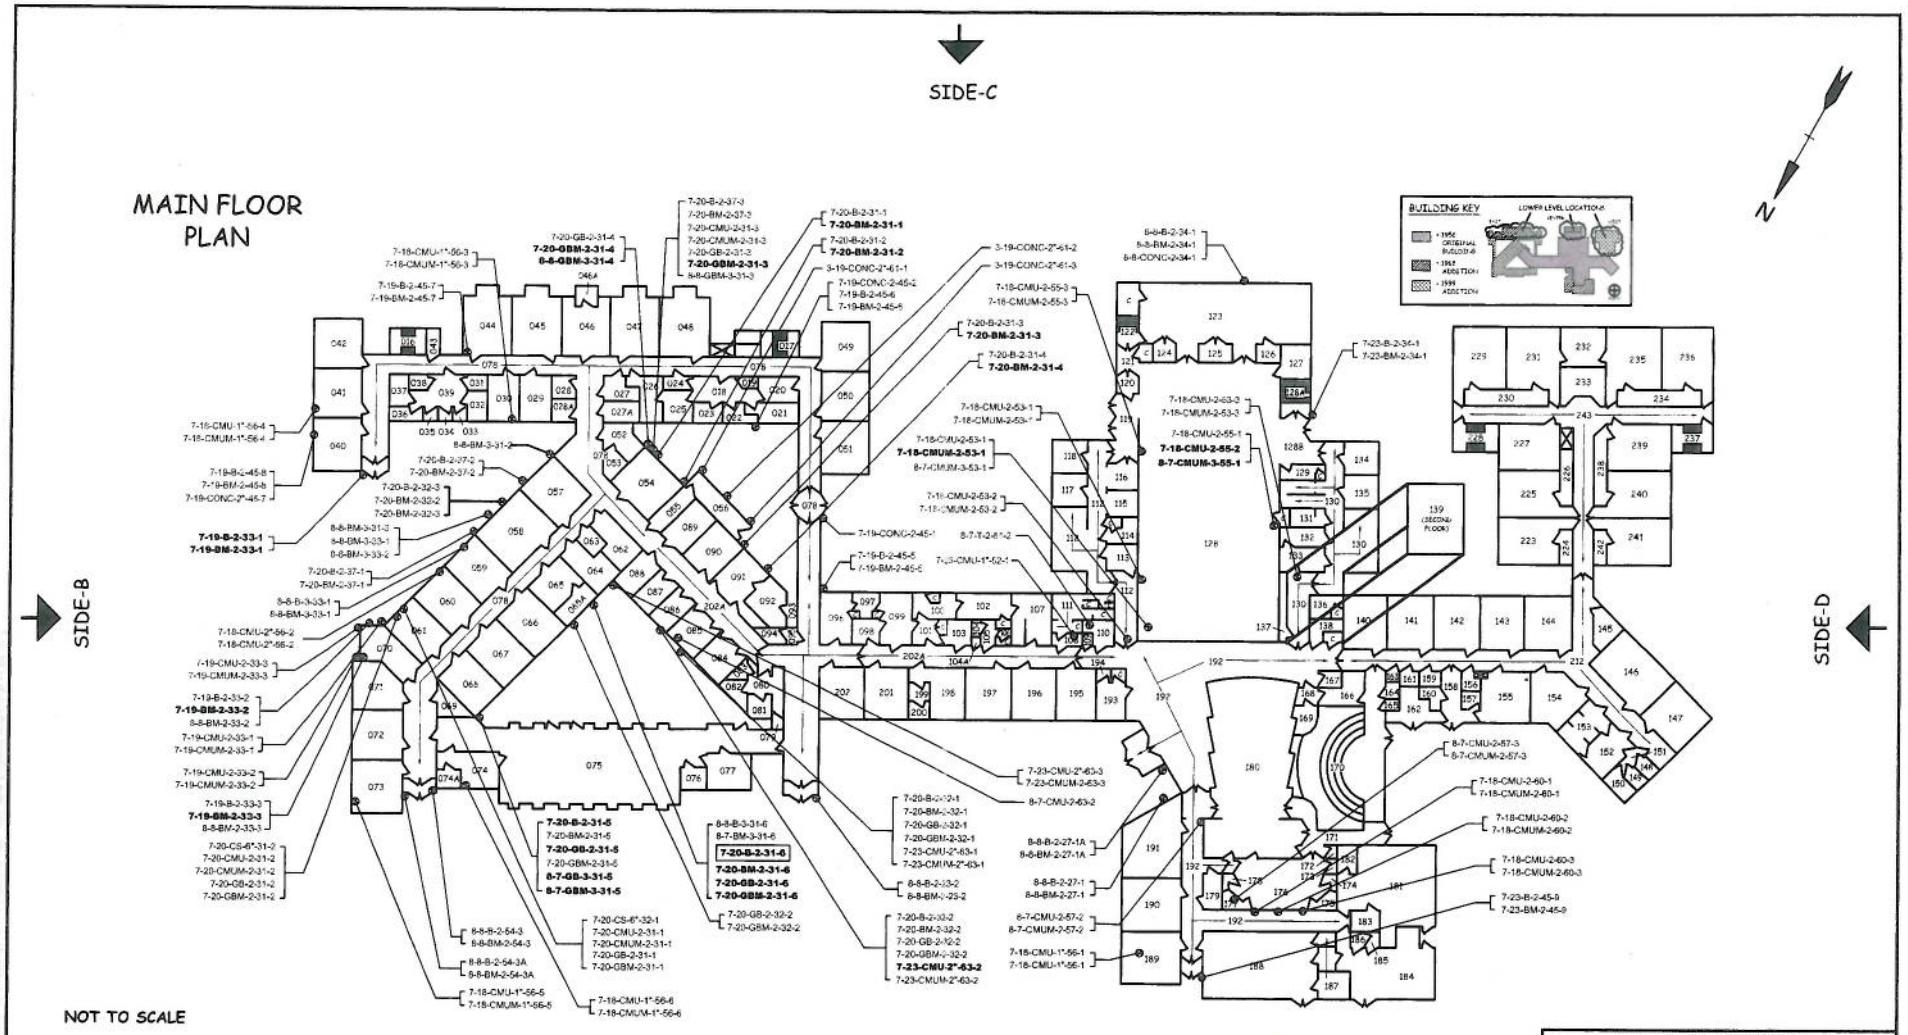
PCB Substrate Sample Locations
Main Floor

BOLDED SAMPLE NUMBERS INDICATE PRESENCE OF PCBS IN A CONCENTRATION > 1 PPM.

BOXED SAMPLE NUMBERS INDICATE PRESENCE OF PCBS IN A CONCENTRATION > 50 PPM.

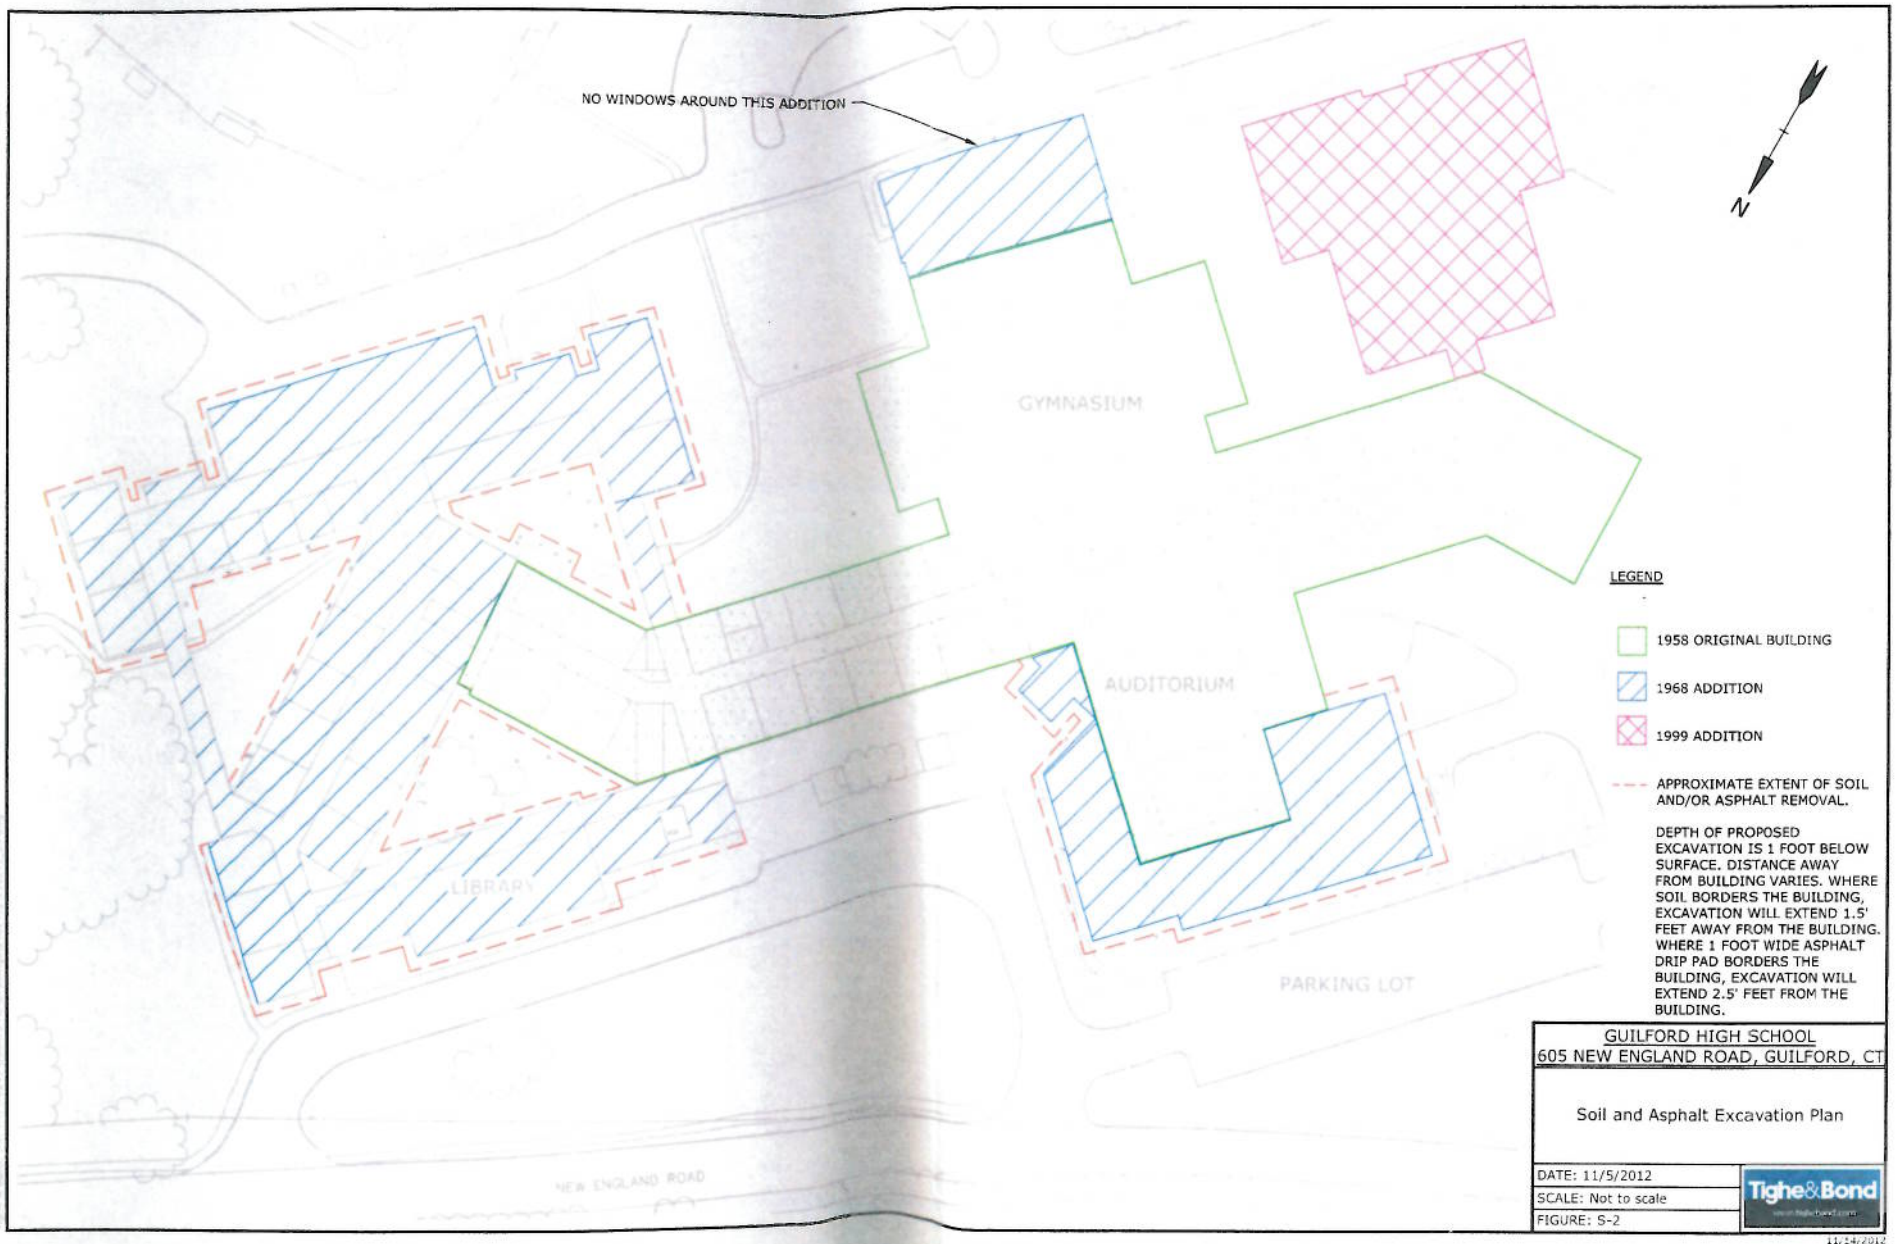
NO WINDOWS AROUND THIS ADDITION
GYMNASIUM
AUDITORIUM
LIBRARY
PARKING LOT
NEW ENGLAND ROAD
N
LEGEND
1958 ORIGINAL BUILDING
1968 ADDITION
1999 ADDITION
APPROXIMATE EXTENT OF SOIL AND/OR ASPHALT REMOVAL.
DEPTH OF PROPOSED EXCAVATION IS 1 FOOT BELOW SURFACE. DISTANCE AWAY FROM BUILDING VARIES. WHERE SOIL BORDERS THE BUILDING, EXCAVATION WILL EXTEND 1.5' FEET AWAY FROM THE BUILDING. WHERE 1 FOOT WIDE ASPHALT DRIP PAD BORDERS THE BUILDING, EXCAVATION WILL EXTEND 2.5' FEET FROM THE BUILDING.
GUILFORD HIGH SCHOOL
605 NEW ENGLAND ROAD, GUILFORD, CT
Soil and Asphalt Excavation Plan
DATE: 11/5/2012
SCALE: Not to scale
FIGURE: S-2
Tighe&Bond
11/14/2012

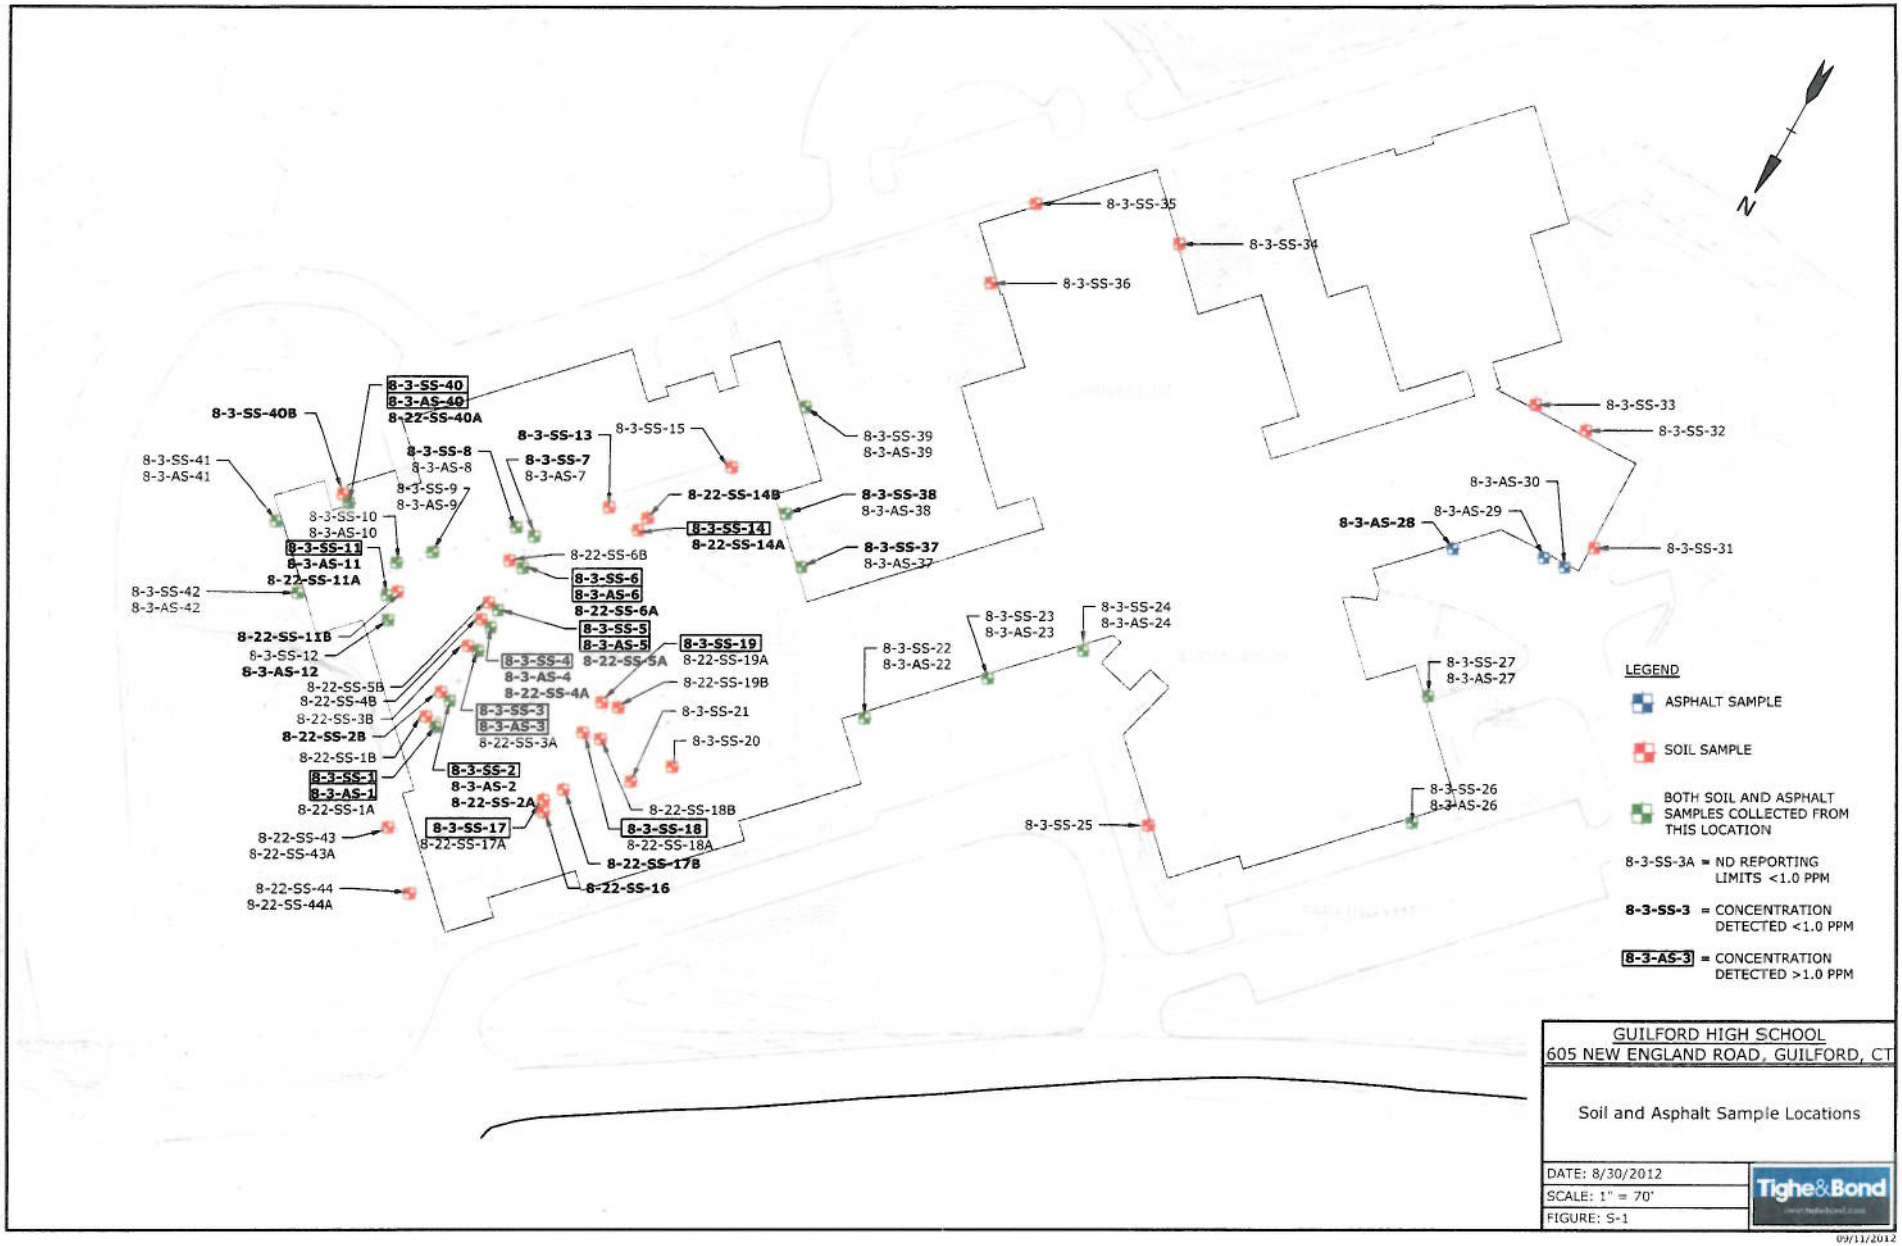
Soil and Asphalt Sample Locations

ID	Date Collected	Location	Notes	Media	Concentration mg/kg
8-3-SS-1 (0-3")	8/3/2012	Southeastern courtyard - 1968 Addition	1 inch off asphalt drip edge	Soil	**7.5**
8-22-SS-1A (12")	8/22/2012			Soil	ND <0.39
8-22-SS-1B (0-3")	8/22/2012		5 feet off asphalt drip edge	Soil	ND <0.40
8-3-AS-1	8/3/2012		Low spot on asphalt drip edge	Asphalt	**1.8**
8-3-SS-2 (0-3")	8/3/2012		1 inch off asphalt drip edge	Soil	**4.2**
8-22-SS-2A (12")	8/22/2012			Soil	0.61
8-22-SS-2B (0-3")	8/22/2012		5 feet off asphalt drip edge	Soil	0.79
8-3-AS-2	8/3/2012		Low spot on asphalt drip edge	Asphalt	0.56
8-3-SS-3 (0-3")	8/3/2012		1 inch off asphalt drip edge	Soil	**3.1**
8-22-SS-3A (12")	8/22/2012			Soil	ND <0.37
8-22-SS-3B (0-3")	8/22/2012		5 feet off asphalt drip edge	Soil	ND <0.42
8-3-AS-3	8/3/2012		Low spot on asphalt drip edge	Asphalt	**1.7**
8-3-SS-4 (0-3")	8/3/2012		1 inch off asphalt drip edge	Soil	**1.7**
8-22-SS-4A (12")	8/22/2012			Soil	0.51

17	- sample exceeds EPA clean-up criteria of 1 mg/Kg
(0-3")	- depth at which sample was collected
ND < 0.39	- concentrations of PCBs not reported above laboratory detection limits

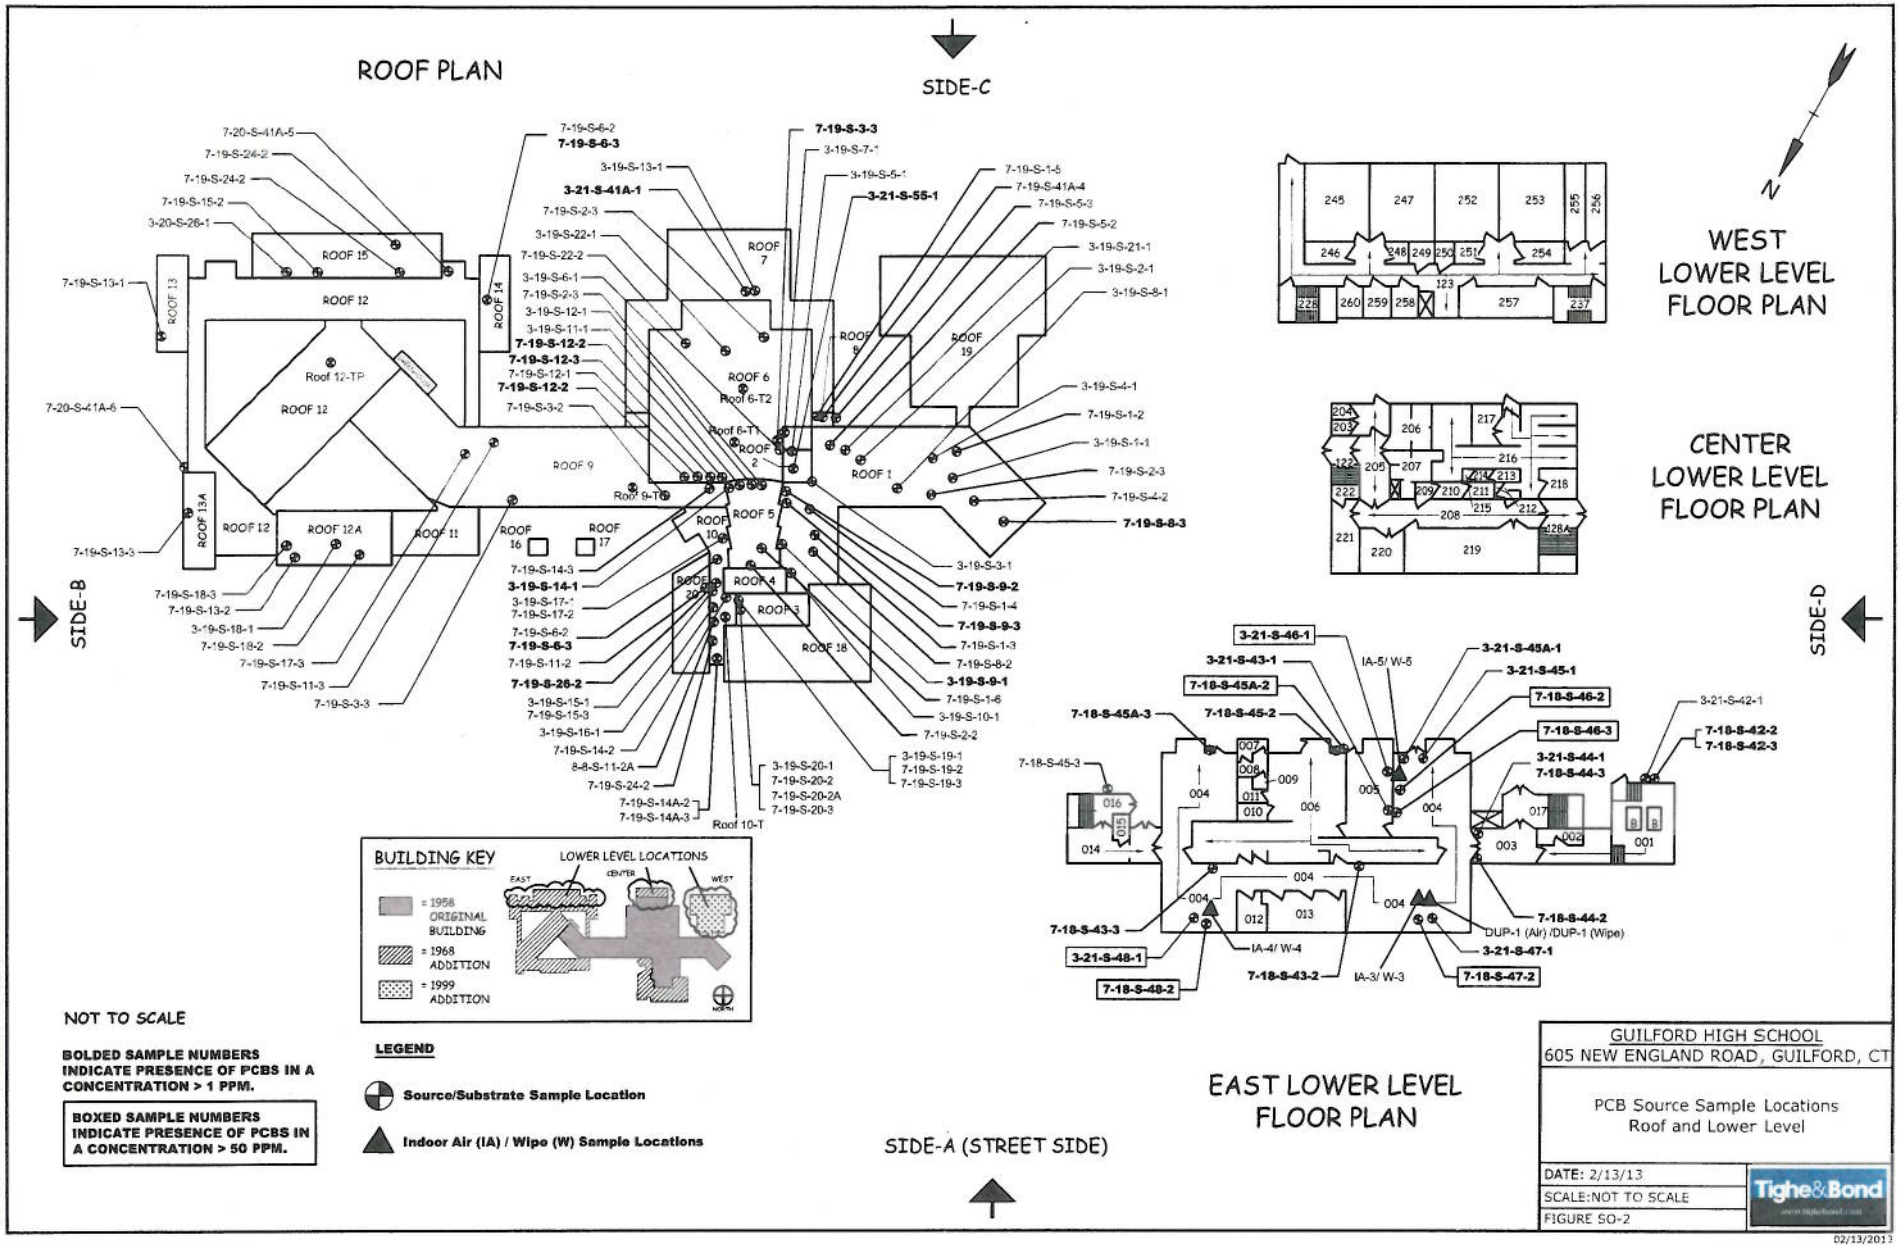
ROOF PLAN
SIDE-C
SIDE-B
SIDE-D
SIDE-A (STREET SIDE)
WEST LOWER LEVEL FLOOR PLAN
CENTER LOWER LEVEL FLOOR PLAN
EAST LOWER LEVEL FLOOR PLAN
BUILDING KEY
LOWER LEVEL LOCATIONS
EAST
CENTER
WEST
= 1958 ORIGINAL BUILDING
= 1968 ADDITION
= 1999 ADDITION
NOT TO SCALE
BOLDED SAMPLE NUMBERS INDICATE PRESENCE OF PCBS IN A CONCENTRATION > 1 PPM.
BOXED SAMPLE NUMBERS INDICATE PRESENCE OF PCBS IN A CONCENTRATION > 50 PPM.
LEGEND
Source/Substrate Sample Location
Indoor Air (IA) / Wipe (W) Sample Locations
GUILFORD HIGH SCHOOL
605 NEW ENGLAND ROAD, GUILFORD, CT
PCB Source Sample Locations
Roof and Lower Level
DATE: 2/13/13
SCALE:NOT TO SCALE
FIGURE SO-2
Tighe&Bond
02/13/2013

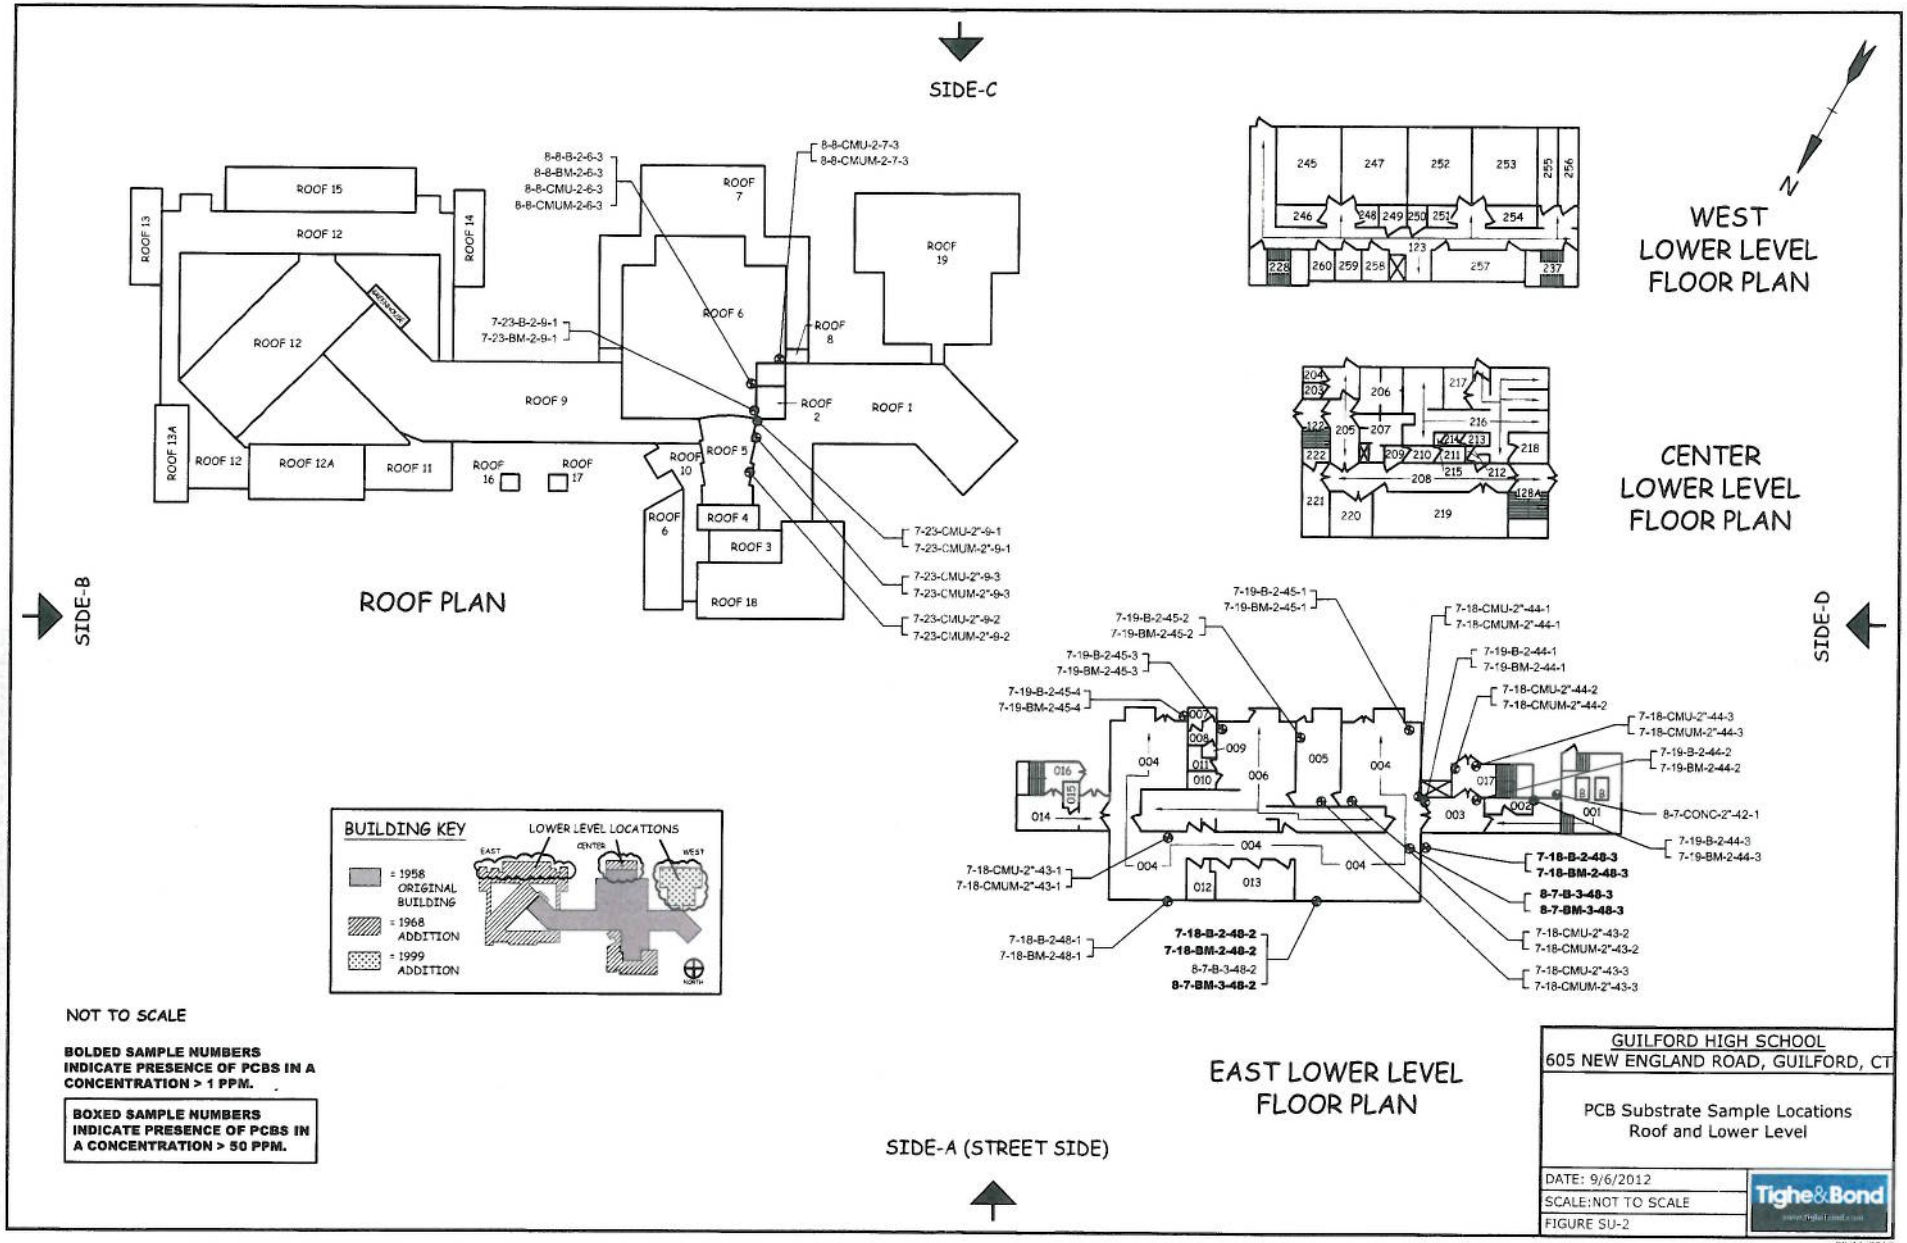
PCB Substrate Sample Locations
Roof and Lower Level

BOLDED SAMPLE NUMBERS INDICATE PRESENCE OF PCBS IN A CONCENTRATION > 1 PPM.

BOXED SAMPLE NUMBERS INDICATE PRESENCE OF PCBS IN A CONCENTRATION > 50 PPM.
