ANNUAL POLYCHLORINATED BIPHENYL ACTION SUMMARY REPORT

BODYCOTE THERMAL PROCESSING MELROSE PARK, ILLINOIS

PROJECT NO. 1998002.304

December 19, 2011

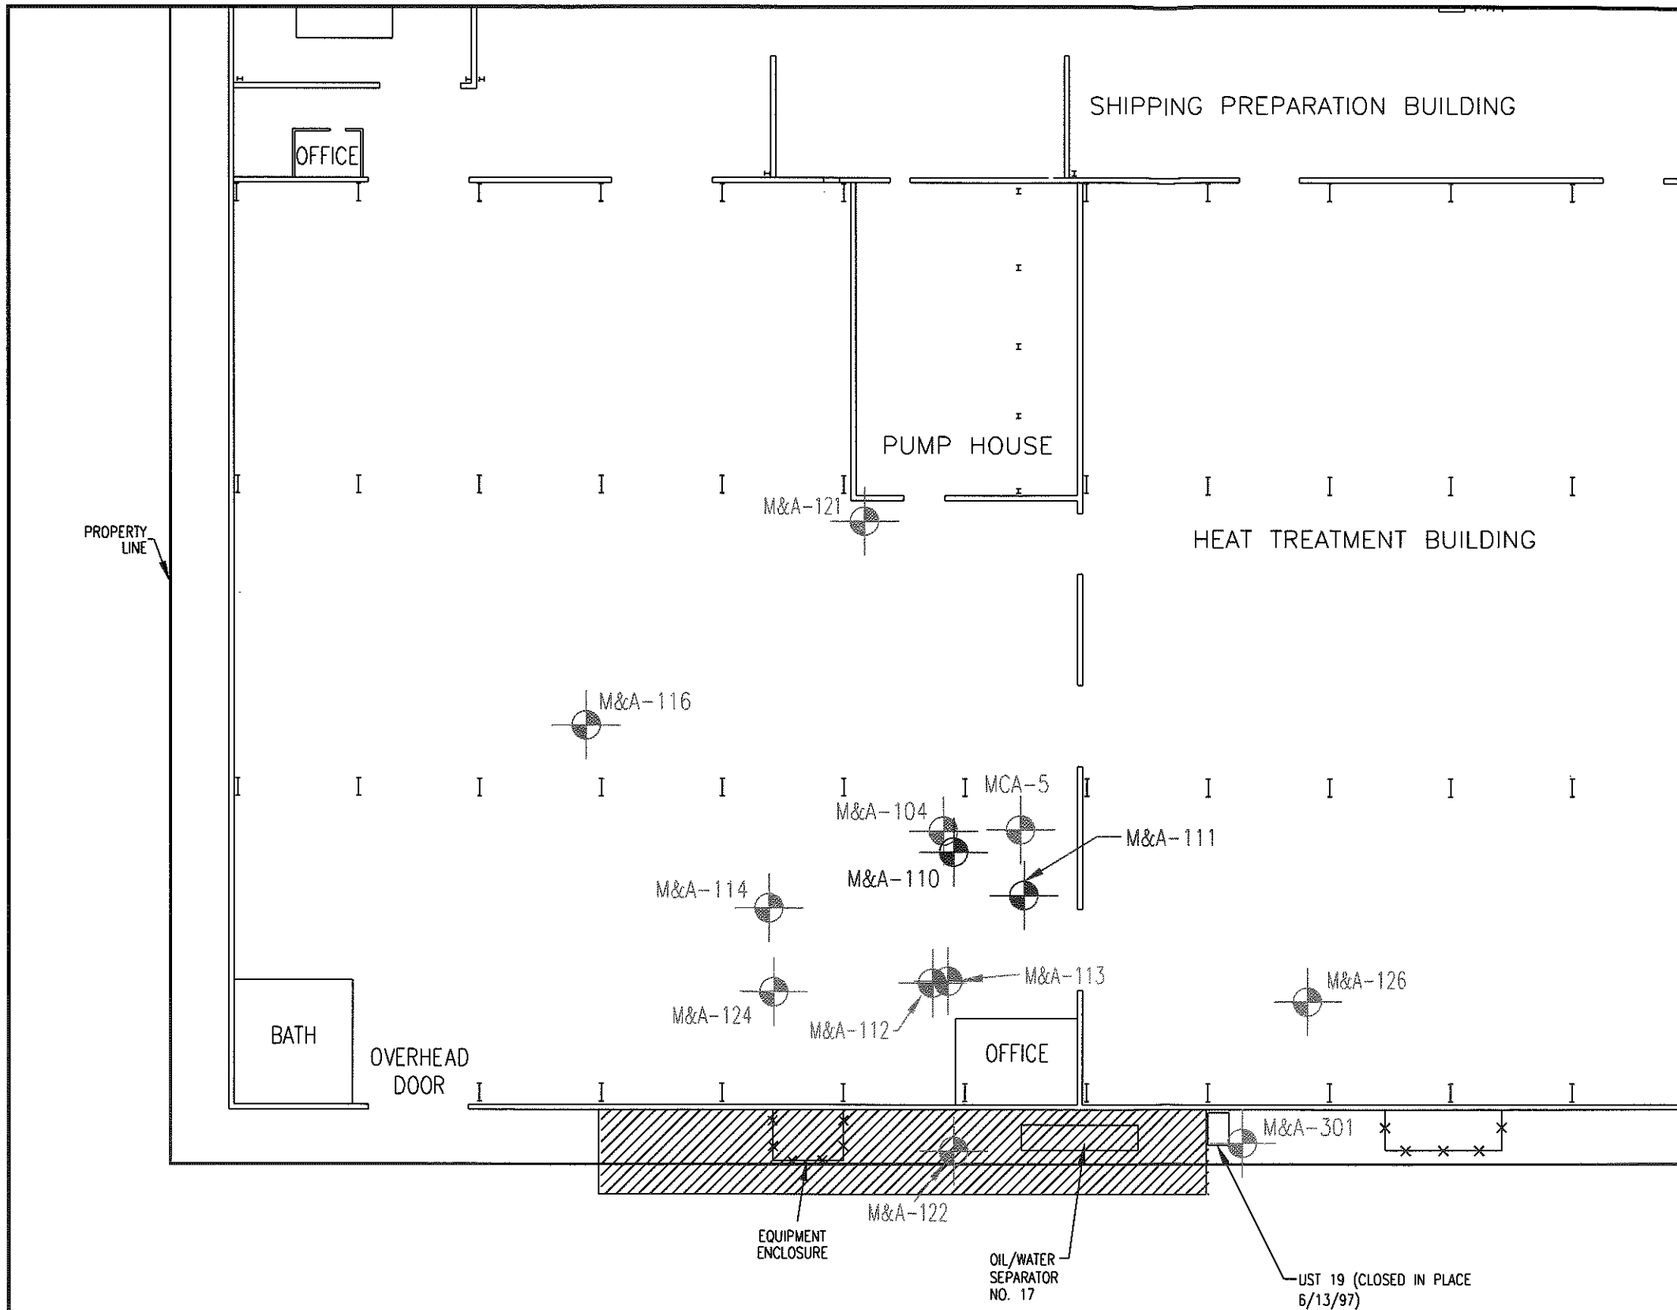
On November 15, 2006, Mabbett personnel oversaw the advancement of three soil borings in and around the northwestern portion of the HTB for the purpose of delineating the extent of PCBs. The soil borings were advanced by Precon Drilling, Inc. of Addison, Illinois using hollow stem auger drilling techniques. The soil borings were completed with 2-inch diameter monitoring wells and designated M&A-130, M&A-131, and M&A-133 (refer to Drawing L-2).

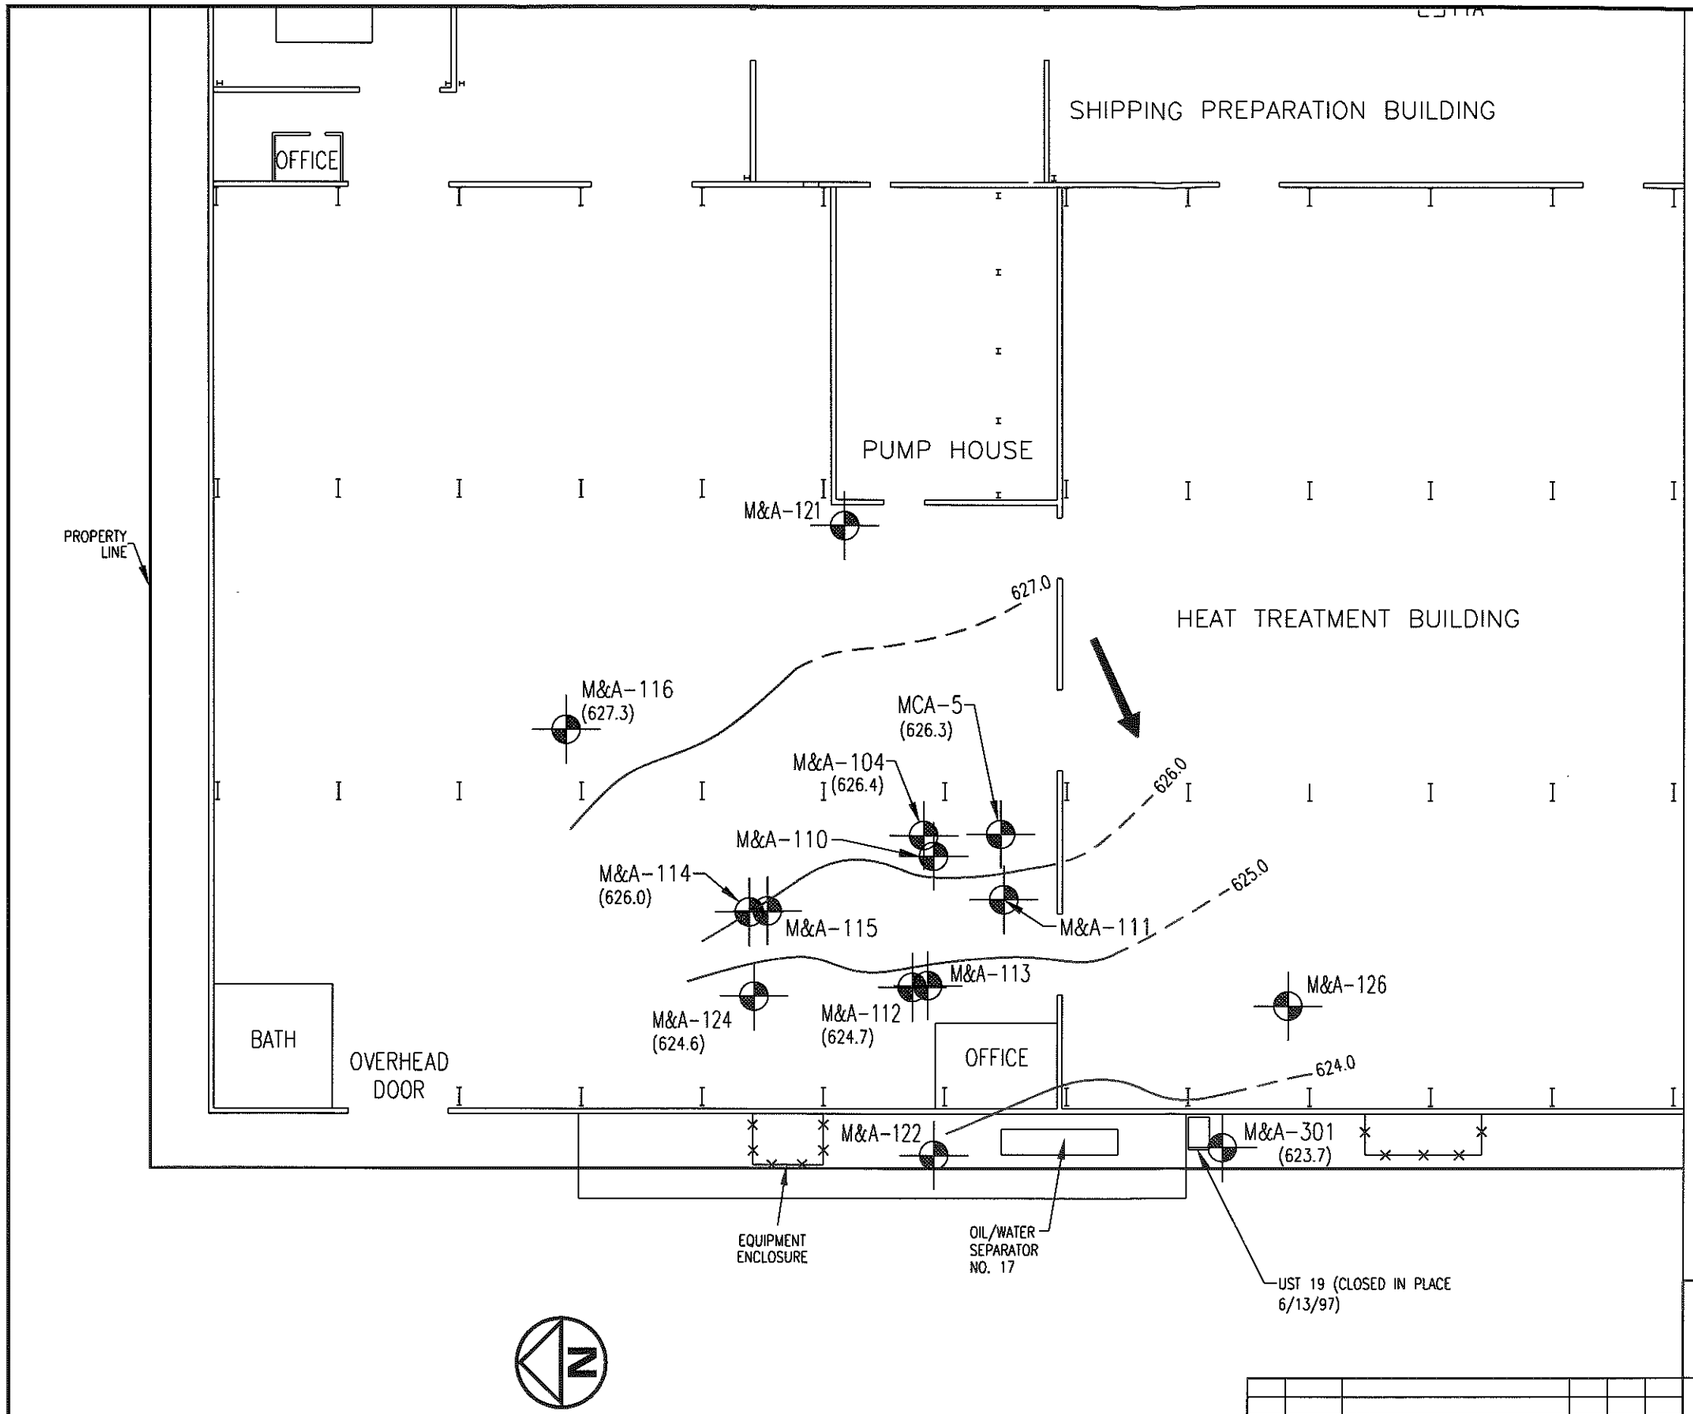
Drawing L-3 depicts the area of PCB groundwater contamination beneath the HTB in October 2011. The successful elimination of LNAPL in monitoring well M&A-301 and the absence of PCBs in groundwater at downgradient boundary wells M&A-122 and M&A-301 indicate that the likelihood for migration of PCB contaminated groundwater in a westerly direction off the property is minimal (refer to Drawing L-4 Heat Treat Building Shallow Groundwater Contours).
