1. STRUCTURAL BRACING, INSULATION & SOME ACCESS NOT SHOWN FOR CLARITY
IA INSTRUMENT AIR WITH FILTER-REGULATOR SET
AS AIR SUPPLY AT 100 PSIG
ES ELECTRICITY SUPPLY AT 120 VAC, 60 Hz
AUG 1 1990
FOR INFORMATION ONLY
THIS DRAWING IS FOR INFORMATION (REFERENCE ONLY) AND IS NOT FOR ENGINEERING OR CONSTRUCTION PURPOSES.
WASTE TECHNOLOGIES INDUSTRIES
INDUSTRIAL WASTE MANAGEMENT FACILITY
EAST LIVERPOOL, OHIO
INCINERATION

DRAWING NUMBER 3647
NORTH ELEVATION
LOOKING SOUTH

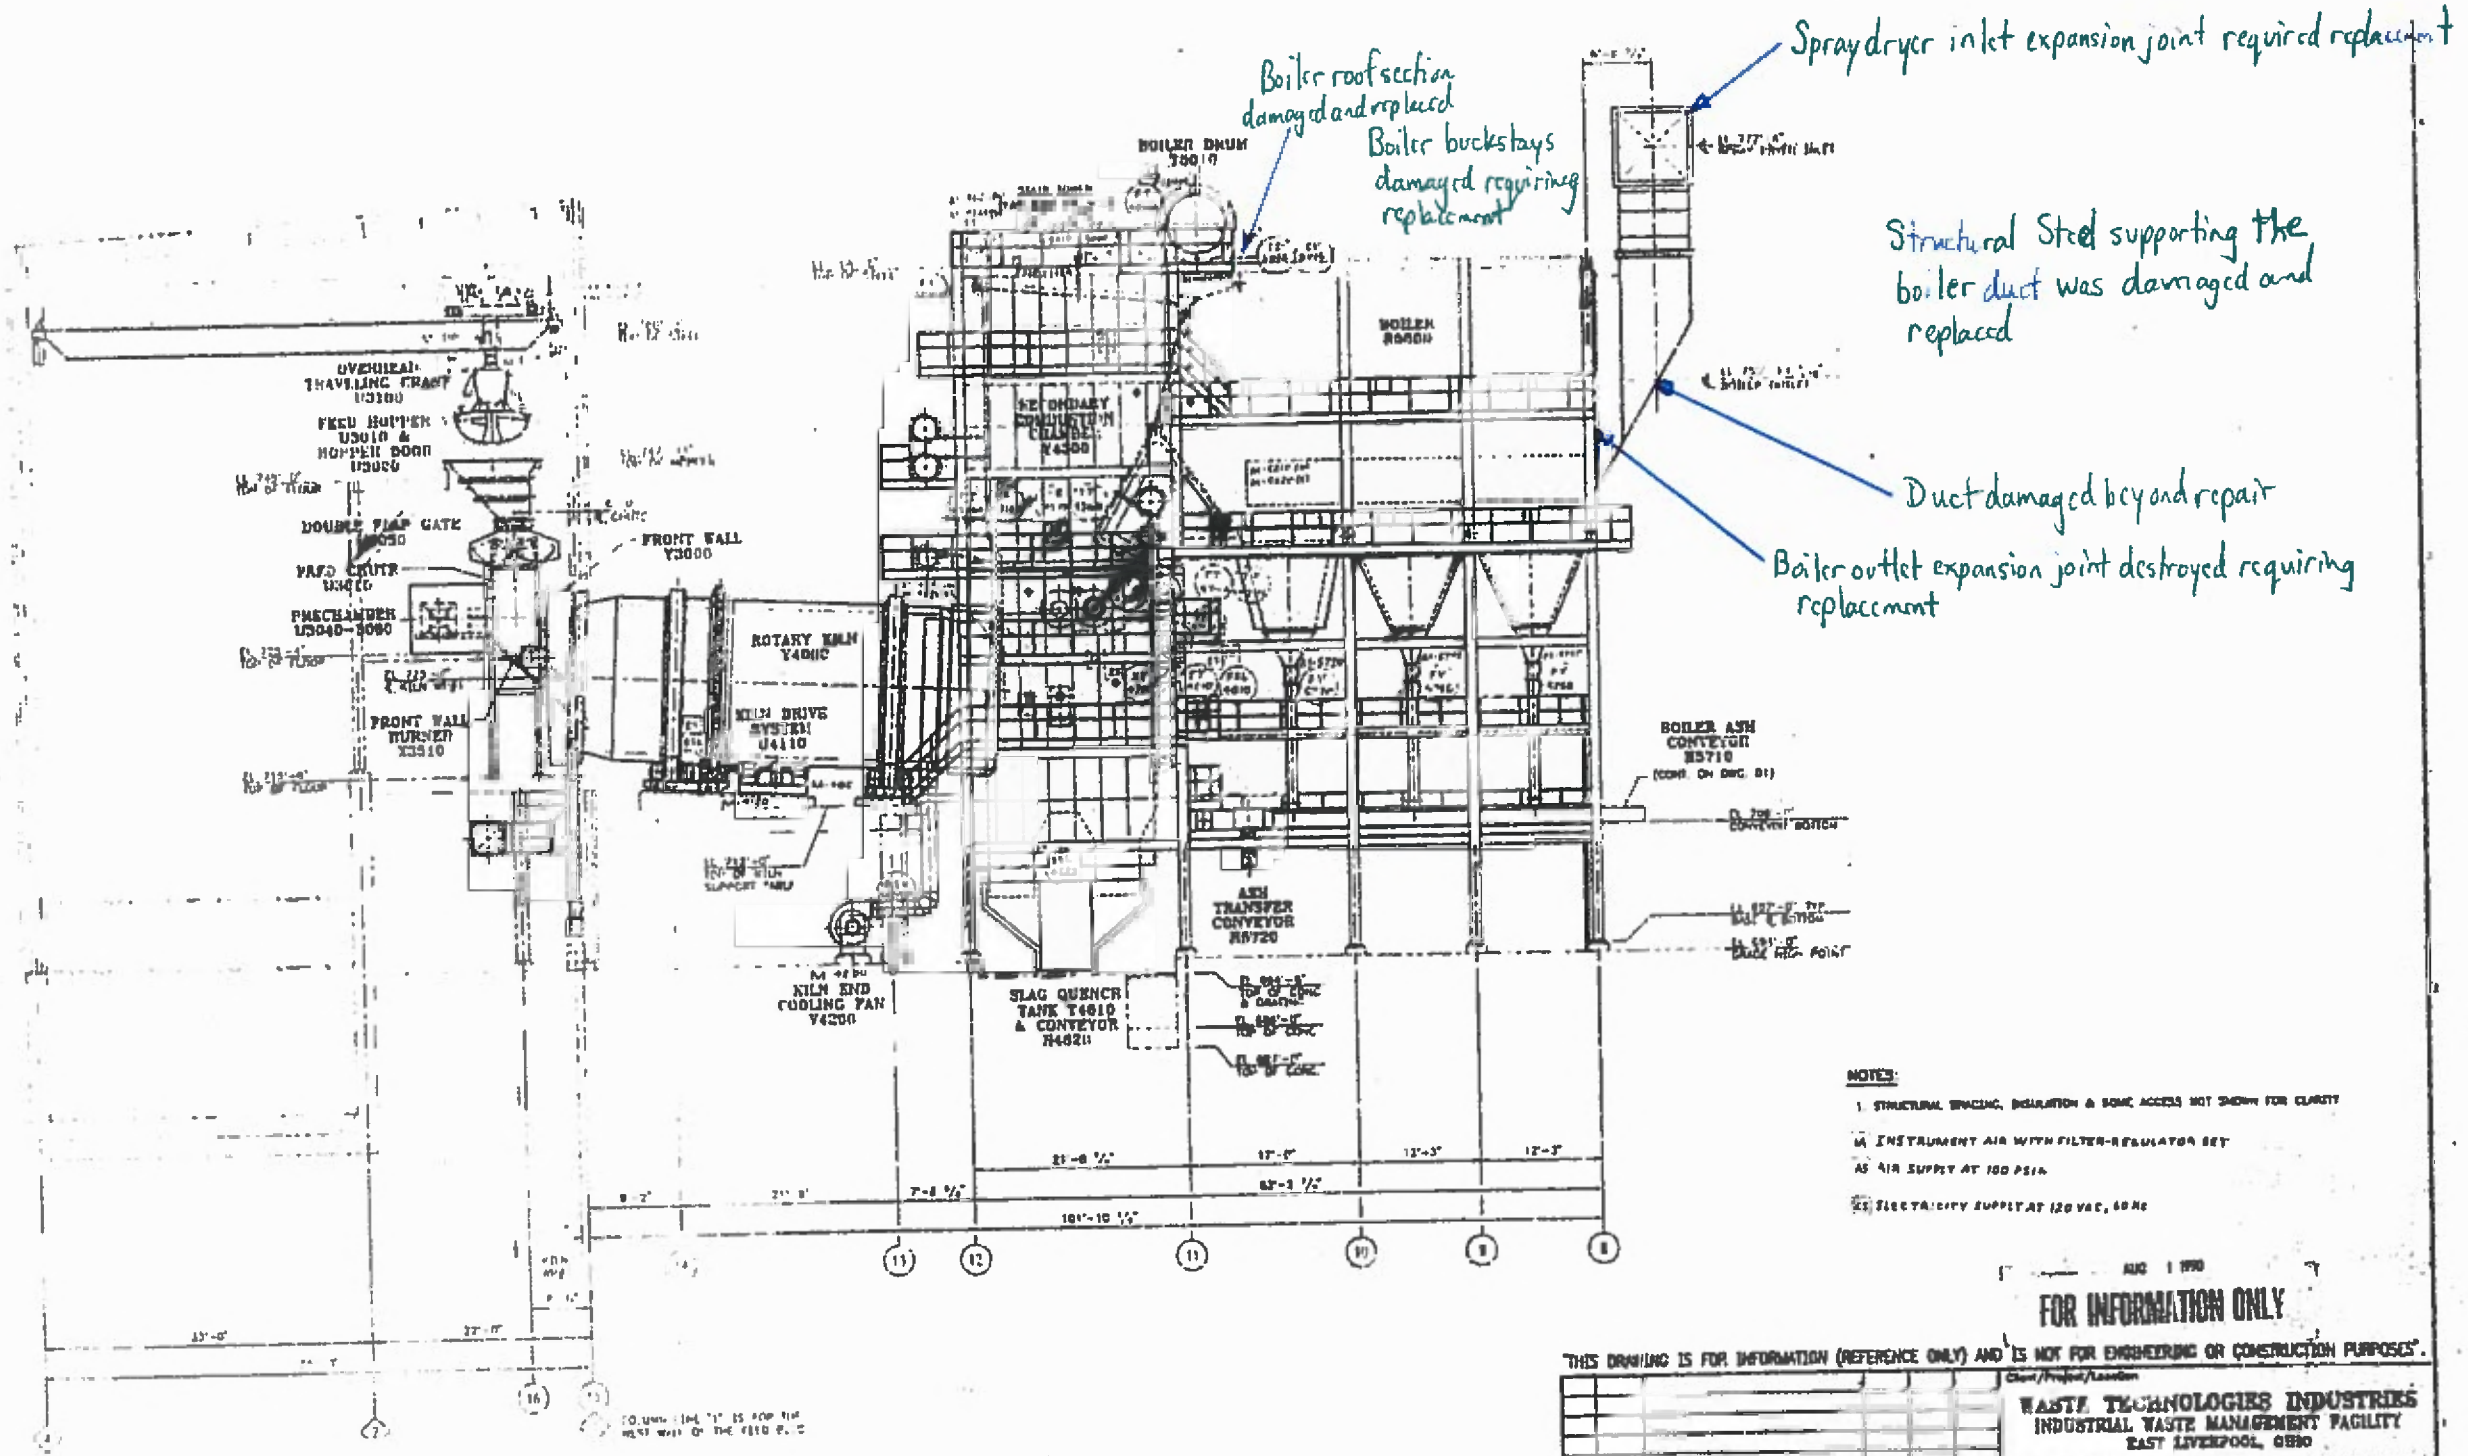
1.

Spraydryer inlet expansion joint required replacement
Boiler roof section damaged and replaced
Boiler buckstays damaged requiring replacement
Structural Steel supporting the boiler duct was damaged and replaced
Duct damaged beyond repair
Boiler outlet expansion joint destroyed requiring replacement
BOILER DRUM
BOILER ROOM
SECONDARY COMBUSTION CHAMBER
OVERHEAD TRAVELING CRANE
FEED HOPPER
HOPPER DOOR
DOUBLE FLAP GATE
FEED CHUTE
PRECHAMBER
FRONT WALL
FRONT WALL BURNER
ROTARY KILN
KILN DRIVE SYSTEM
KILN END COOLING FAN
SLAG QUENCH TANK
CONVEYOR
ASH TRANSFER CONVEYOR
BOILER ASH CONVEYOR
NOTES:
