Inspection Report
U.S. Environmental Protection Agency
Region 9
Toxics and Waste Management Division
Field Operations Branch

Purpose: RCRA Investigation

Facility: IT Corp., Baker Facility
896 Waterbird Way
Martinez, CA 94553

Report number: R(86)E096

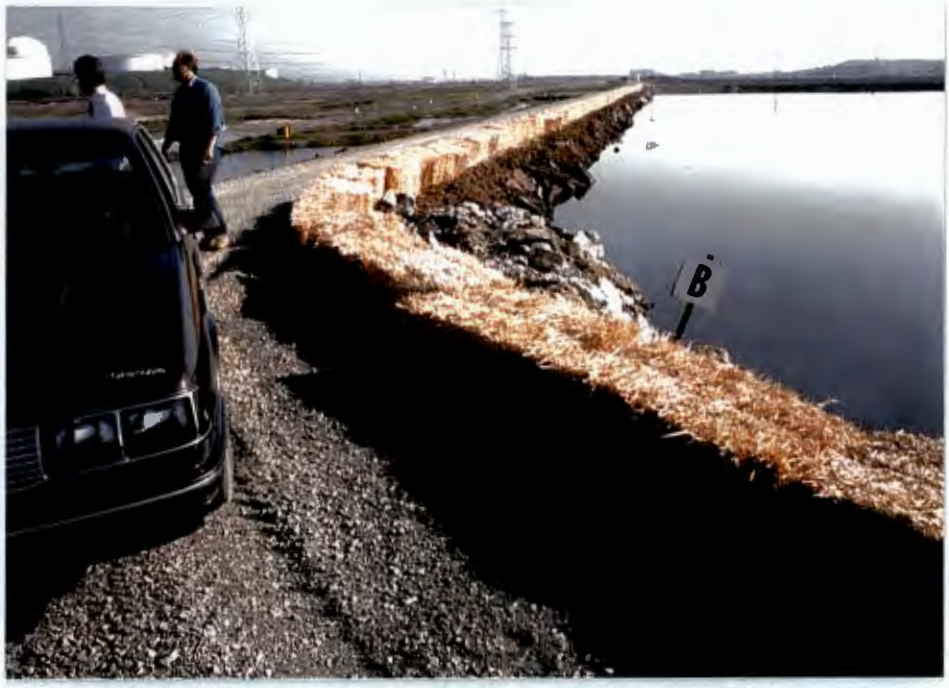
During the inspection of February 20, 1986 the northeast corner of the pond B dike was found discolored. An oily stain extended across the roadway and partway down the opposite side of the dike. See report R(86)E081. Photographs 8A-B of this report show hay bales that are set out to absorb any oil blowing from the impoundment, fresh gravel placed on the roadway, and clean dirt placed on the outside of the dike. More hay bales are stockpiled nearby.

DATE: 3/3/86 NAME: COFER 8A
DESCRIPTION: NORTHEAST CORNER OF POND B SHOWING NEW GRAVEL AND HAY BALES SET OUT TO CONTROL FOAM BLOWING

DATE: 3/3/86 NAME: COFER 8B
DESCRIPTION: AS ABOVE, SHOWING FRESH GRAVEL AND CLEAN SOIL
