To Kimberly Tisa/R1/USEPA/US@EPA
cc
bcc
Subject RE: FW: Westport Sampling Locations

Attached are plans and tables for sampling at Westport Middle School. The plans are hand mark-ups which we will have CAD drafted but are just for information presently. Marked locations are for Tables 1-5, but exclude table 3A which is additional wipes collected on 6-27 and additional bulks in Table 6, I personally collected on 6-29. I will prepare those drawings this afternoon and send when ready.

WESTPORT MIDDLE SCHOOL
400 Old County Road
Westport, MA 02790

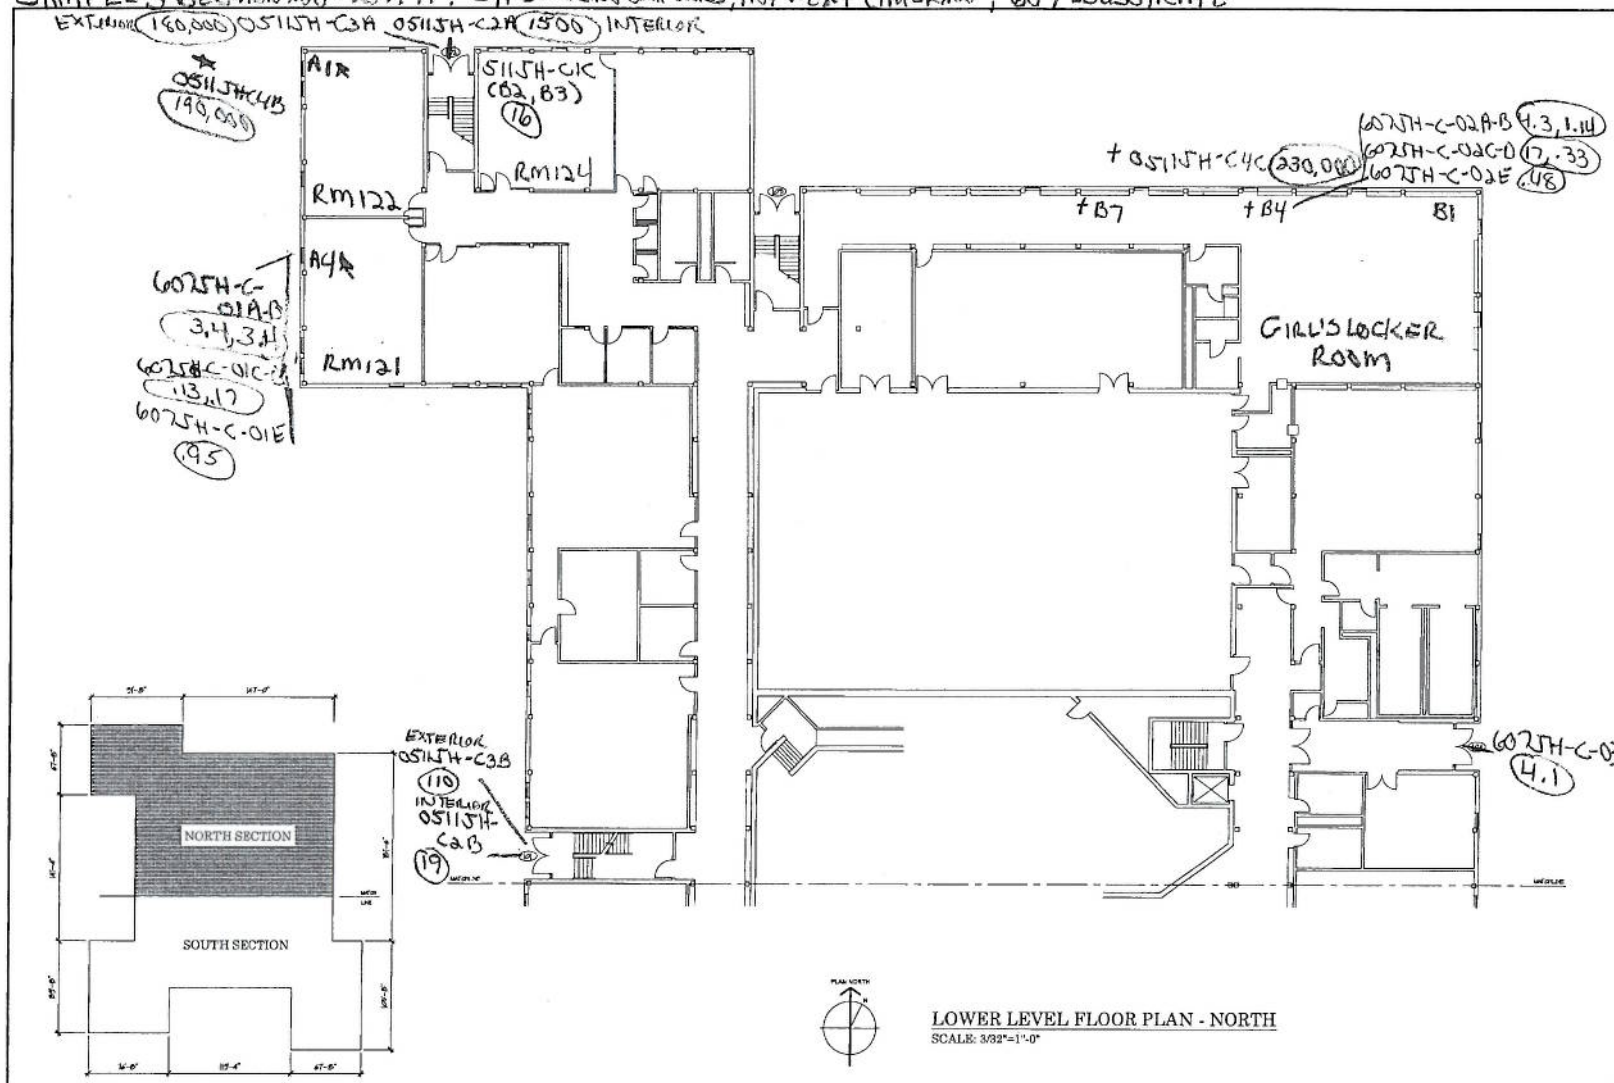
SAMPLES BEGINNING WITH: 511 = GLAZING COMPOUND, INT & EXT CAULKING; 607 = SUBSTRATE
