SUMMARY REPORT INTERIM CLEANUP OF POLYCHLORINATED BIPHENYLS (PCB) CONTAMINATED SOILS NEAR FORMER BUILDING 503

03/03/1989
ERM-WEST

NAVAL STATION, TREASURE ISLAND
HUNTERS POINT ANNEX
SAN FRANCISCO, CALIFORNIA

Submitted March 3, 1989

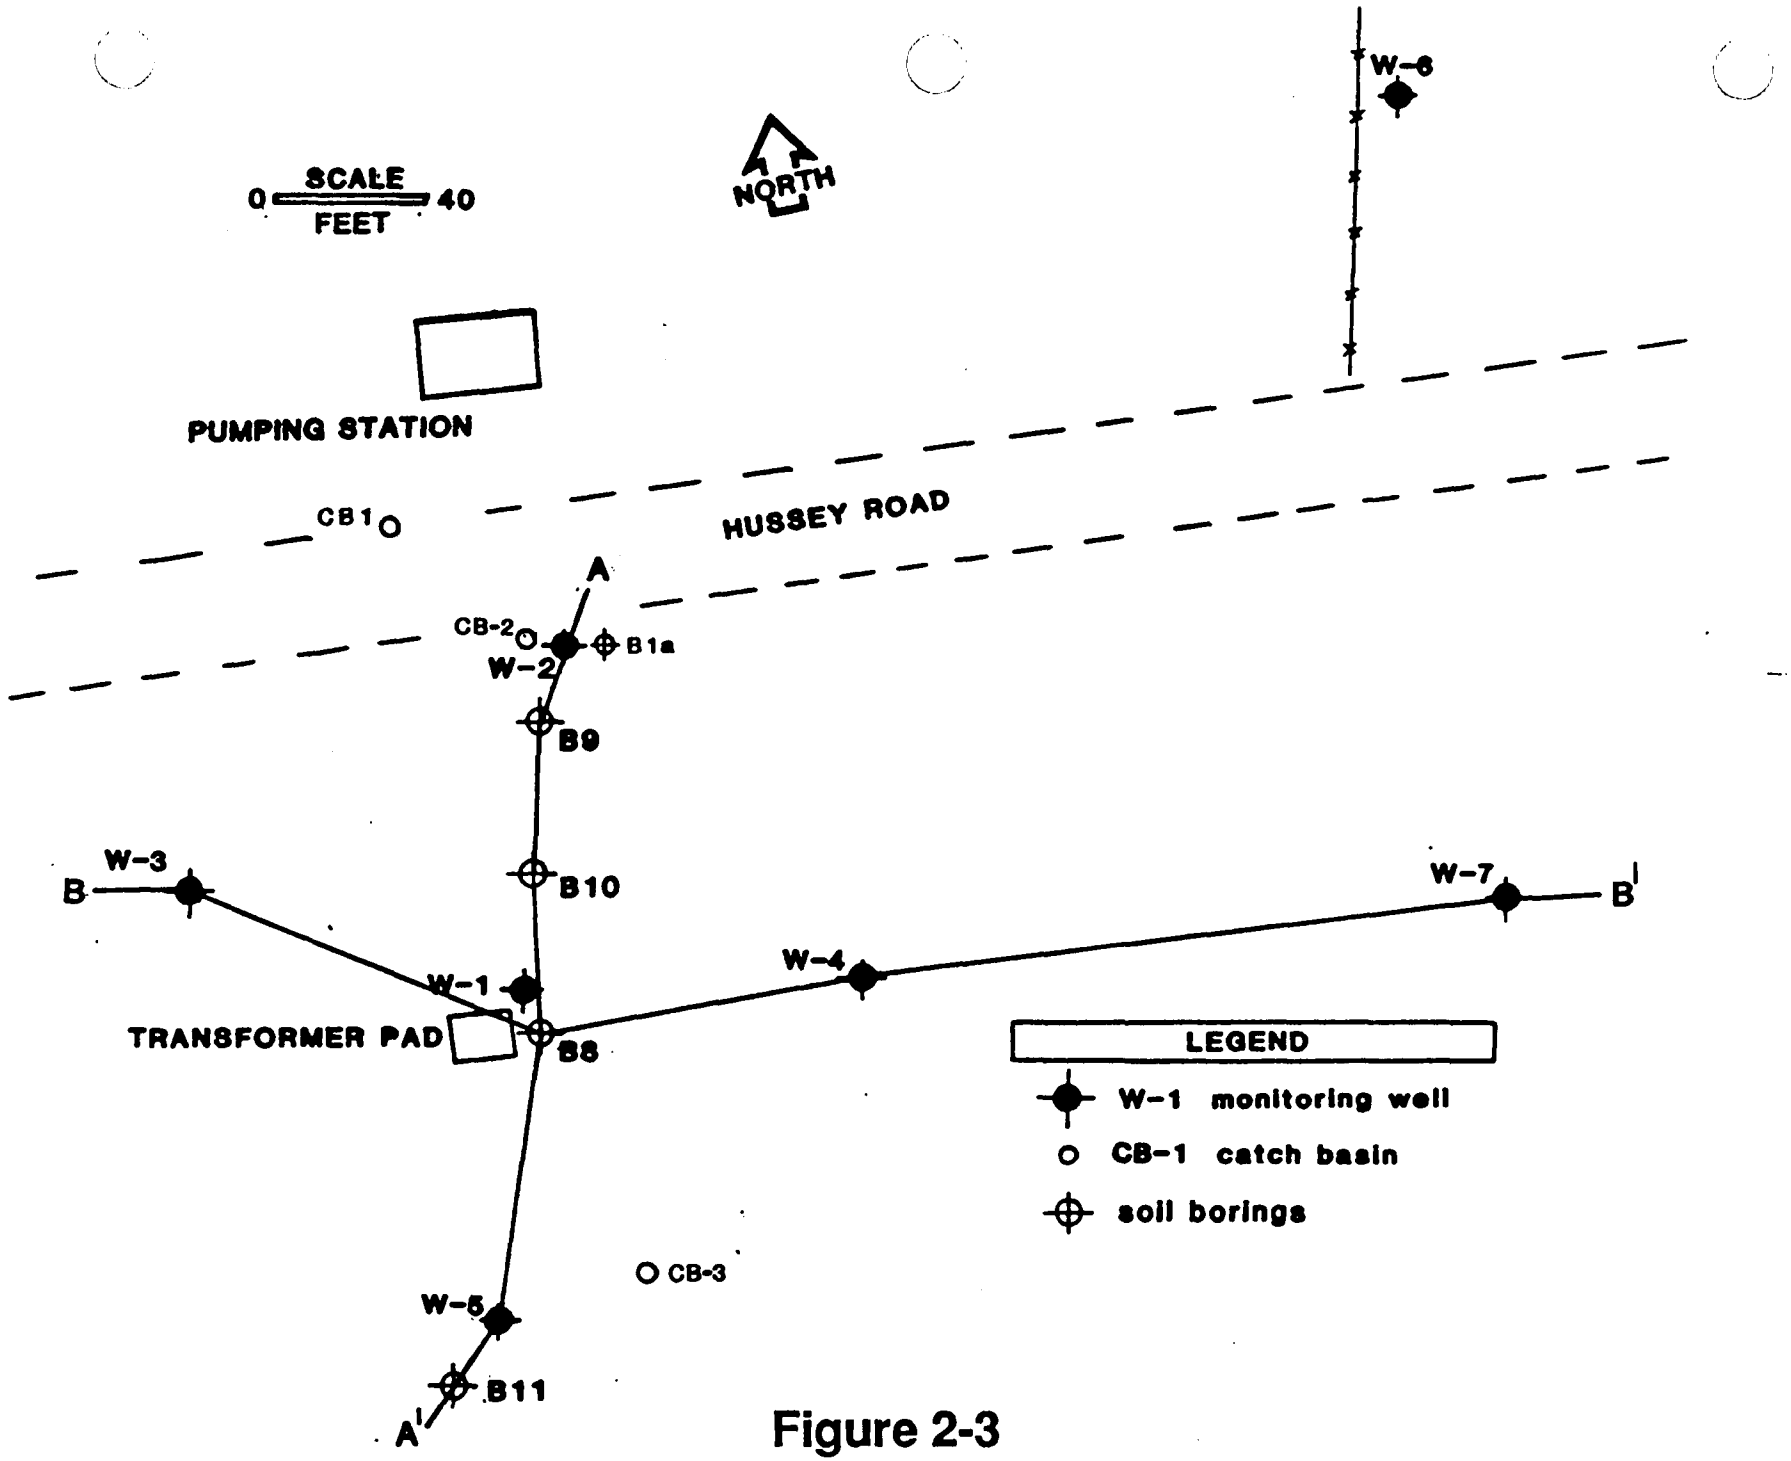
Figure 2-3

PCBs were found in the subsurface soils at depths as great as 27 feet. The concentrations at depths greater than 20 feet were typically trace concentrations, less than 0.1 mg/kg. The highest

Locations of Borings, Wells and Geologic Cross Sections

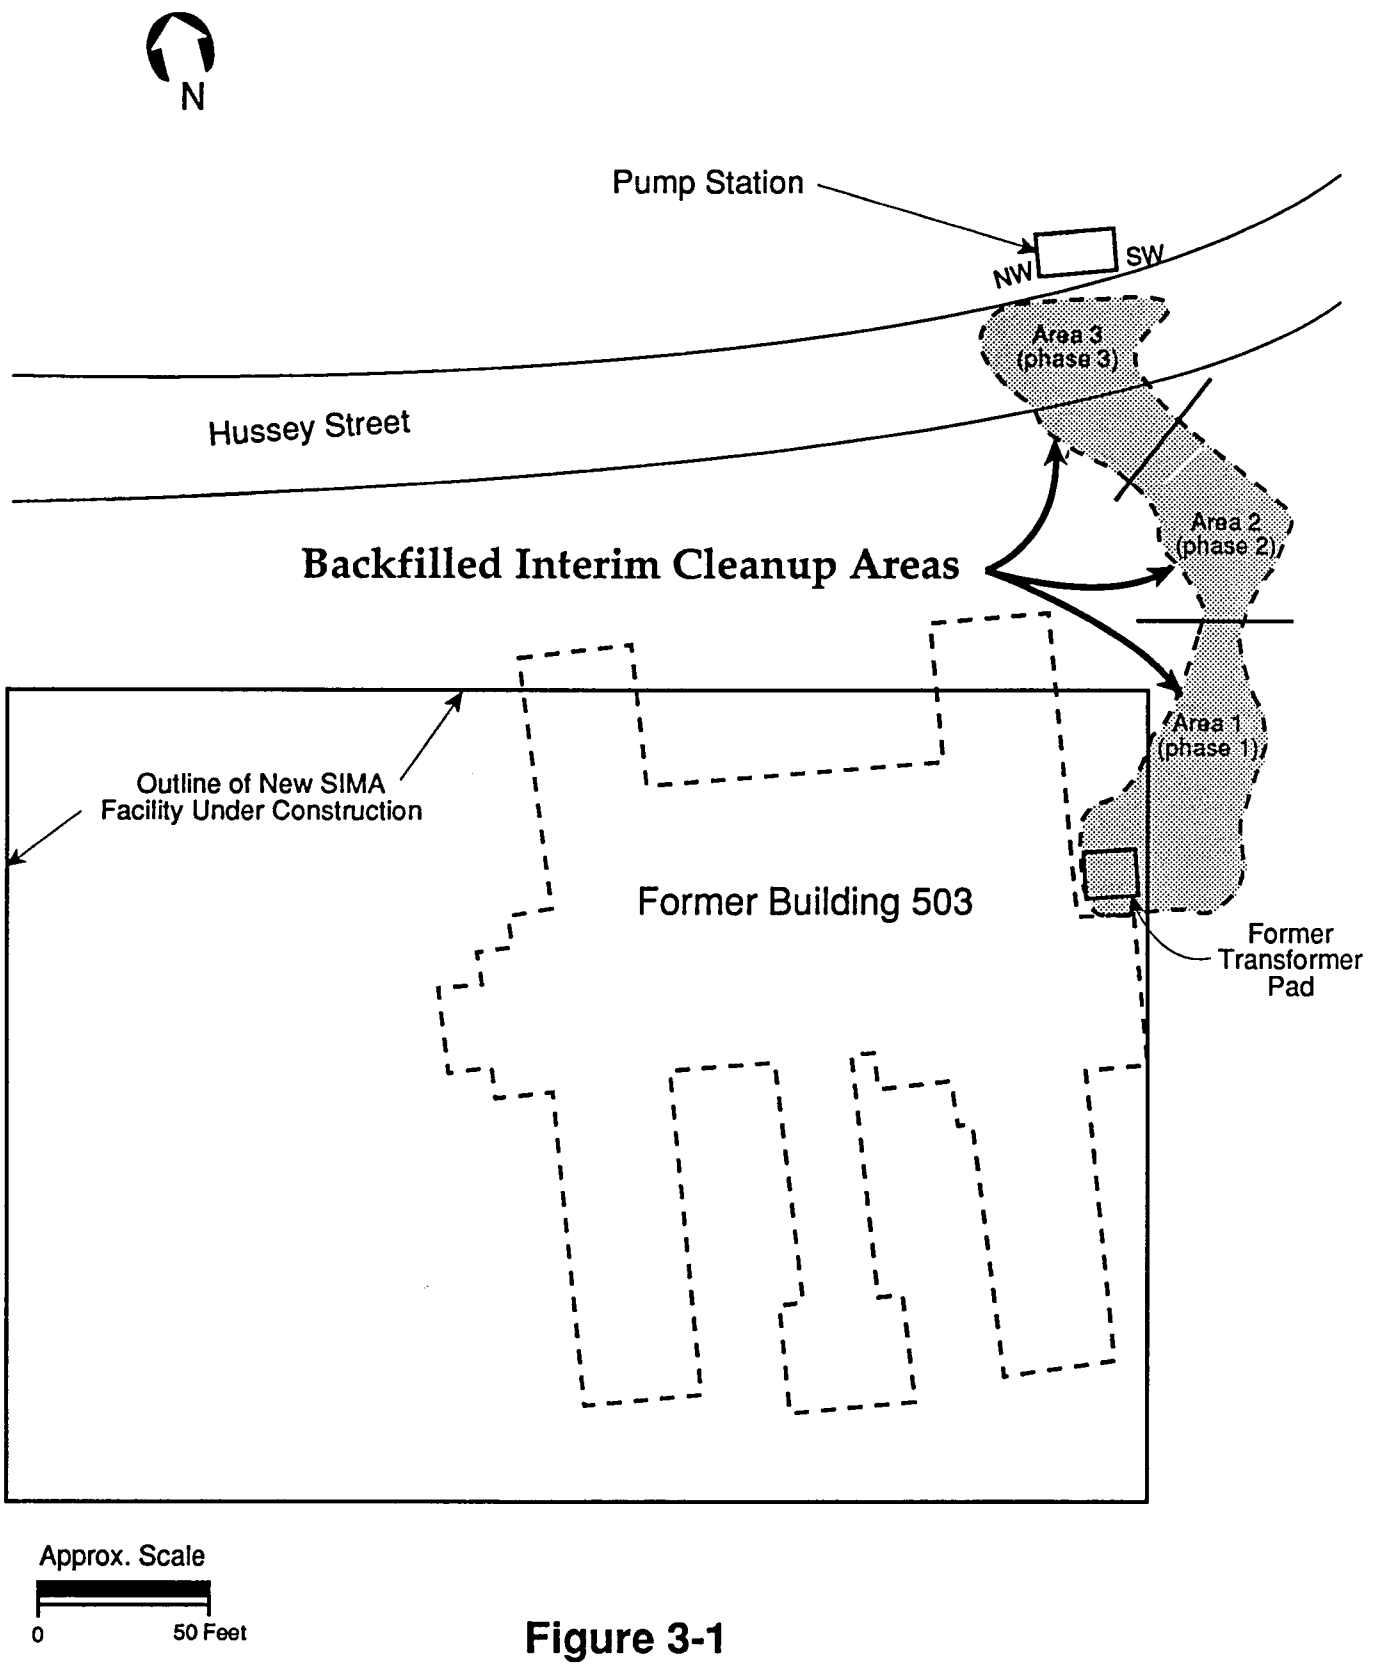
Figure 3-1

The cleanup work was performed in three phases. A report[4,5,6] was prepared at the completion of each work phase to summarize the excavation activities, the soil sampling results, and the final verification sampling results. The Navy would authorize the cleanup activities to proceed onto the next cleanup area of the site after review and comment by the regulatory agencies of the results and recommendations of the previous work phase.

PCB Site-Work Areas

Each excavated area was backfilled with acceptable engineered fill and compacted to minimize soil settlement. The entire cleanup area was topped with asphalt paving to prevent surface water infiltration and surface erosion.

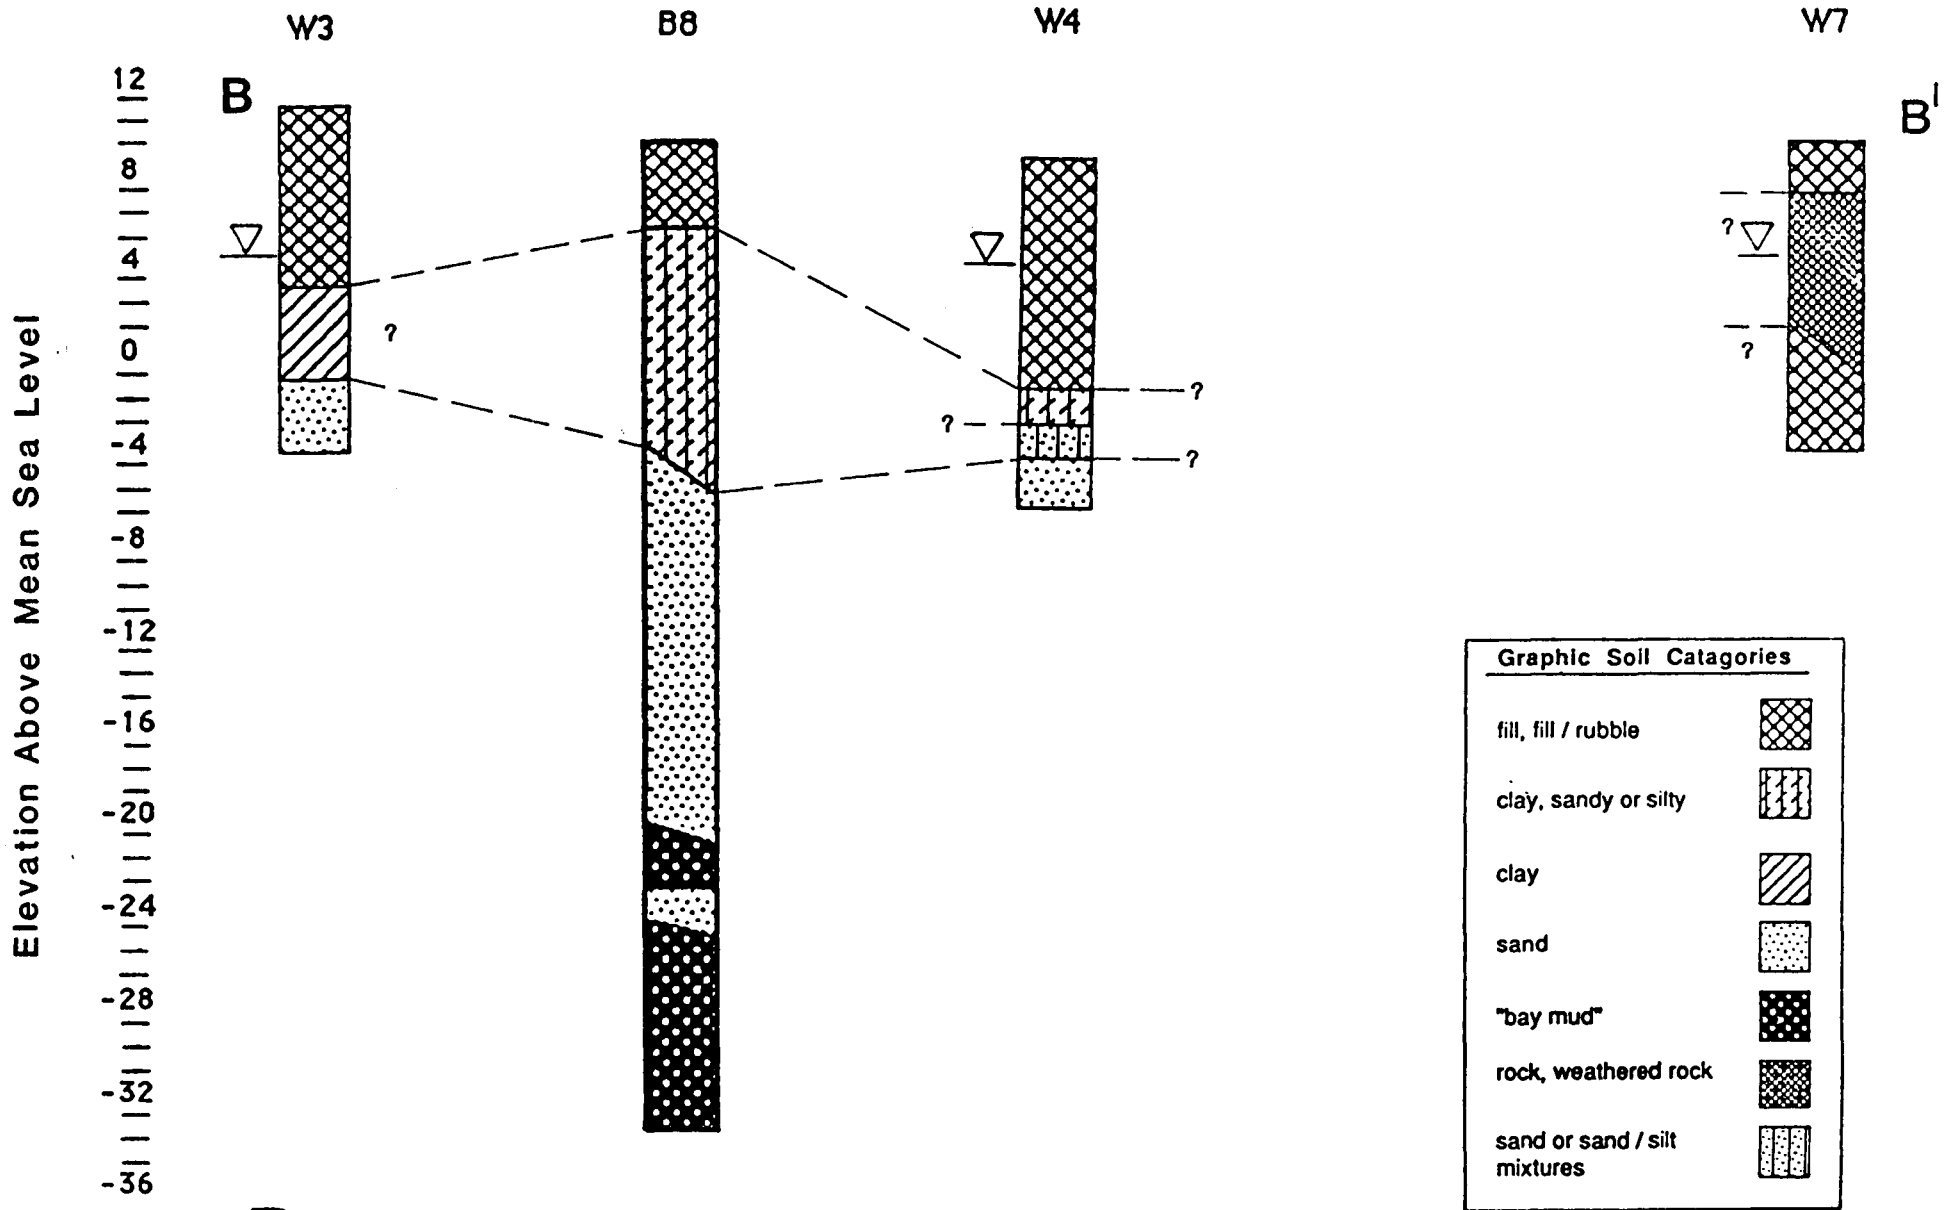
FIGURE 2-2b

Geologic Cross Section B - B'
