CONTRACTOR QUALITY CONTROL REPORT

DATE 18/AUG/10

REPORT NO 045

PHASE | CONTRACT NO N62473-09-D-2608 | CONTRACT TITLE RA at IR-07 & -18 at Parcel B; Soil Hotspot Locations at Parcels B, D-1, and G; and Soil Stockpiles at Parcels D-1 and G, HPS, SF

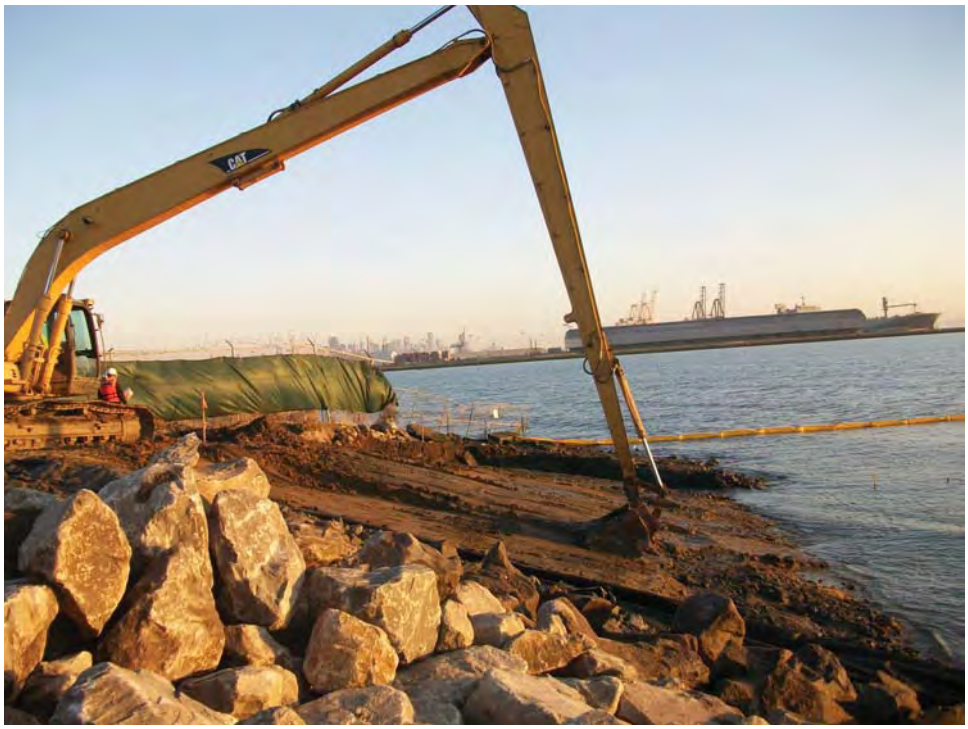
Photo 1: Shoreline Excavation and Revetment – Excavation of section AO2L subgrade.
HPS Parcel B IR Sites 07 and 18 Remedial Action, San Francisco, California
Photographed by: Elizabeth Binning (ERRG, Inc.) Date: August 25, 2010

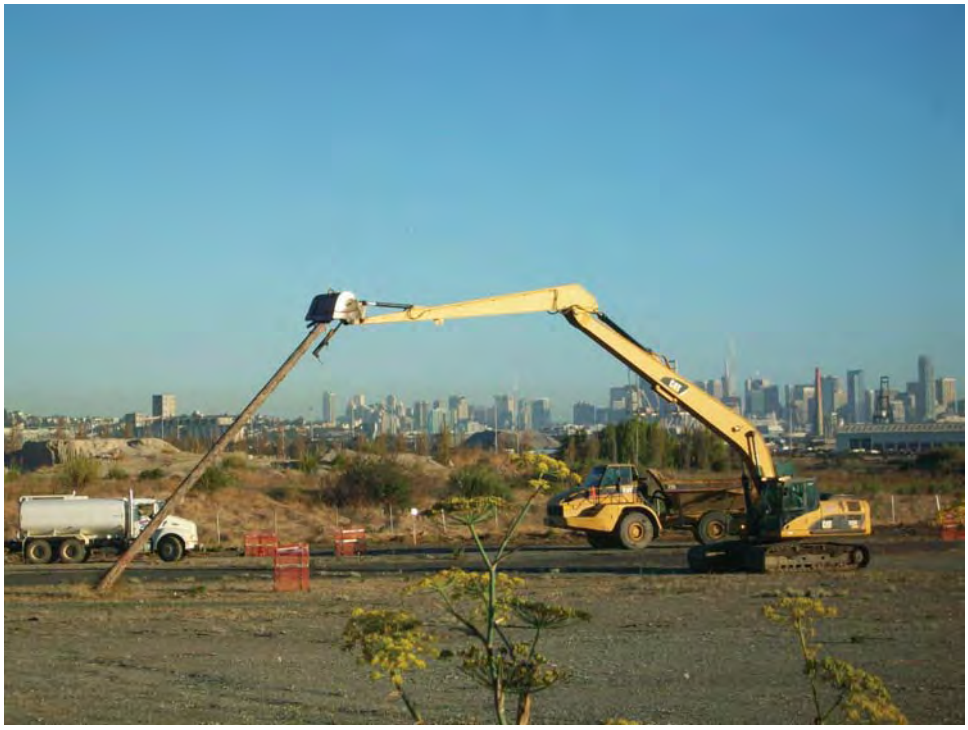
Photo 1: Site Clearing and Demolition – Removal of existing power poles within the site boundary.

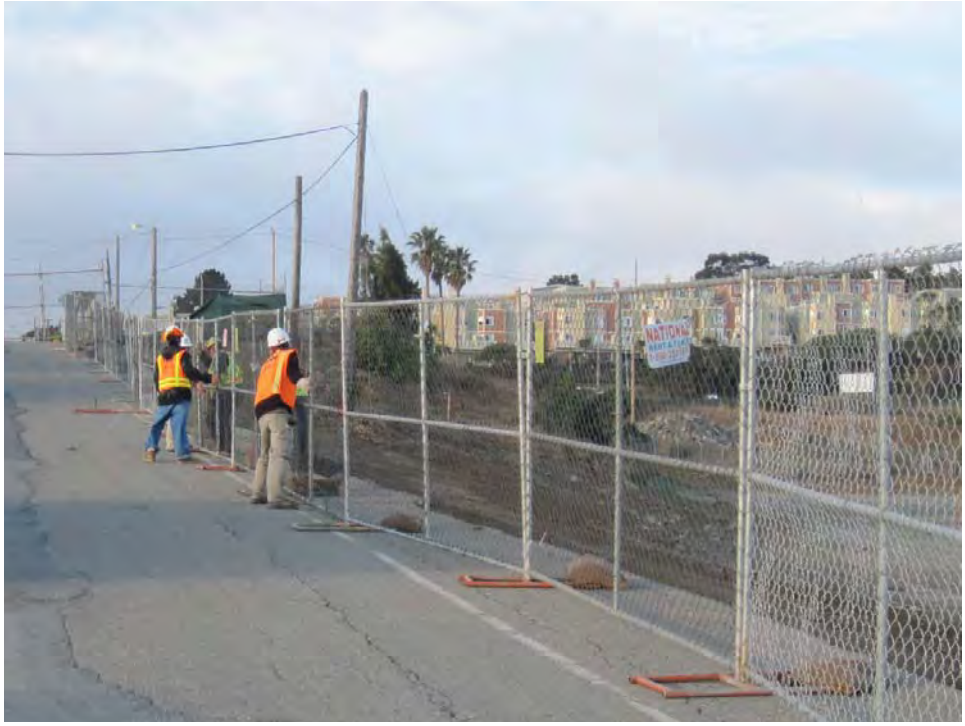
Photo 1: Radiological Screening and Remediation – Securing the temporary fence along the southeast IR boundary after it was blown down due to high winds.
