9540 Niagara Falls Boulevard (N002)

Figure 3: Property N002 Unvalidated Soil Analytical Results Map

Niagara Falls Boulevard Radiological Site
Niagara Falls, New York

U.S. ENVIRONMENTAL PROTECTION AGENCY
Removal Support Team 3
CONTRACT # EP-S2-13-01

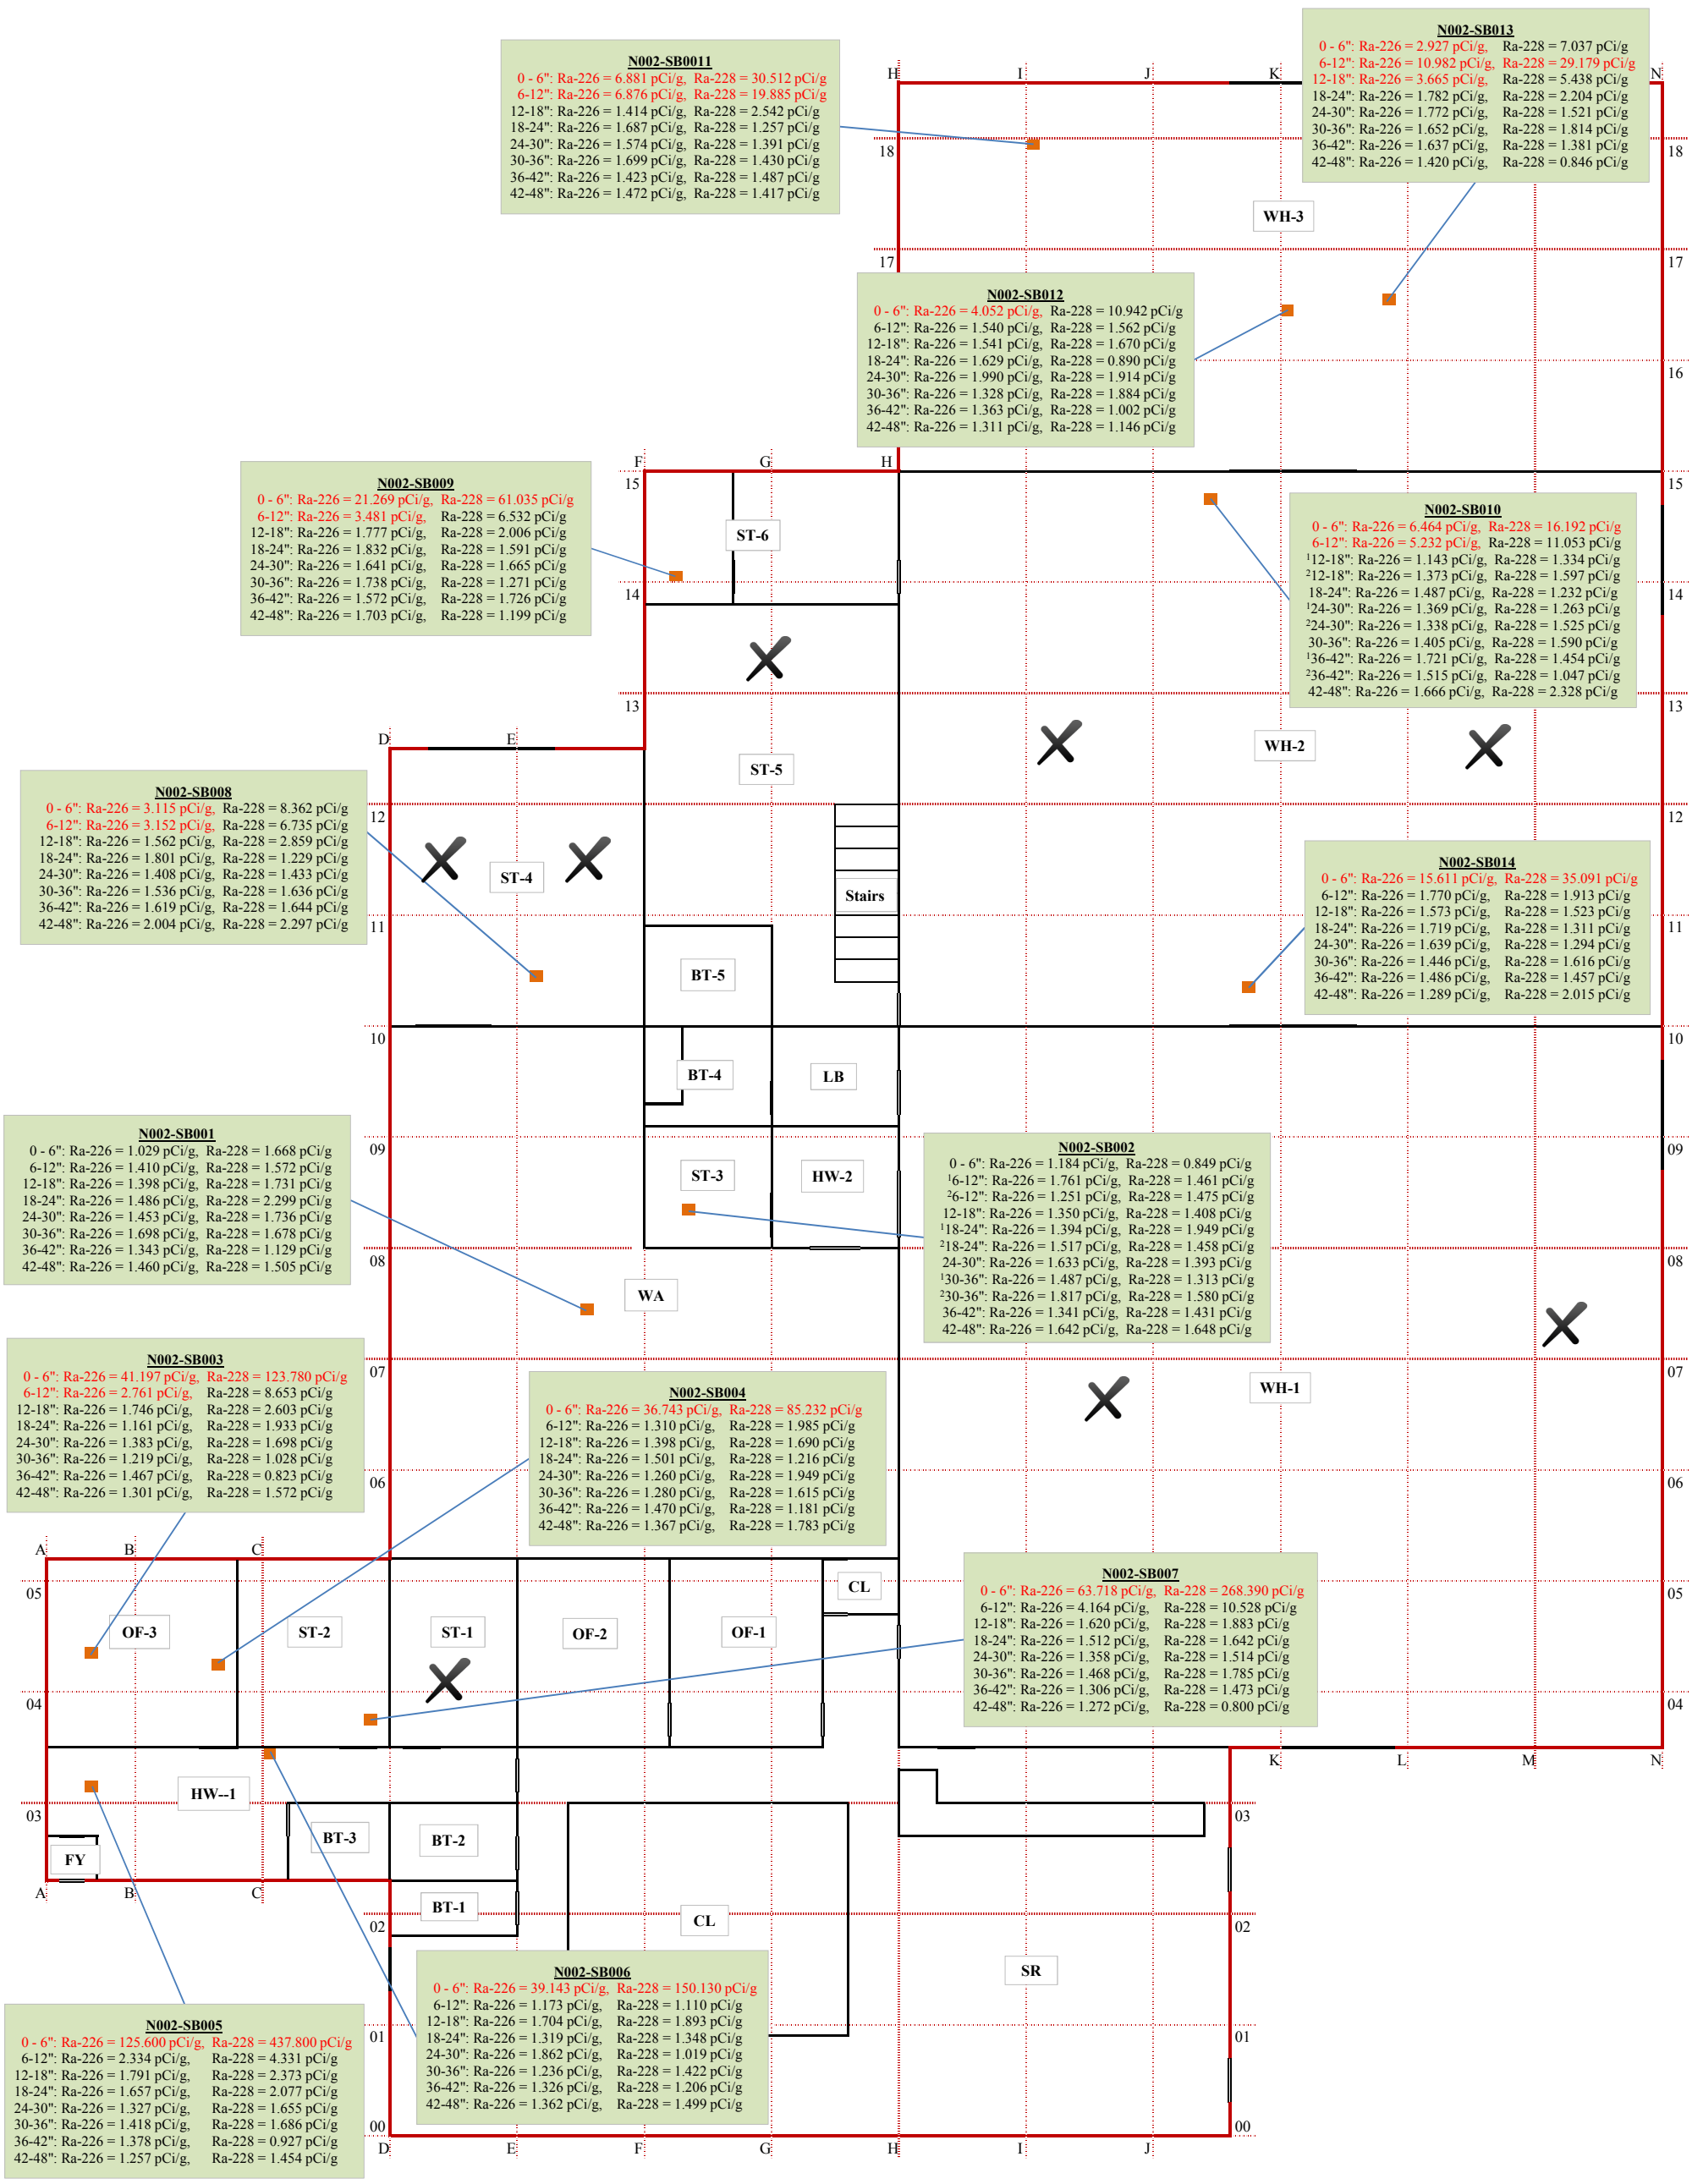
All results presented in picocuries per gram (pCi/g), Sampling depth intervals are in inches (")
[1]Soil Sample, [2]Field Duplicate of Soil Sample
Results in red exceed the U.S. Environmental Protection Agency's (EPA) Preliminary Remediation Goals (PRGs) for Radium-226 (Ra-226) and Radium-228 (Ra-228)
EPA PRG for Ra-226 = 2.48 pCi/g and for Ra-228 = 15.9 pCi/g
