Navajo Abandoned Uranium Mine Site Screen Report

Nanabah Vandever AUM Site

Navajo AUM Eastern Region

May 2009

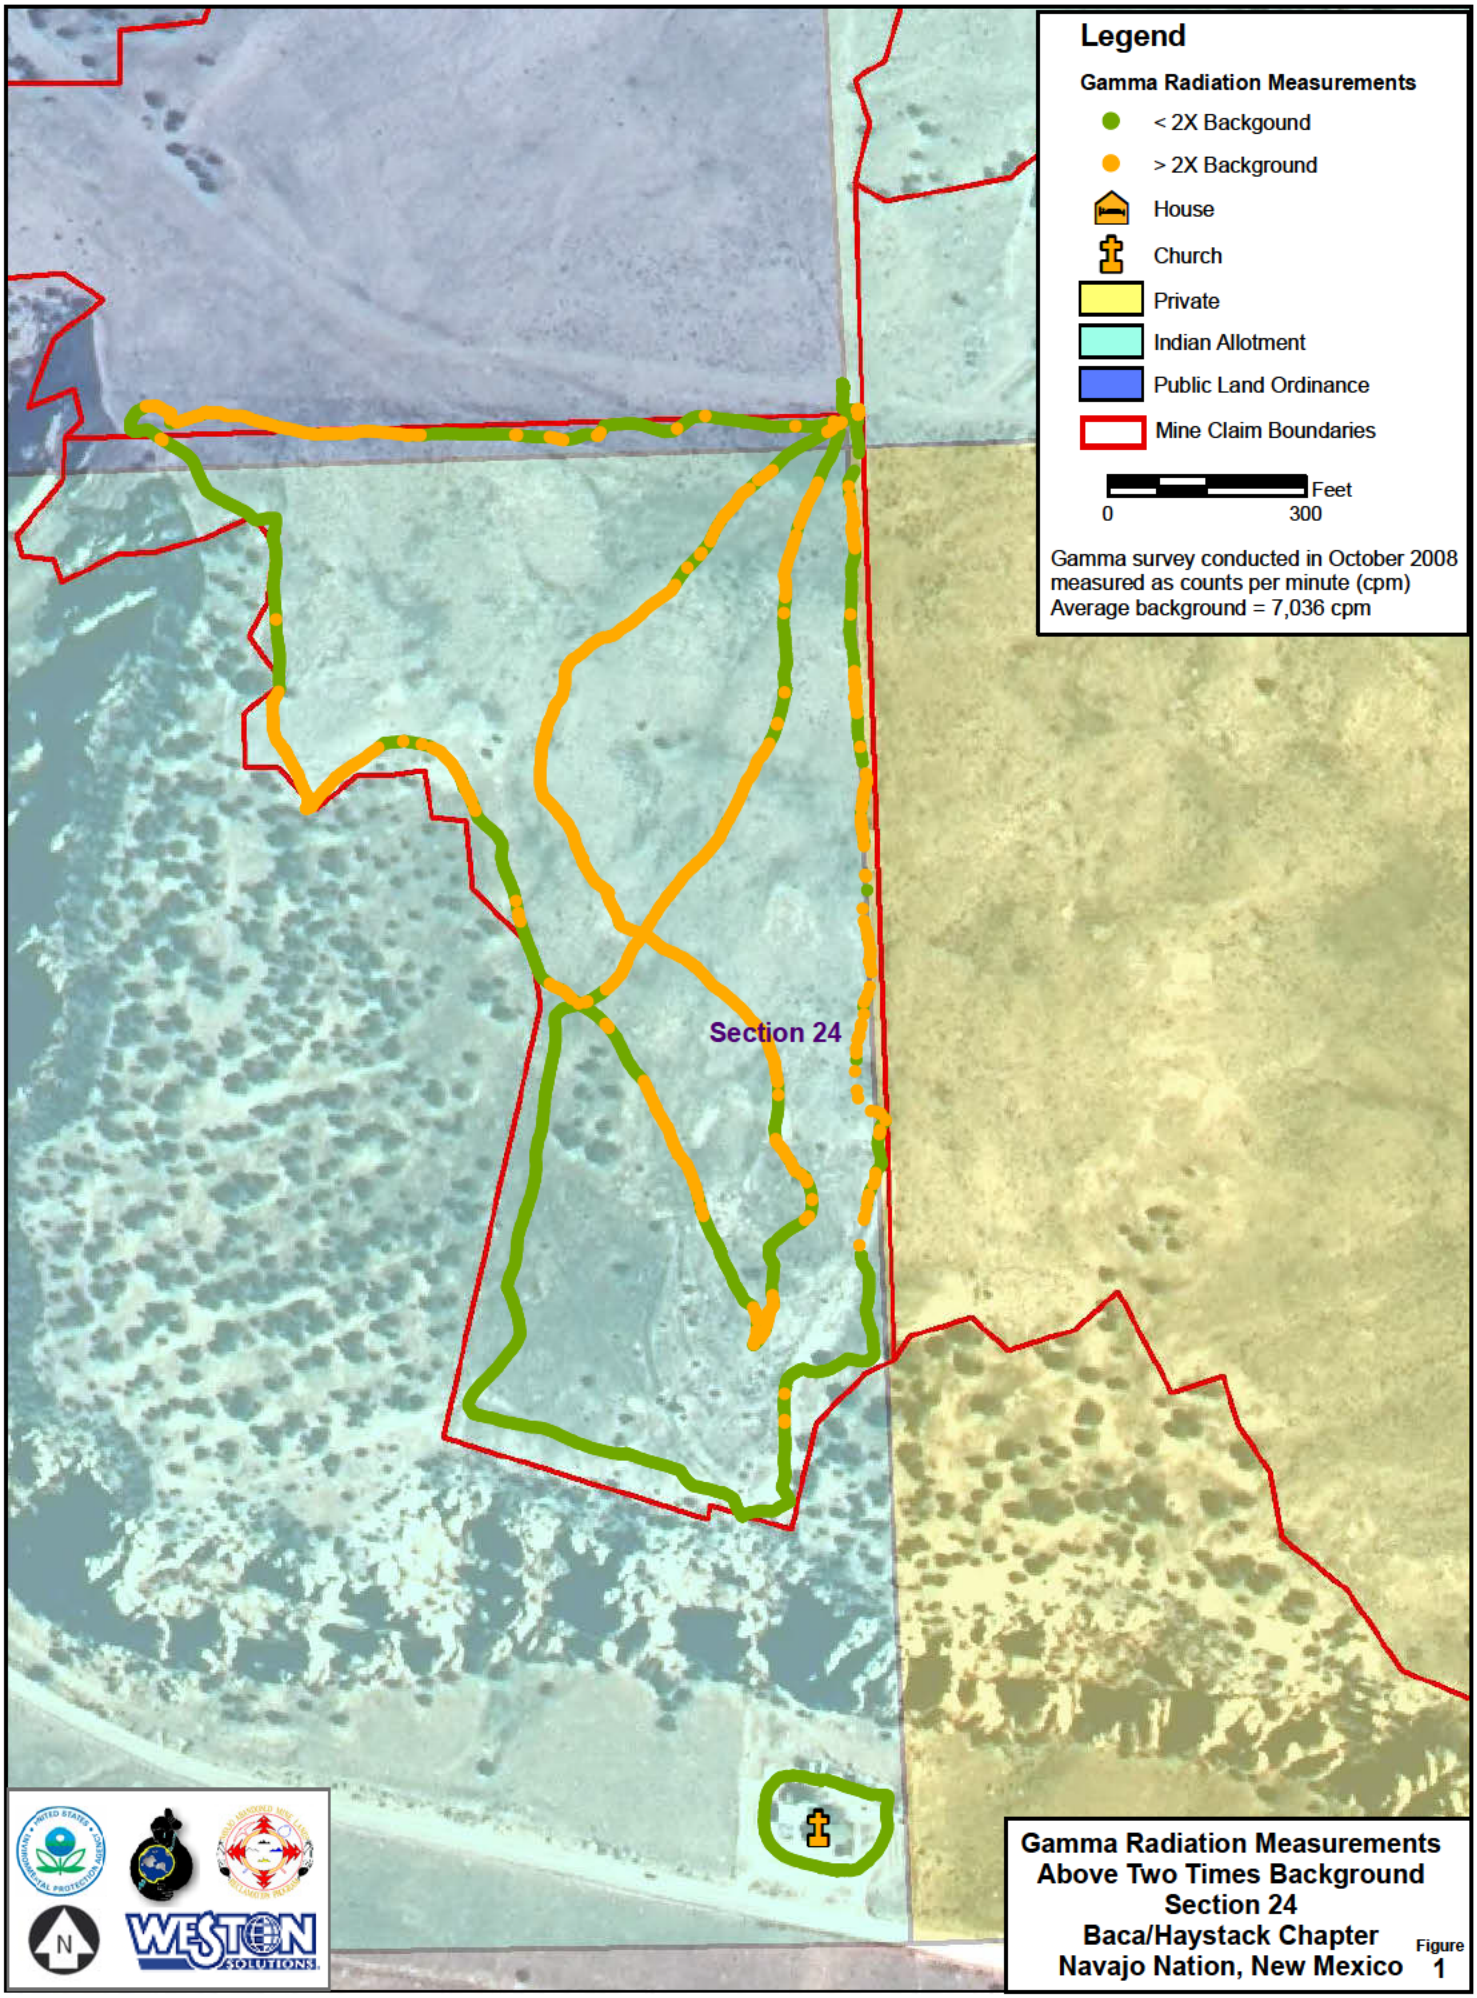
Figure 1

A total of 3,024 gamma radiation measurements were collected from mine sites, ranging from 4,569 cpm to 594,083 cpm. The measurements are represented in Figures 1 and 2.

Gamma Radiation Measurements Above Two Times Background
Section 24
Baca/Haystack Chapter
Navajo Nation, New Mexico

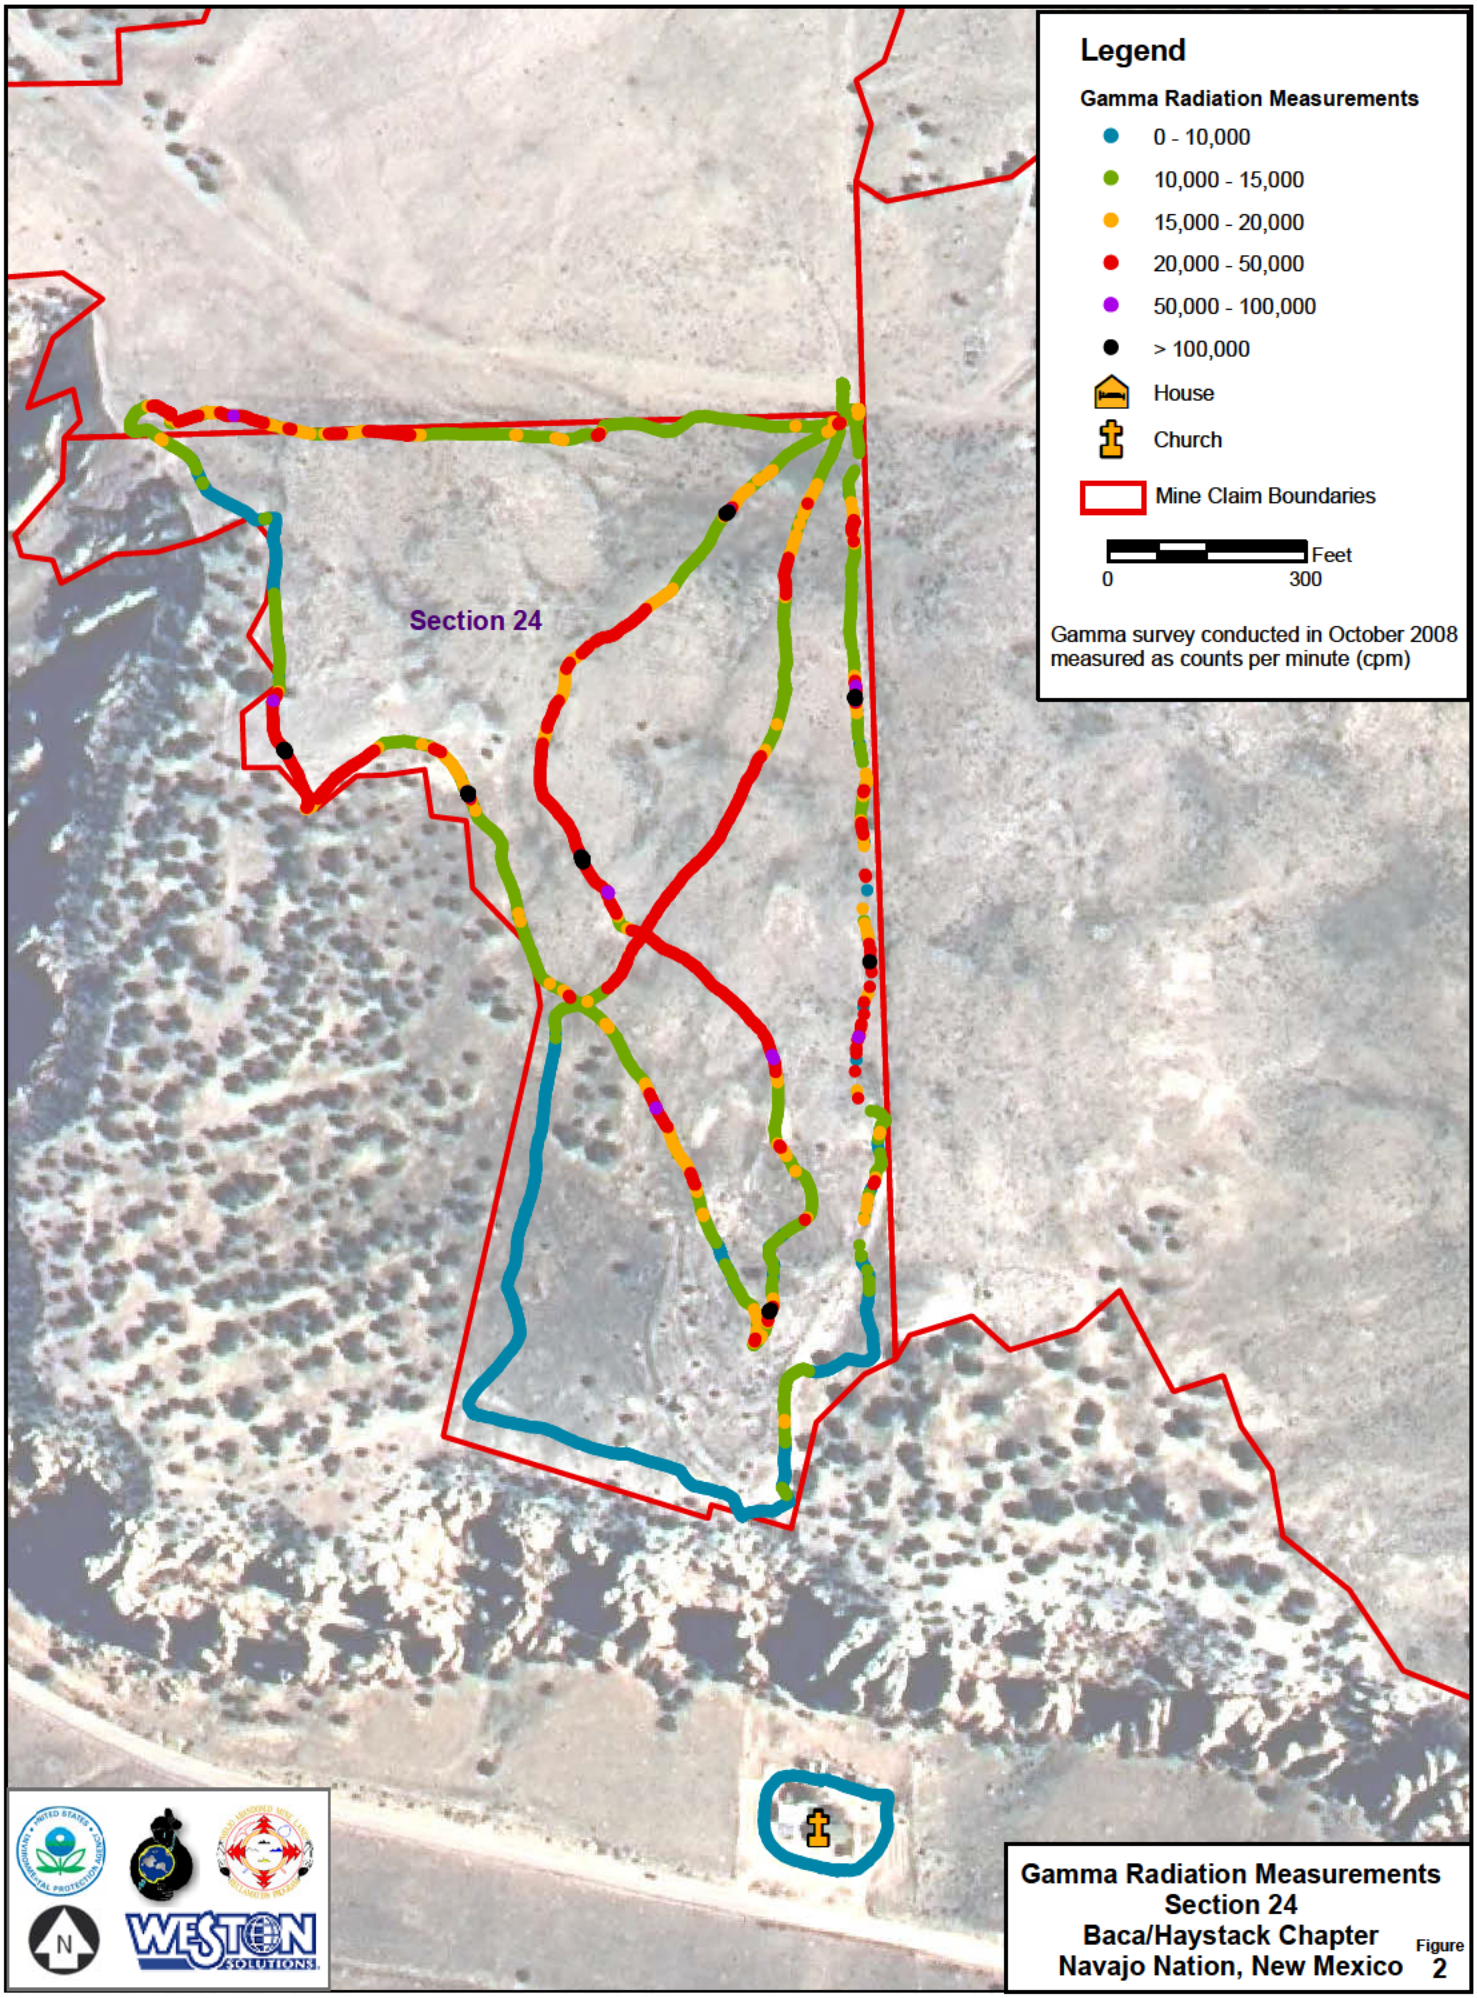
Figure 2

Gamma Radiation Measurements
Section 24
Baca/Haystack Chapter
Navajo Nation, New Mexico
