APPENDIX A - LEAK DETECTION AND REPAIR (LDAR) INSPECTION REPORTS

Inspection Date: January 26-27, 2021

New Indy Containerboard - Catawba Mill
5300 Cureton Ferry Rd.
Catawba, SC 29704

2021 Monthly LDAR Inspection Summary Report

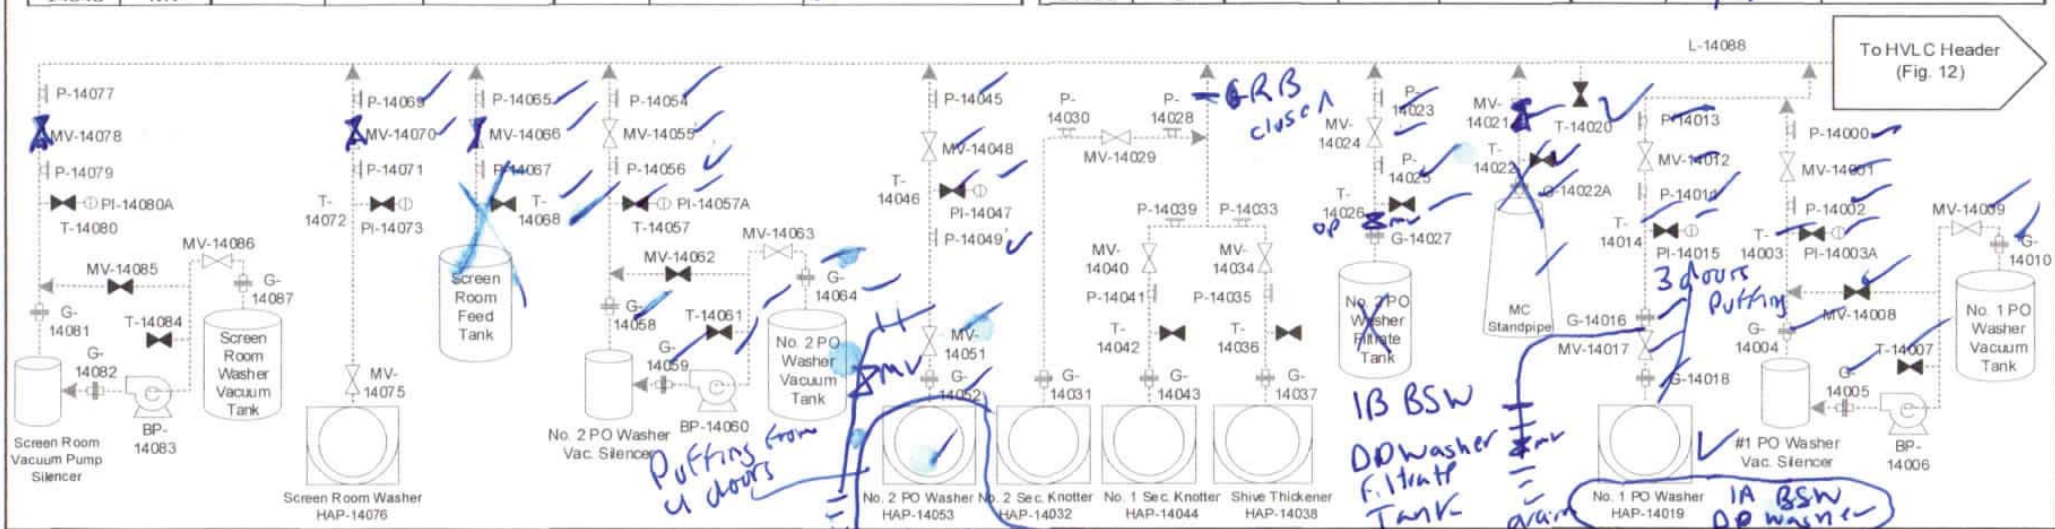
Equipment Number	Date	Description of Leak or Visual Defect
MV-1137	1/26/2021	Manual Valve MV-1137 is located on foul condensate line at outlet of HVLC Foul Condensate Tank No. 3 and prior to the pump. The drain valve is open and dripping from spout.
NA	1/27/2021	The 1A Screw Press Dilution Conveyor is puffing from top hatch door.
NA	1/27/2021	The 1B Screw Press Dilution Conveyor is puffing from top hatch door.
NA	1/27/2021	The 1A Brown Stock Washer is puffing from three open hatch doors.
NA	1/27/2021	The 1B Brown Stock Washer is puffing from four open hatch doors.
NA	1/27/2021	The 2A Brown Stock Washer is puffing from four open hatch doors.
NA	1/27/2021	The 2B Brown Stock Washer is puffing from four open hatch doors.
NA	1/27/2021	The 3A Brown Stock Washer is puffing from one open hatch door.
NA	1/27/2021	The 3B Brown Stock Washer is puffing from four open hatch doors

14048	MV	X168					
14049	P						
14051	MV						
14052	G						
14053	~~HAP~~ NA					NO	Puffing
14054	P					yes	
14055	MV	X167				y	
14056	P					y	
14057	T					y	
14057A	PI					y	
14058	G					y	
14059	G					y	
14060	BP	E52-0128				y	
14061	T	X159				y	
14062	MV	X265				y	
14063	MV					y	
14064	G					y	
14065	P					yes	
14066	MV	SR313				yes	
14067	P						Remove Remove
14068	T	SR320					
14069	P					yes	
14070	MV	SR312					Keep Remove
14071	P						
14072	T	SR319					
14073	PI						
14075	MV						
14076	HAP						
14077	P						
14078	MV	SR311				yes yes	~~Remove~~ Keep Remove
14079	P						
14080	T	SR318					
14080A	PI						
14081	G						
14082	G						
14083	BP	E52-0194					
14084	T	SR265					
14085	MV	SR276					
14086	MV						
14087	G						
14088	L					yes

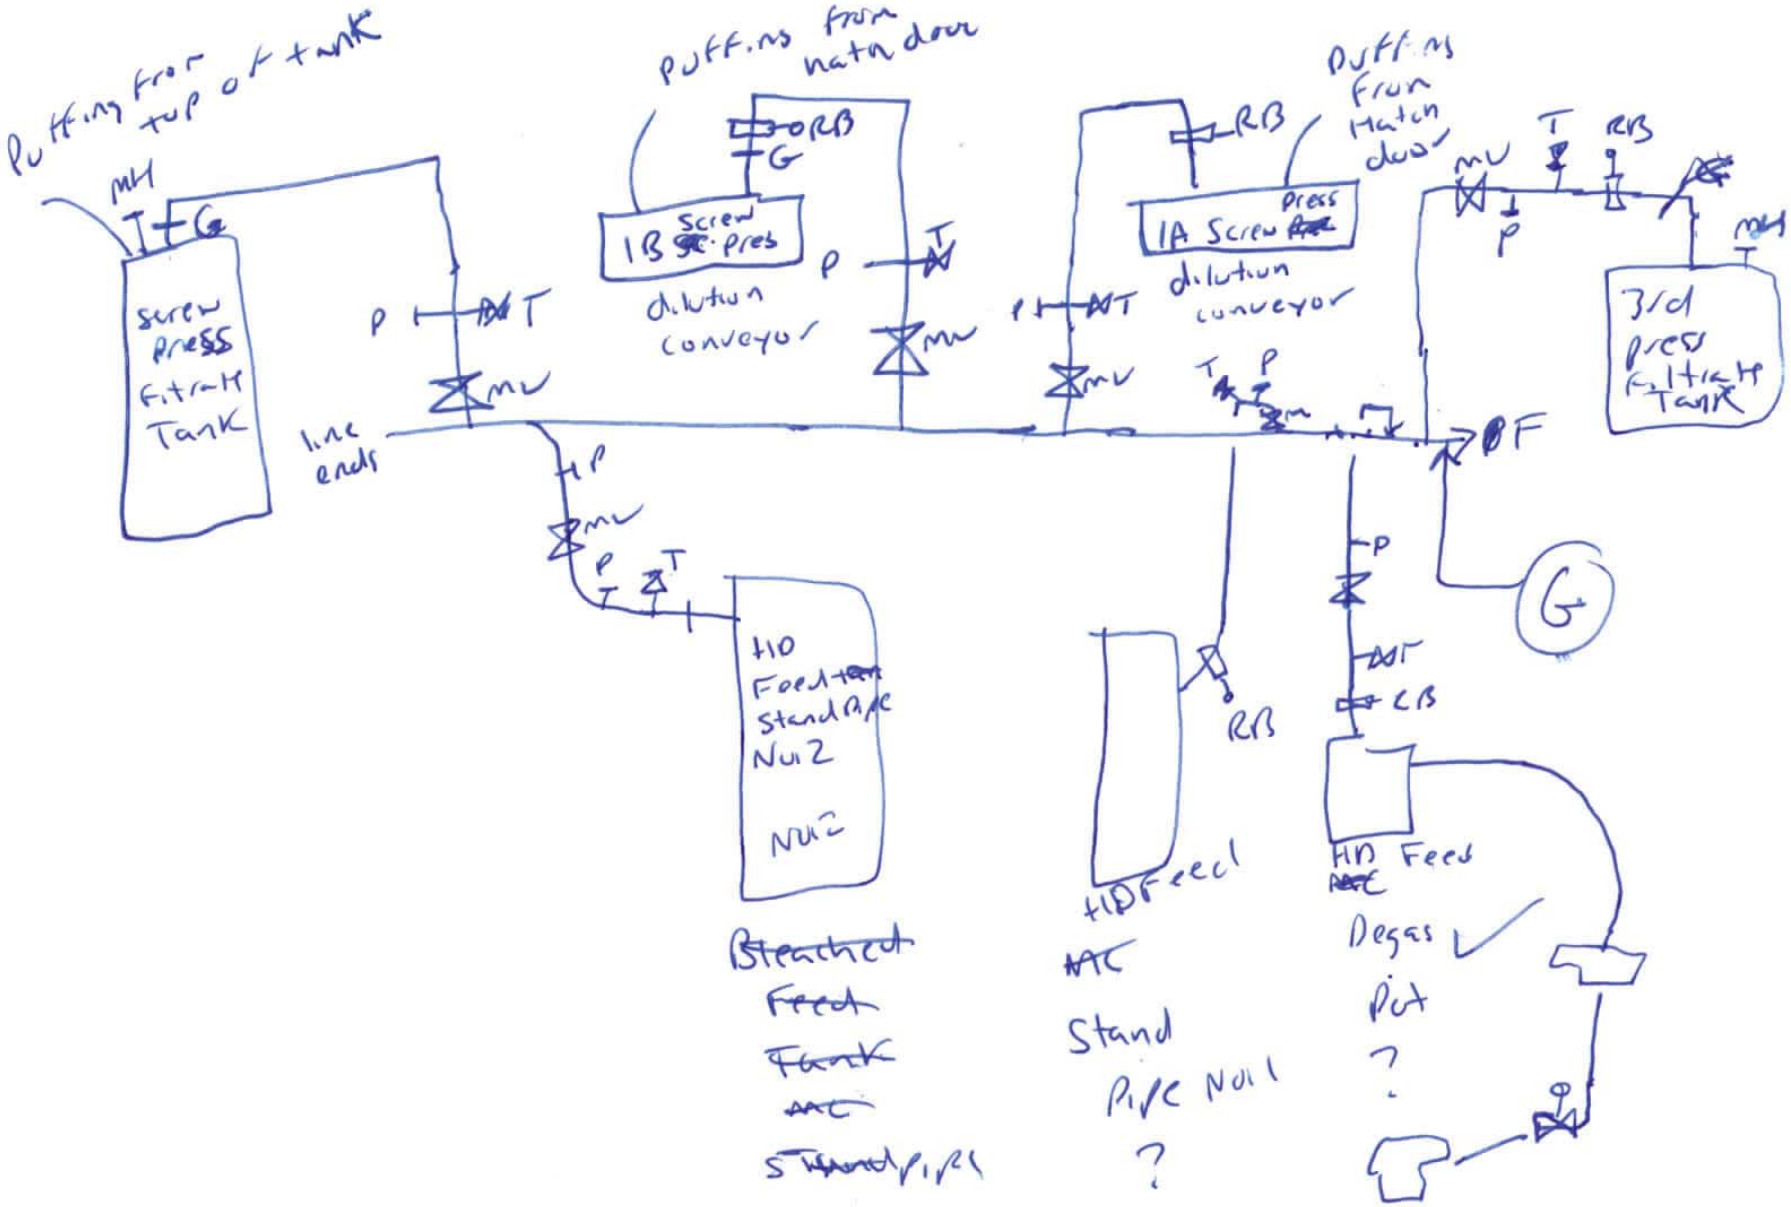
Puffing from top of tank
MH
G
screw press filtrate Tank
P
T
MV
line ends
Puffing from hatch door
RB
G
1B Screw press
dilution conveyor
P
T
MV
RB
1A Screw press
dilution conveyor
P
T
MV
T
P
MV
Puffing from hatch door
MV
T
RB
P
MH
3rd press filtrate Tank
F
G
P
MV
P
T
HD Feed Stand Pipe No 2
No 2
RB
HD Feed
Stand Pipe No 1
?
P
CB
HD Feed
Degas Pot
?
Bleached Feed Tank
Stand Pipe

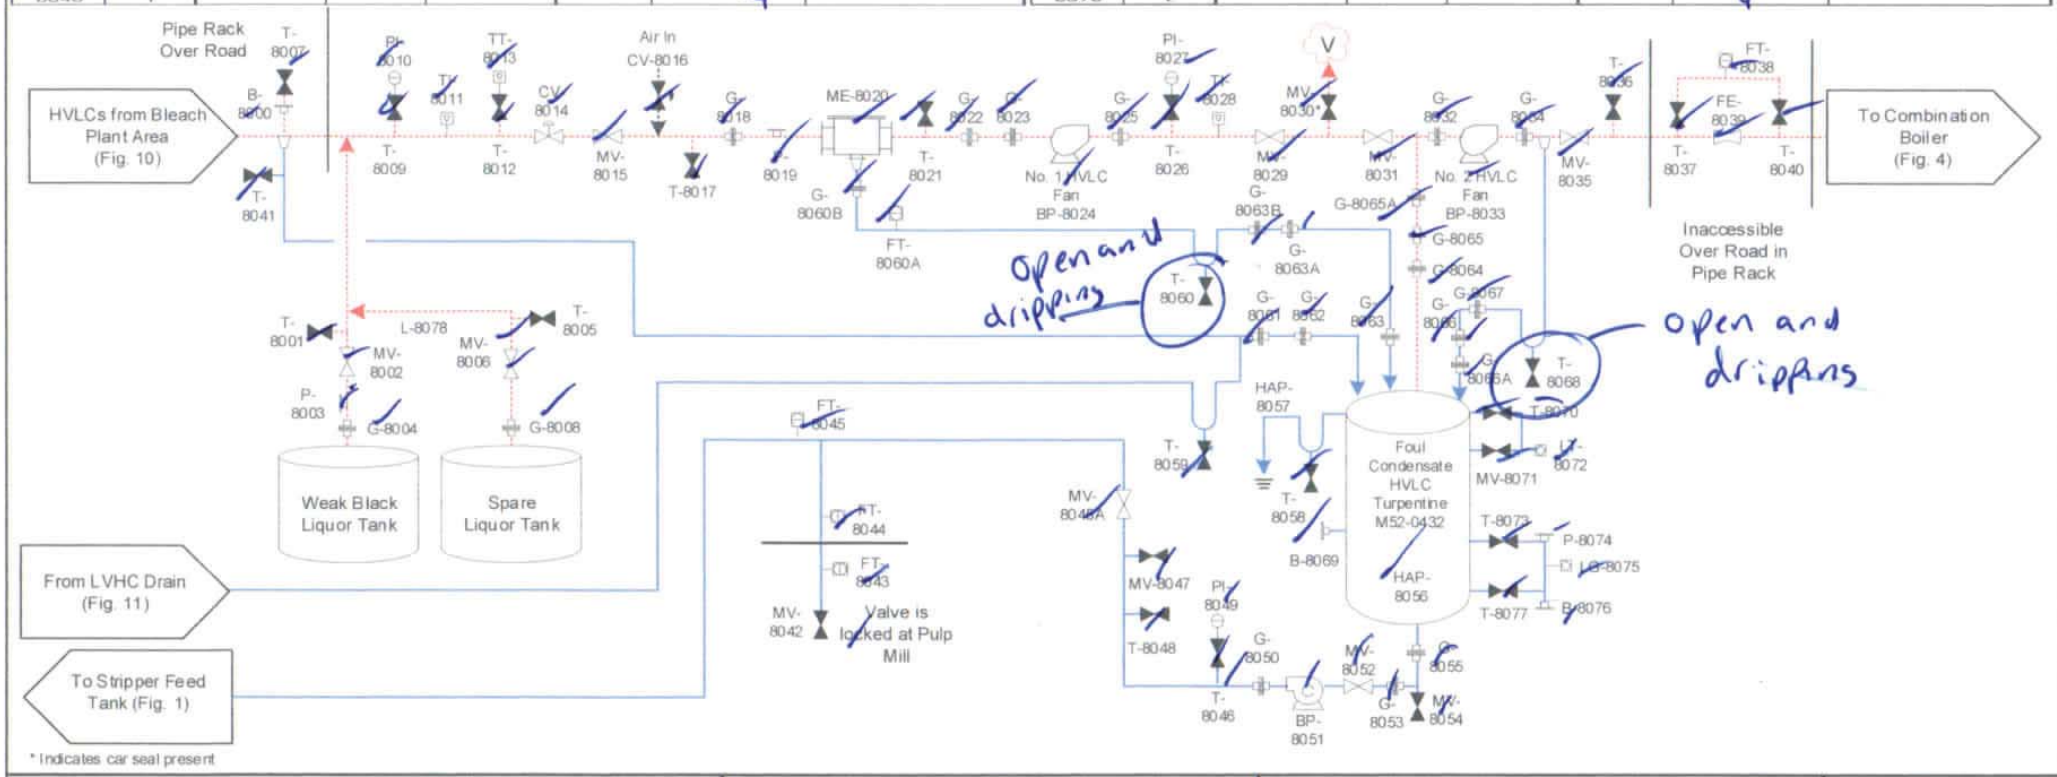
Equipment Number	Date	Description of Leak or Visual Defect
T-8060	2/17/2021	Tap valve T-8060 is located on foul condensate low point drain, coming from mist eliminator on HVLC line at inlet of No. 1 HVLC fan. The valve is open and dripping.
T-8068	2/17/2021	Tap valve T-8068 is located on foul condensate low point drain, coming from HVLC line at outlet of No. 2 HVLC fan. The valve is open and dripping.
HAP13007	2/17/2021	The 1A Screw Press Dilution Conveyor is puffing from top hatch door.
HAP-13013	2/17/2021	The 1B Screw Press Dilution Conveyor is puffing from top hatch door.
HAP-13117	2/17/2021	The 2B Brown Stock Washer is puffing from four open hatch doors.

8052	MV					Y	
8053	G					Y	
8054	MV					Y	
8055	G					Y	
8056	HAP					Y	
8057	HAP					Y	
8058	T					Y	
8059	T					Y	
8060	T					NO	open + dripping
8060A	FT					Y	
8060B	G					Y	
8061	G					Y	
8062	G					Y	
8063	G					Y	
8063A	G					Y	
8063B	G					Y	
8064	G					Y	
8065	G					Y	
8065A	G					Y	
8066	G					Y	
8066A	G					Y	
8067	G					Y	
8068	T					NO	open + dripping
8069	B					Y	
8070	T					Y	
8071	MV					Y	
8072	LT					Y	
8073	T					Y	
8074	P					Y	
8075	LG					Y	
8076	B					Y	
8077	T					Y	
8078	L					Y
