Site Name: Kerr Glass Mfg. Co, Huntington, W. Virg.
EPA No:
TDD No:
Date: June 1, 1983
Env. Cond. Sunny, warm, 68°
Personnel:
NUS (b) (4)

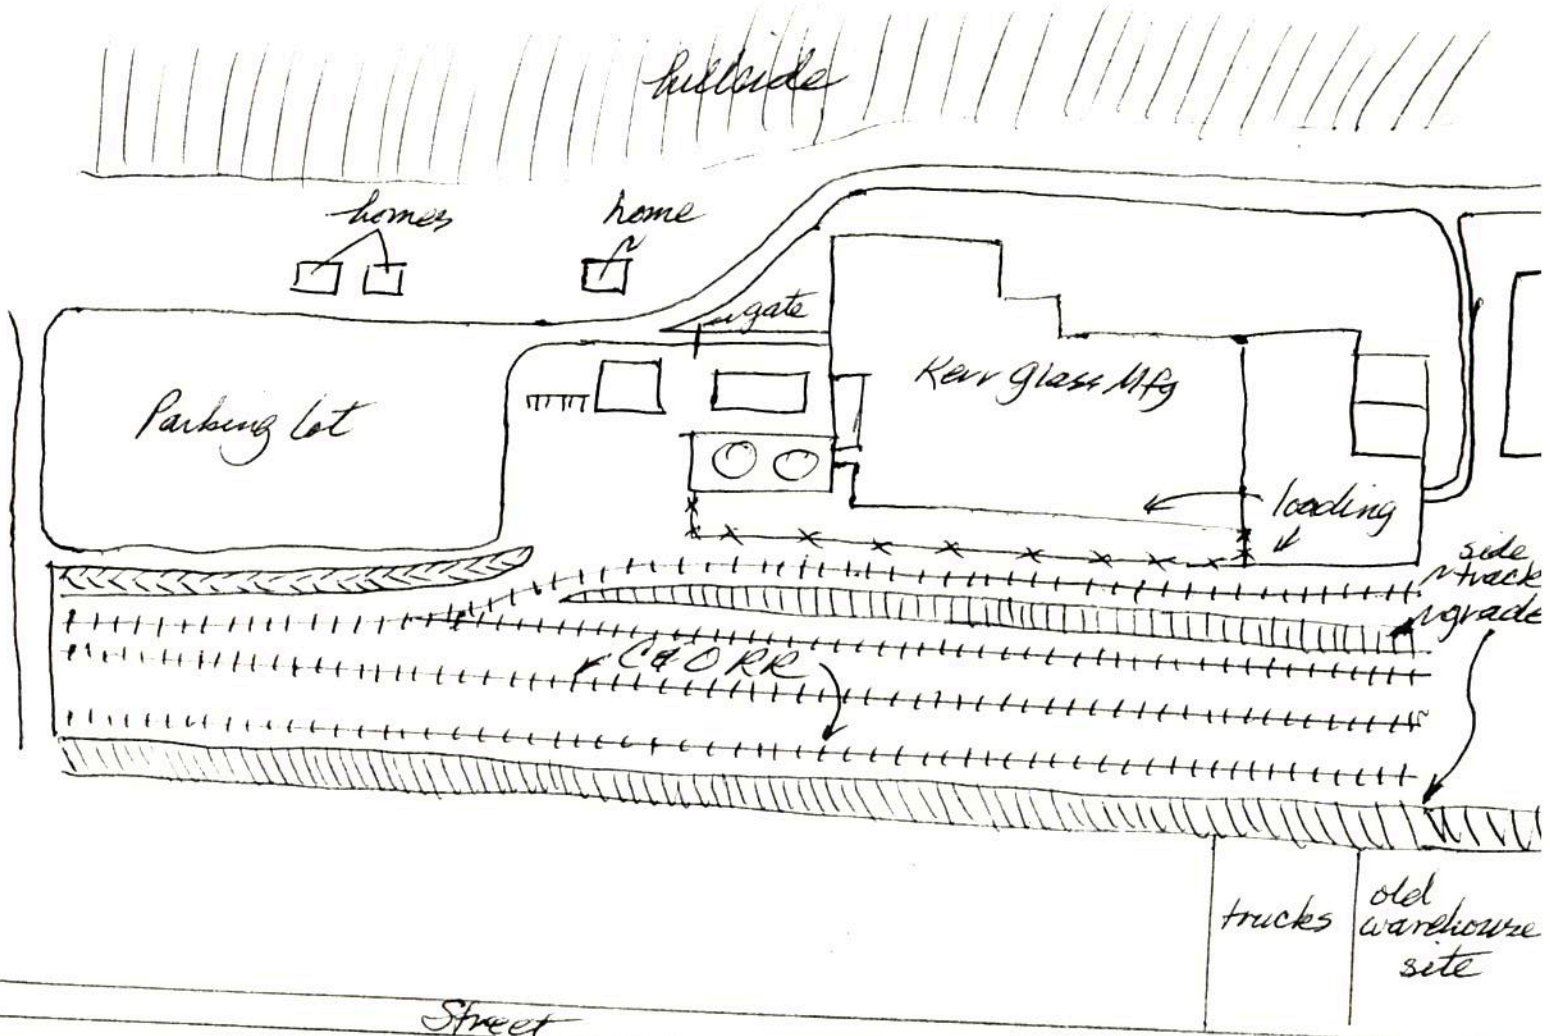
No other visible dumps or disposal sites on premises although soda ash, lime and/or fine quartz sand covered portions of the Kerr Glass plant RR siding track. Photos taken

Left site at 1607 after photographing parking lot
