Re: Notification of TSCA Self-Implementing Clean-up of PCBs
Andrew J. Petro Swimming Pool
Randolph Street
Southbridge, Massachusetts 01550
ATC Project No. 060.29841.0002

NOTIFICATION OF TSCA SELF-IMPLEMENTING CLEAN-UP OF PCBS

ANDREW J. PETRO SWIMMING POOL
RANDOLPH STREET
SOUTHBRIDGE, MASSACHUSETTS 01550

OCTOBER 21, 2011

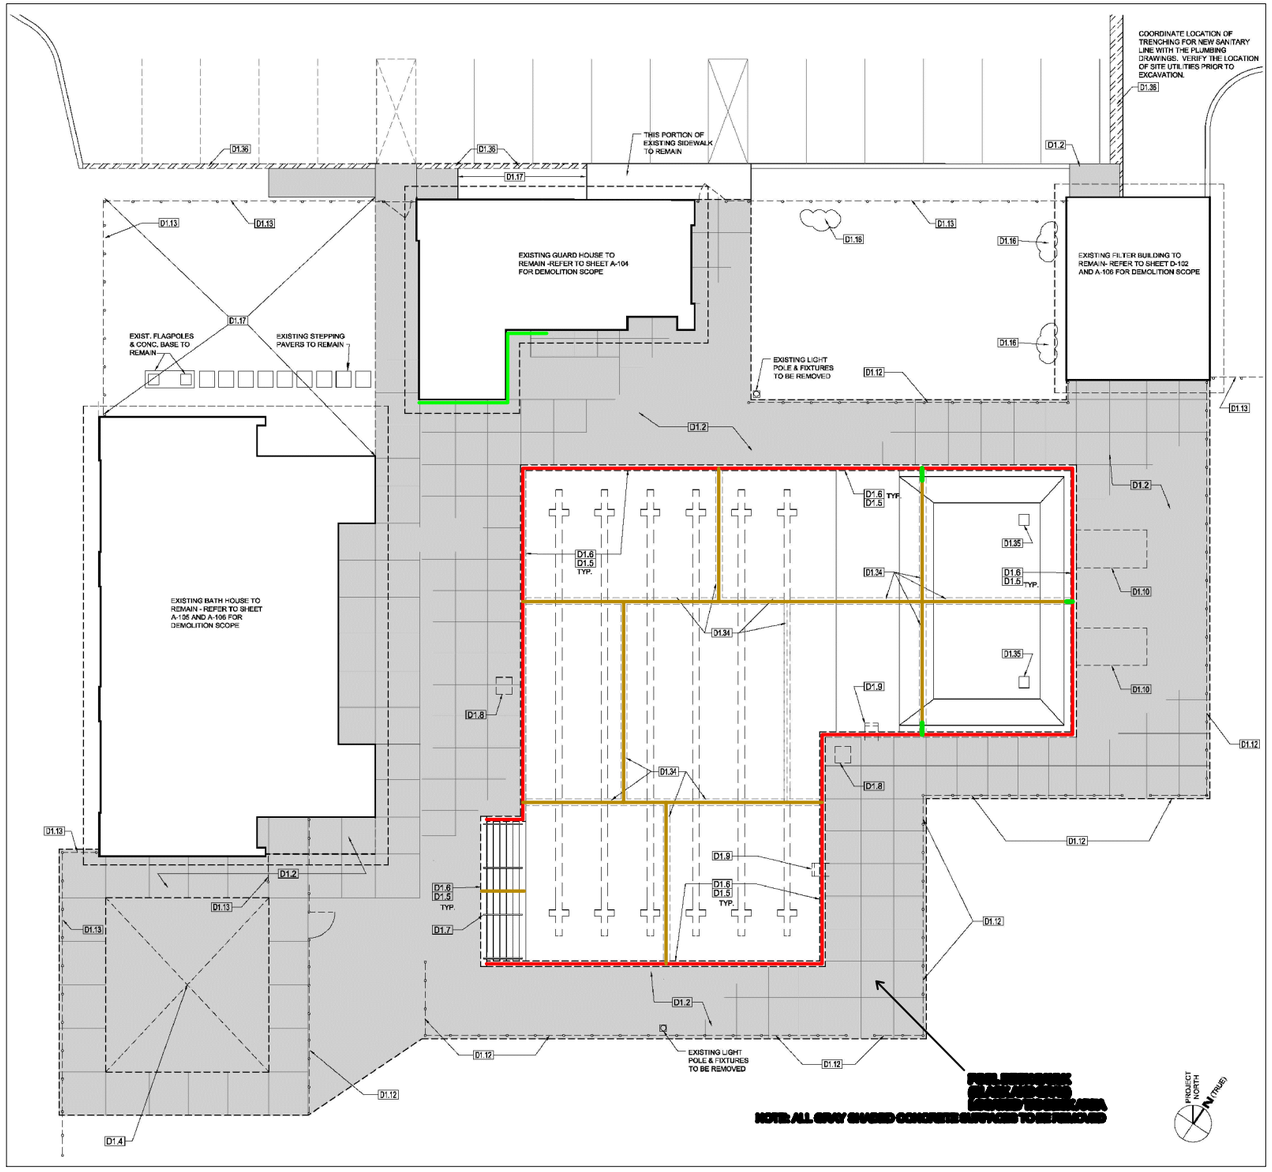
PROJECT NUMBER: 060.29841.0002	FIGURE NUMBER: 3
SCALE: NTS	CHECKED BY: CA
DRAWN BY: JAB	REVISED BY:
DRAWING FILE: H:\Enviro\Clients - Projects\A - F\DCR\Southbridge

A Site plan showing the layout of the Site is included as ***Figure 2***. Plans showing the approximate location of PCB Bulk Product sealants as observed in the field by ATC are included as ***Figures 3, 4 and 5***.

Caulk was observed between the pool wall and stainless steel pool gutter, vertical joints in the pool walls where the pool transitions from shallow to deep, pool bottom and pool shallow end stairs.

One vertical caulk sample was collected by Yee and had PCB concentration of 2,500 ppm. Of the eight other non-gutter pool sealant samples analyzed, PCBs were only detected in two other samples at a concentration of 1.37 and 14 ppm. In addition, PCBs were not observed in 19 of the 20 pool concrete samples analyzed, and PCBs were only reported at 0.52 ppm in the one sample they were present in. The pool paint/coating also had low (less than 8 ppm) PCB concentrations. Based upon these facts, ATC concludes that the vertical caulk sample is a PCB Remediation Waste impacted by the adjacent pool gutter caulk. As a conservative measure, the material will be managed off-Site with the PCB Bulk Product Waste and additional caulk sampling will be performed to confirm this conclusion.

Based upon the fact that PCBs were only observed in one of the concrete samples at 0.52 ppm, ATC classifies the concrete as Demolition Debris except for areas adjacent to the gutter and vertical caulk. As a conservative measure 6-inches of concrete beneath the pool gutter and on either side of the vertical caulk joint will be removed and managed as PCB Remediation Waste.

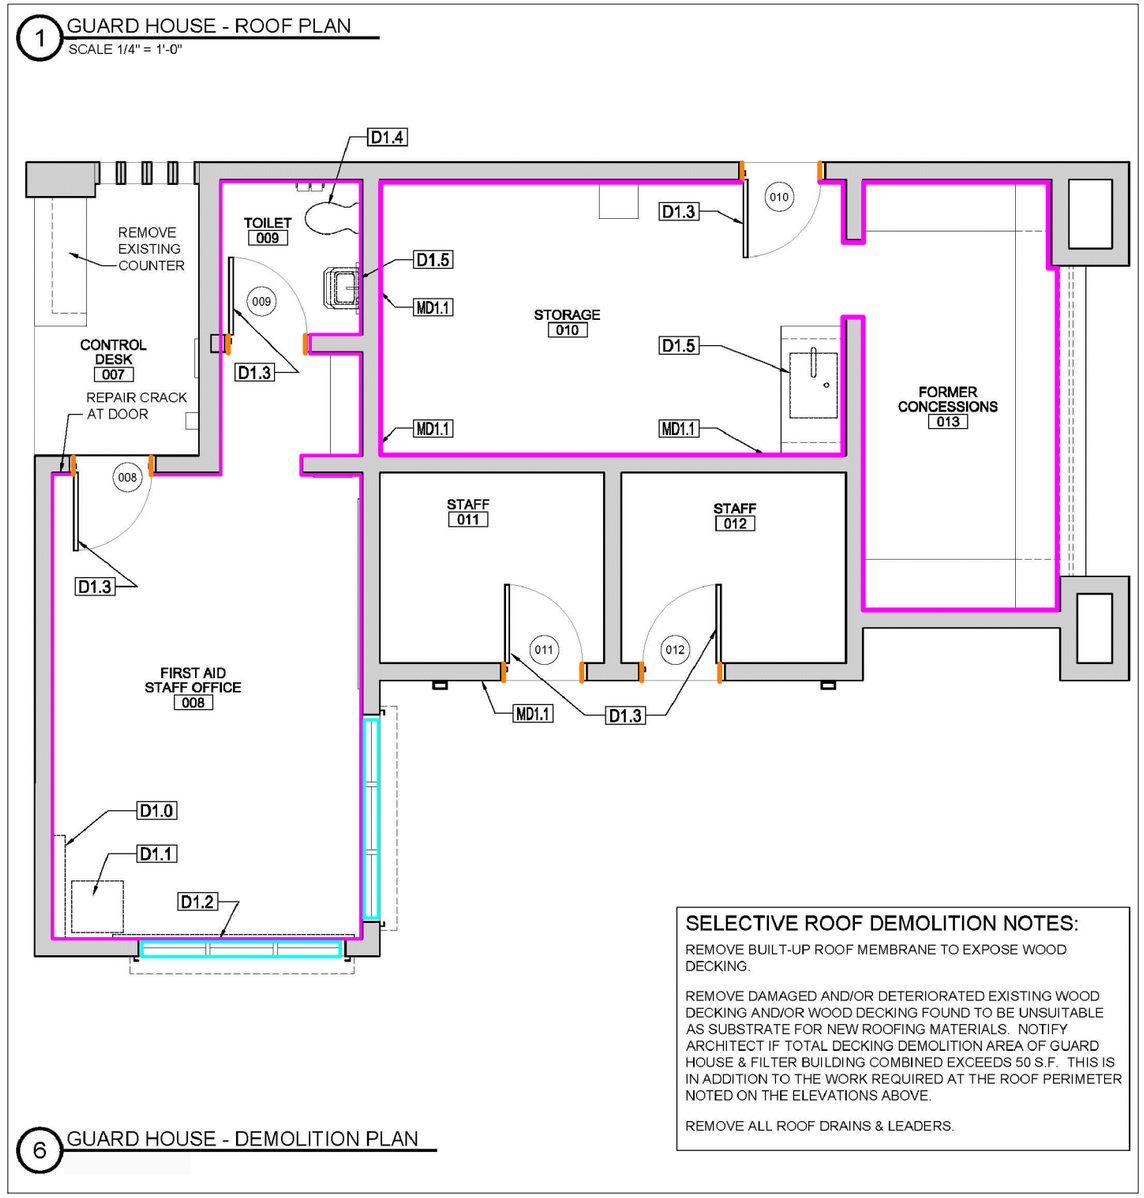
PROJECT NUMBER: 060.29841.0002	FIGURE NUMBER: 4
SCALE: NTS	CHECKED BY: CA
DRAWN BY: JAB	REVISED BY:
DRAWING FILE: H:\Enviro\Clients - Projects\A - F\DCR\Southbridge

Sealants were observed around the doorway jambs, portions of the interior and exterior foundation, and windows.

Three samples of the doorway jamb caulk were analyzed with PCB concentrations ranging from 1.2 to 10 ppm. ATC characterized this material as Excluded PCB Product. However, as a conservative measure this material will be managed as PCB Bulk Product Waste because elevated PCBs concentrations were observed in similar door frames in other buildings.

Due to the PCB concentrations observed in the First Aid Window glazing and caulk the entire window is considered a PCB Bulk Product. To determine impacts to adjacent building materials concrete and CMU samples were collected from increasing distances away from the window. Based upon this sampling ATC concludes that the first CMU course (8-inches) around the window is impacted with PCB at ≥ 1 ppm and is PCB Remediation Waste.

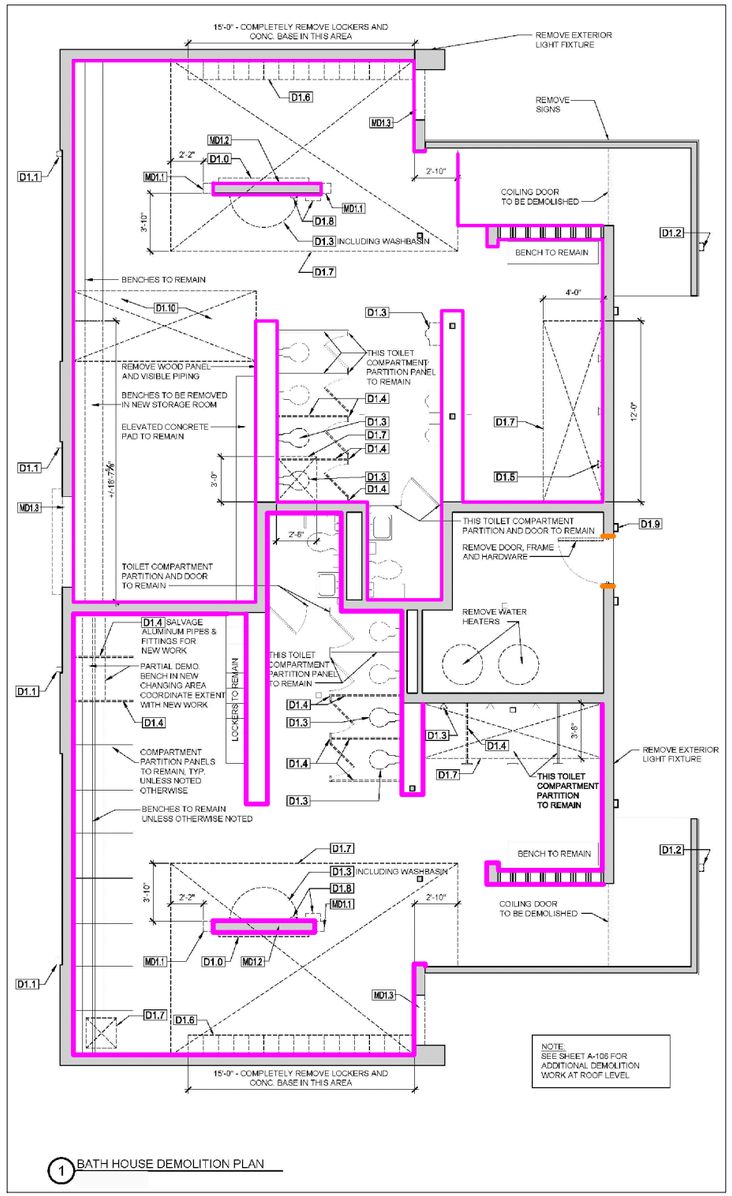
1 BATH HOUSE DEMOLITION PLAN

Caulk was observed around the door and the entire interior floor where it connects with perimeter and interior wall.

As discussed for the Guard House, all door caulk is assumed to be PCB Bulk Product. The levels observed in the Bath House are greater than the Guard House. To confirm that the adjacent CMU has not been impacted the adjacent CMU will be sampled.
