United Oil Recovery
Services

Middletown, OH
5/24/11 PJN

UNITED ~~SOLUTIONS~~, INC.

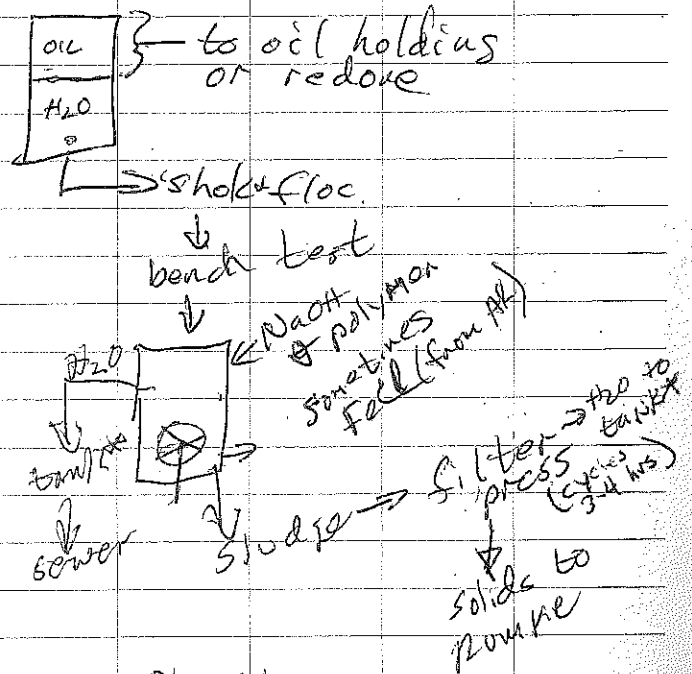
- visible operation to check when H_2O hits

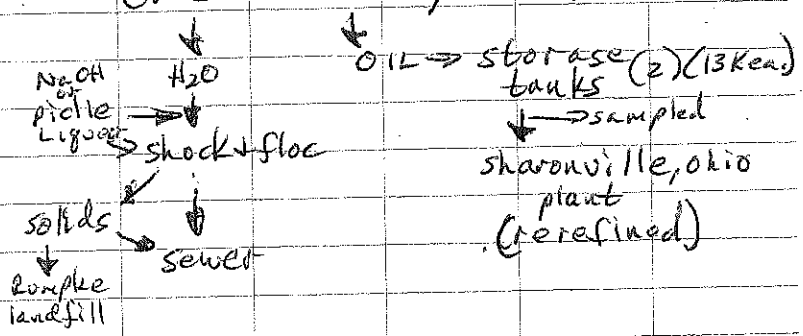
- subcontractors bring in wastes to Frac storage tanks & is screened for PCBs & if o.k. is trucked to process
- subsc have their own customers
- 1 load of PCBs came in April 2010, R.S. Oil
- normal loads - to heat treatment process -
