SUMMARY REPORT

NEW YORK CITY SCHOOL CONSTRUCTION AUTHORITY PILOT STUDY TO ADDRESS PCB CAULK IN NEW YORK CITY SCHOOL BUILDINGS

USEPA CONSENT AGREEMENT AND FINAL ORDER
DOCKET NUMBER: TSCA-02-2010-9201

May 24, 2013

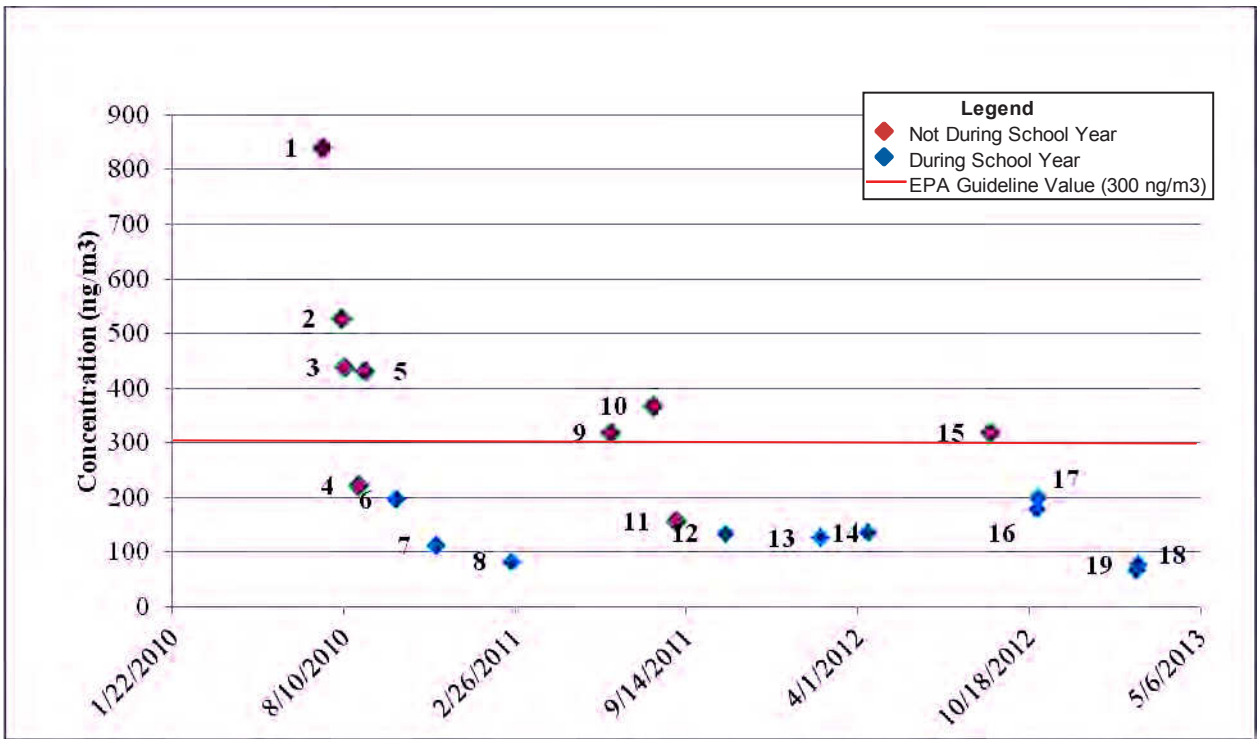
Figure 2.1 – P.S. 199M Building Average Concentration Over Time

Between August 23, 2008, and February 22, 2013, twenty-five (25) rounds of wide-scale testing were performed in P.S. 199M. Four (4) of these rounds were performed prior to the initiation of the Pilot Study, and the other twenty-one (21) rounds were performed as part of the Pilot Study. Eight (8) rounds of sampling were performed in the month of August, five (5) rounds in October, four rounds in February, two (2) rounds in September, and one (1) round each in January, April, June, July and November. Building-wide monthly PCB averages ranged from a high of 839.67 ng/m^3, measured in July 2010, to a low of 67.24 ng/m^3, in February 2013 Refer to Figure 2.1 below for a graphical representation of the building-wide airborne PCB average concentration trend since the beginning of the Pilot Study in June 2010. The same trend has also been noted in P.S. 309K, as detailed in Supplemental Report #1 located in Appendix M of the RIR.

These data indicate that school wide averages were generally highest over the summer months and at the beginning and end of the school year and lowest during the school year winter months. As indicated by the data, average building-wide airborne PCB concentrations at P.S. 199M have tended to decrease with time and following implementation of the remedial and post-pilot activities. The same trend has also been noted in P.S. 309K, as detailed in Supplemental Report #1 located in Appendix M of the RIR.

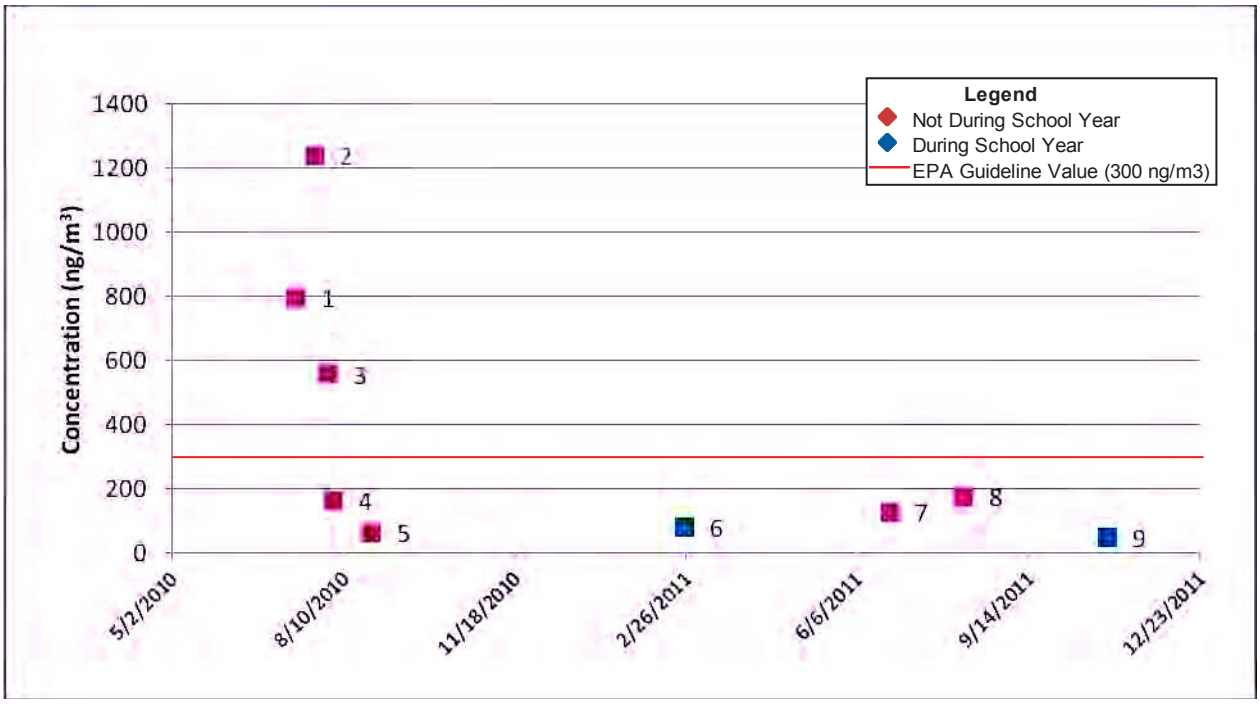
Figure 2.2- P.S. 309K Building Average Airborne PCB Concentration Over Time

Nine rounds of wide-scale testing were performed in P.S. 309K from July 2010 to October 30, 2011. Six rounds of sampling were performed in August, two rounds in July, and one round each in February, June and October. Building-wide monthly PCB averages ranged from a high of 1,240 ng/m^3, measured in July 2010, to a low of 49.8 ng/m^3, measured in October 2011. See Figure 2.2 for a graphical representation of the building-wide airborne PCB average concentration trend since the beginning of the Pilot Study in July 2010.

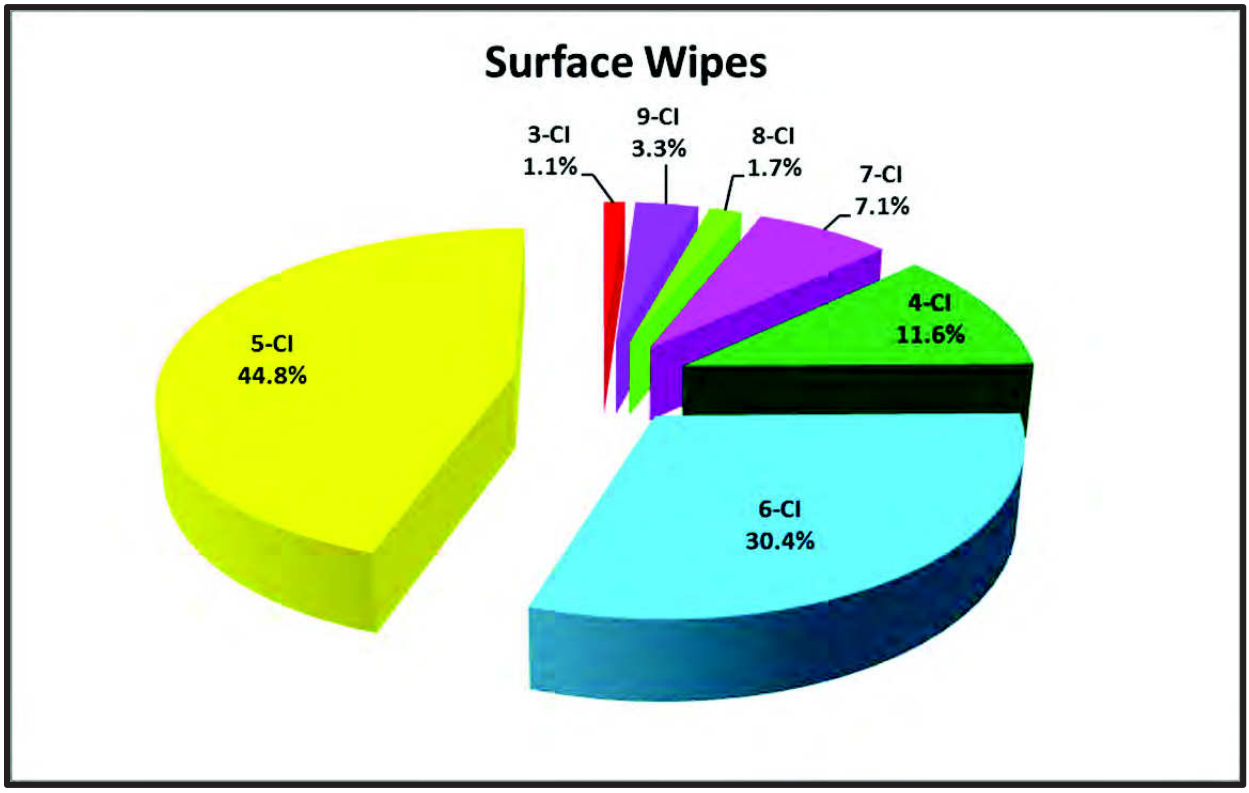
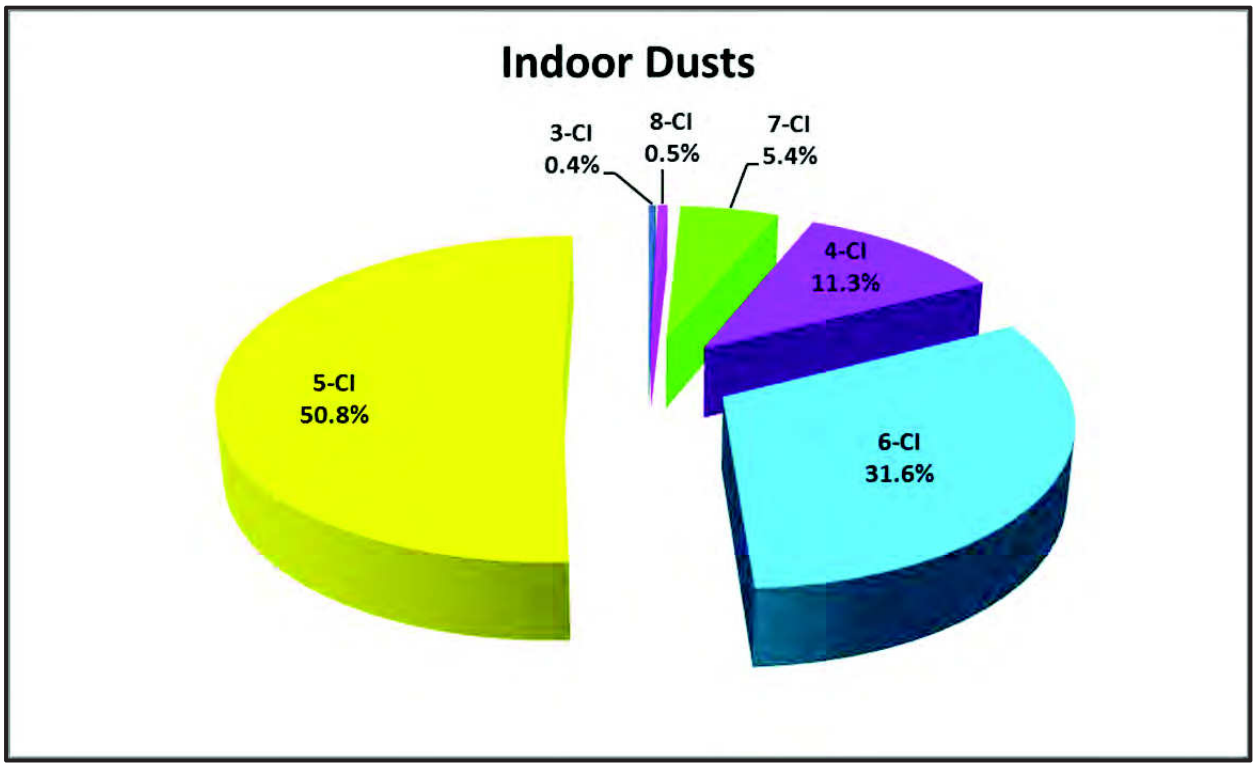
- Aroclor 1254 was, by far, the most common contributor to the reported total PCB concentrations in air and wipe samples, with a much smaller portion being attributed to Aroclor 1248. No other Aroclors were identified in any of the air or wipe samples collected in the Pilot School Buildings. USEPA analyses of the SCA/TRC data base corroborate the predominance of Aroclor 1254 in the air and wipe samples collected during the six (6) school study (see Section 3.4 and Figure 1 in Appendix C).

- Examination of homologue profiles indicated that surface wipes and dusts displayed very similar profiles. These data suggest that surface wipes have a dust component. Examination of the indoor air homologue profiles indicate contributions from airborne particulate and not vapor phase PCBs alone. This particulate matter likely includes a dust component (see Figures 4-13 and 4-17, PCBs in School Buildings). Figure 1 in Appendix C shows a comparison of PCB homologue profile data for surface wipes and indoor dusts (adapted from Figure 4-17, PCBs in School Buildings).

Figure 1. Comparisons of PCB Homologue Profiles – Surface Wipes and Indoor Dusts

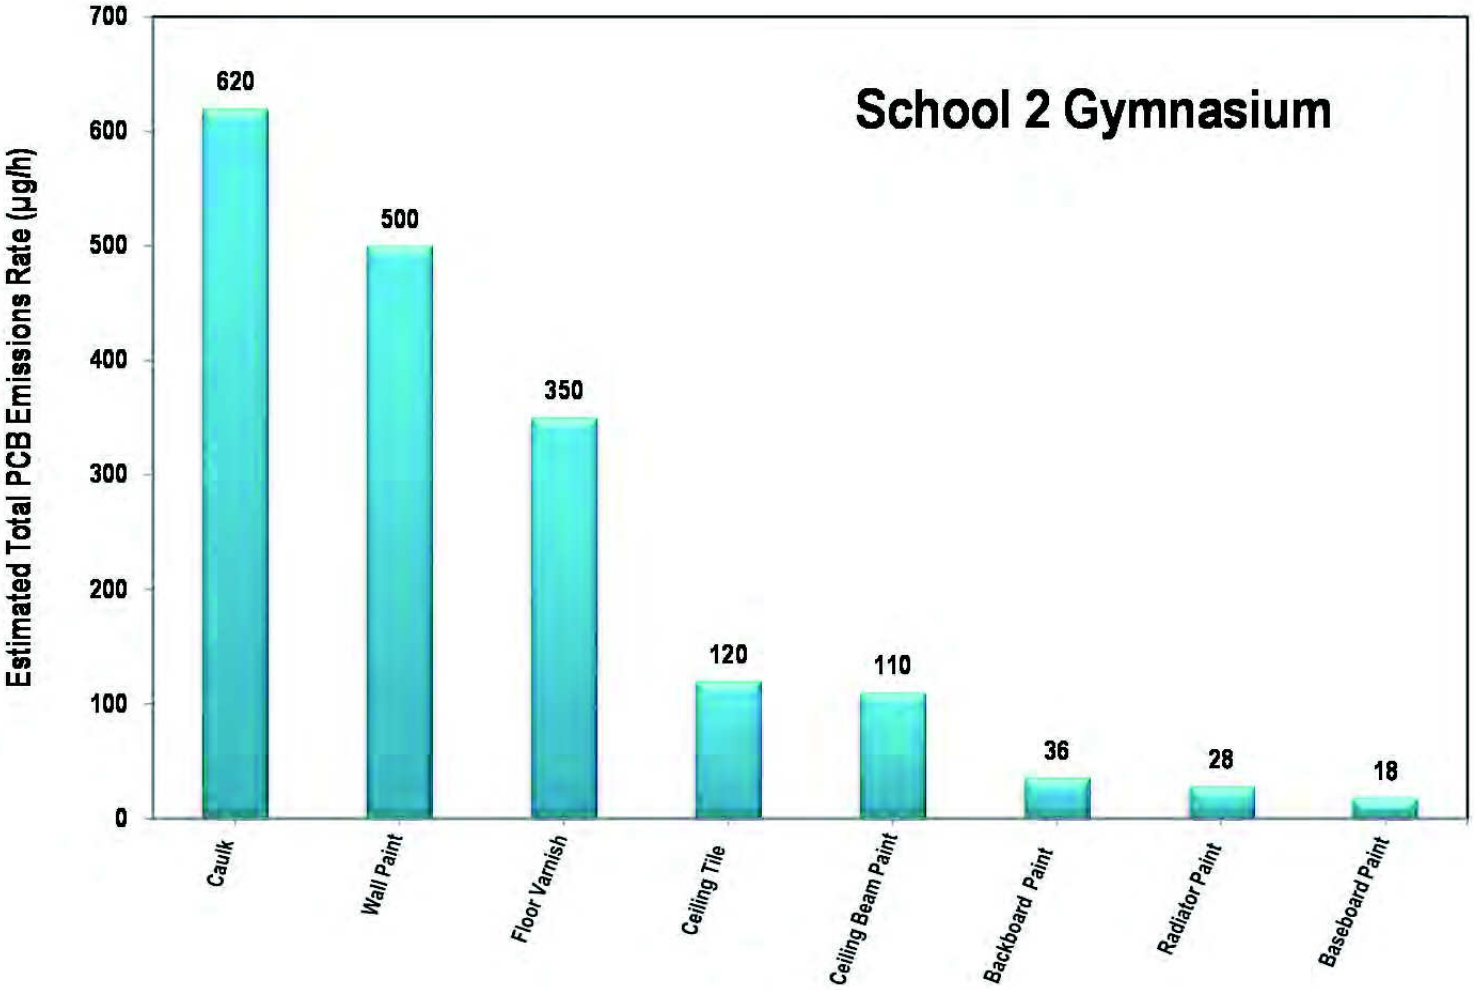
- Airborne PCB concentrations were found to be elevated in several spaces prior to and after removal and replacement of all identified PCB caulk during the summer, 2011. This suggests one or more other contributing sources of PCBs are likely present P.S.199M. These may include secondary sources, such as painted surfaces, that remain after the primary sources have been removed (see Section 3.3.1, Section 3.5 and Figure 2 in Appendix C).

- PCB emissions from secondary sources (in combination) can be significant even after all primary sources have been removed or mitigated (see Page 44, PCBs in School Buildings). For example emission rates estimated for paints (500 µg/hr) in gymnasium (P.S. 199M) were found to be comparable to caulk emission rates (620 µg/hr) (see Table 4-8, PCBs in School Buildings). Paints and varnishes combined resulted in an emission rate of 850 µg/hr in the same gymnasium location (see Table 4-14, PCBs in School Buildings). Refer to Figure 2 in Appendix C for a comparison of estimated PCB emission rates for a number of the gymnasium primary and secondary sources.

Figure 2. Estimated Total PCB Emission Rates – Comparison of Primary and Selected Secondary Sources – School 2 Gymnasium (Adapted from Figure 4-5, EPA/600/R-12/051 September 2012).

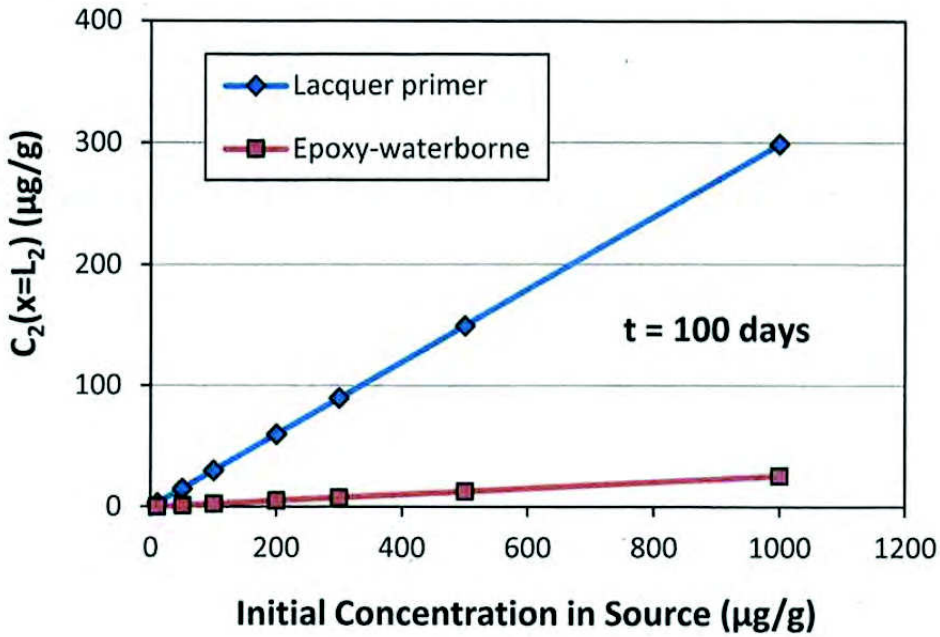
- Long-term monitoring results consisting of wipe samples from surfaces of PCB caulk that were encapsulated at P.S. 309K indicate that PCBs from the caulk have migrated through the encapsulant layer to the surface over time. These results indicate that the coatings used and methods employed in the pilot study do not represent an effective remedial measure for encapsulation of PCB caulk. USEPA ORD laboratory tests performed with ten (10) commercially available coatings indicated that encapsulation was not effective when high concentrations of PCBs were present in the caulk. None of the ten (10) encapsulants evaluated represented a long term remedial measure for PCB caulk concentrations greater than 4,300 ppm if wipe test results < 10 µg /100 cm^2 are desired. Furthermore, none of the ten (10) encapsulants were found to be truly impenetrable to PCBs. As a result, encapsulation of PCB caulk may only represent a short term or interim control measure and not a long term or permanent remedial measure, especially when high concentrations of PCBs are present (see Section 3.6.1 and Figures 3 to 6 in Appendix C).

Figure 3. Concentration of congener #110 at the exposed surface of the encapsulant layer [$C_2(x = L_2$] as a function of initial concentration in the source (t = 100 days).

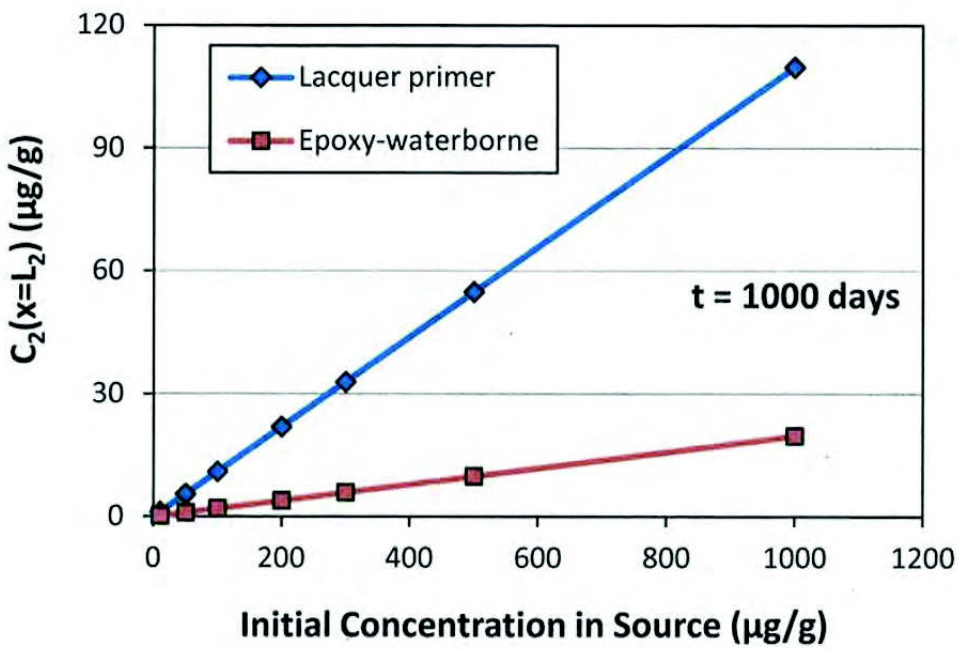
Figure 4. Concentration of congener #110 at the exposed surface of the encapsulant layer [$C_2(x = L_2$] as a function of initial concentration in the source (t = 1000 days).

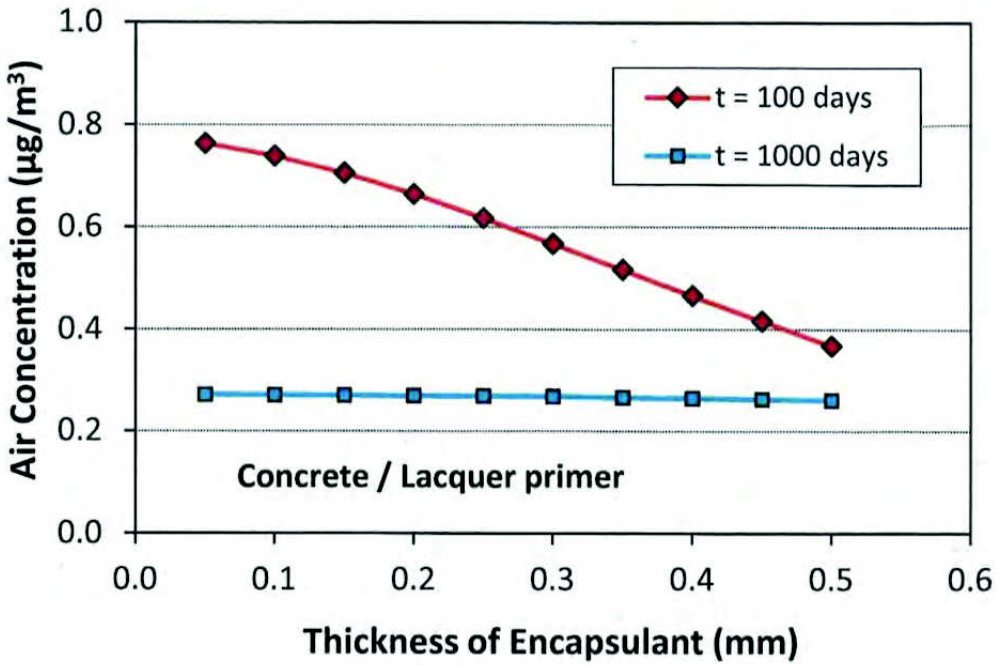
- Test results demonstrated that multiple coatings of the encapsulant when applied to the source or substrate were more effective than a single coating. These findings were based upon PCB concentrations found in wipe samples taken at the surface of the encapsulant. PCB concentrations decreased as the thickness of the encapsulant layer increased (see Section 4.2.6, Laboratory Study, Part 3) Figures 5 and 6 in Appendix C display estimated concentrations of PCBs in room air as a function of encapsulant film thickness.

Figure 5. Effect of encapsulant thickness on the concentration of congener #110 in room air due to emissions from the encapsulated source – Case 1: Laquer-primer

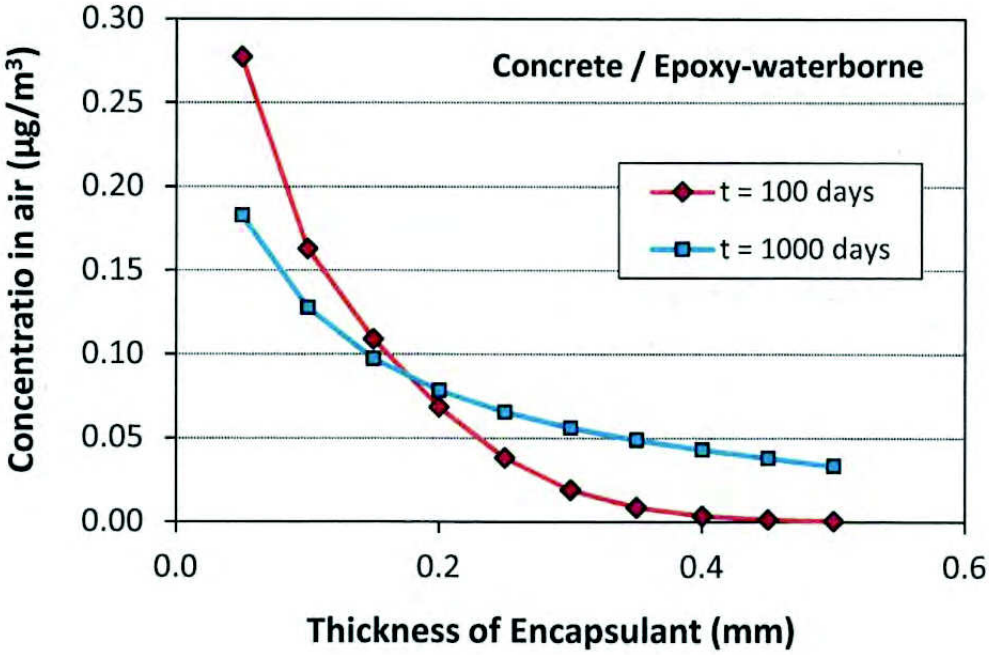
Figure 6. Effect of encapsulant thickness on the concentration of congener #110 in room air due to emissions from the encapsulated source – Case 2: Epoxy-waterborne
