SPGIT Data Package Report

Figure 1 SPGIT Priority Areas
PDQ Auto Salvage
10975 Tuxford Street, Sun Valley, CA

EPA REGION IX SITE SCREENING/PRIORITIZATION CHECKLIST

Site Name: PDQ Auto Salvage

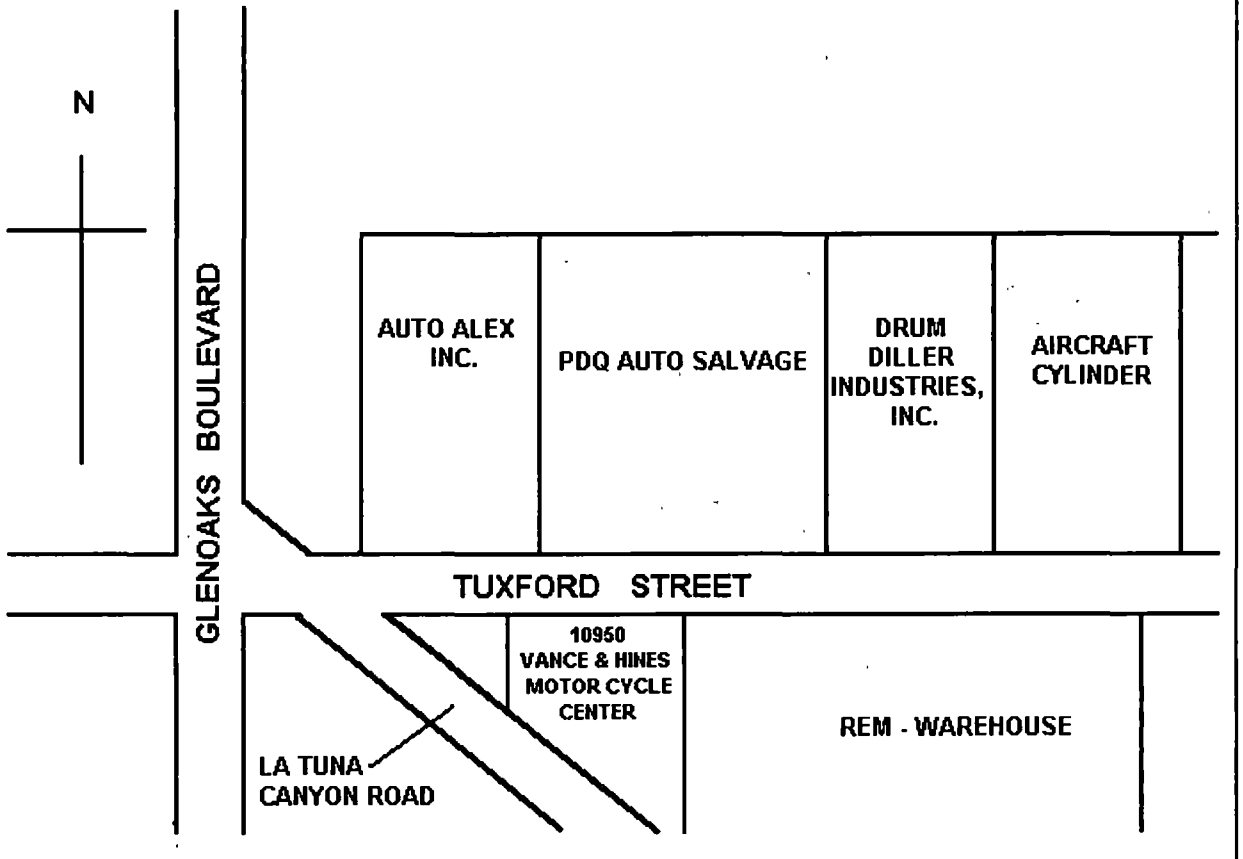
10. **Sketch or attach a diagram of the facility with relevant features and labels.**

Soil is severely discolored with stains. Auto parts and iron pieces are scattered all over the site. Waste oil and antifreeze are stored in drums. Solid wastes such as household wastes and auto parts are stored in dumpsters, buckets, sacks, trash cans, and in piles.

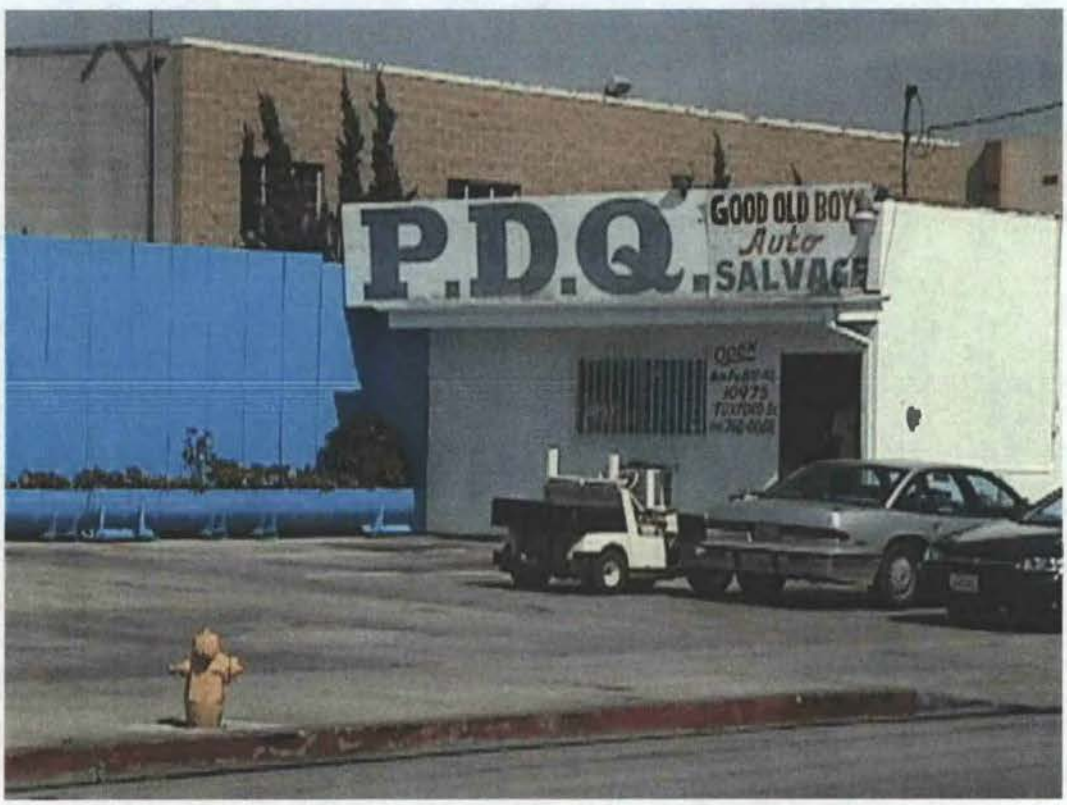
Photograph taken northeast direction showing front view
