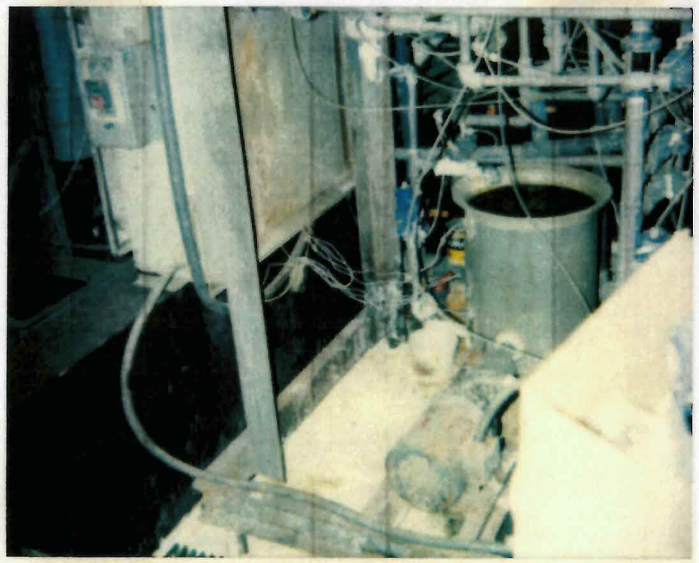
Plasti-Clad Metal Products Inc. 4-29-92
2601 Ridgewood Road
Wall Township, N.J. NJD011417516
7
• Ion Sept Area - contains substantial staining due to spills of chromium waste
Vitone
