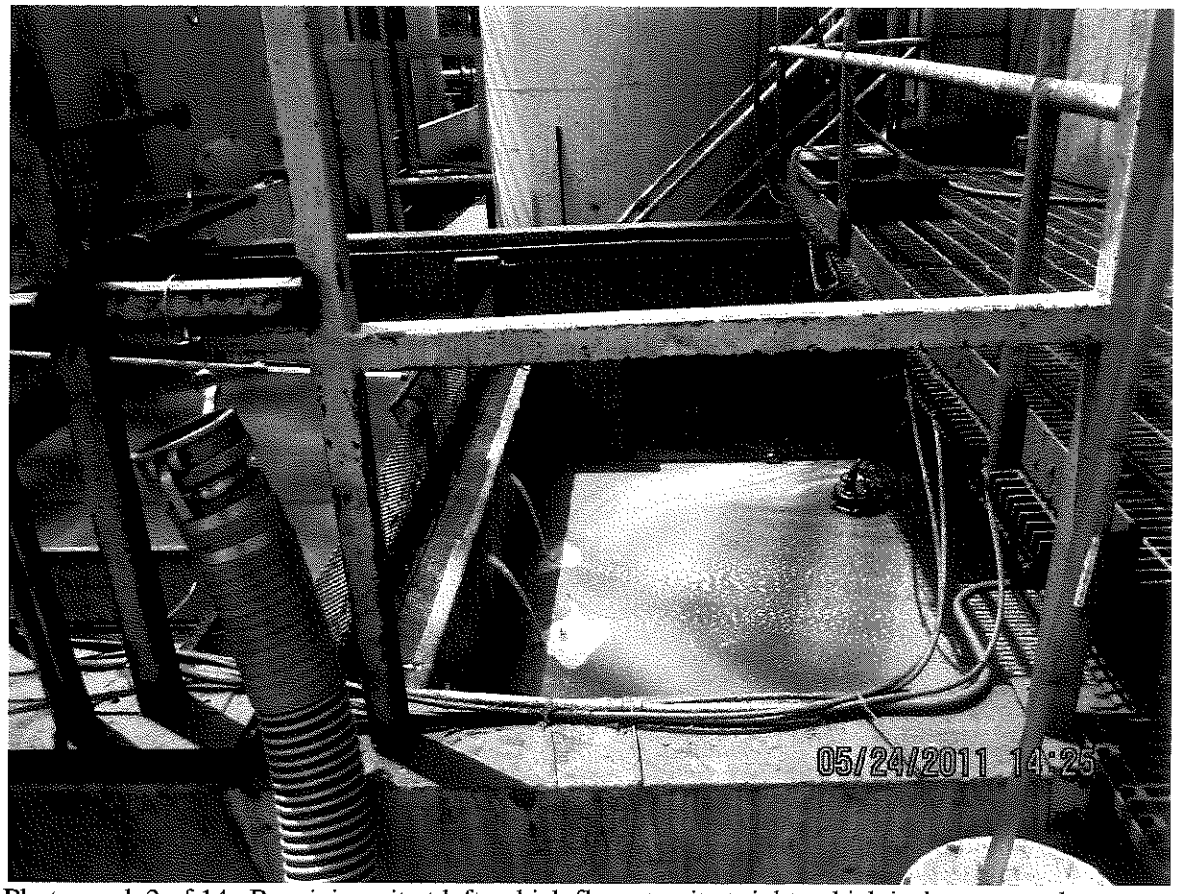
Photograph 1 of 14. Receiving pit with screen. M. Mikulka, U. S. EPA, LCD, 05/24/11, 1424 hrs, Cannon SD1400IS, Ser. No., 212065043412, digital media.
