MEMO

Date:
October 4, 2013

Plainwell No. 2 Dam Area Fall 2013 Bank Repair Plan Technical Memorandum

GEORGIA-PACIFIC LLC
ALLIED PAPER, INC./PORTAGE CREEK/
KALAMAZOO RIVER SUPERFUND SITE
PLAINWELL NO. 2 DAM AREA
FALL 2013 BANK REPAIR PLAN TECHNICAL MEMORANDUM

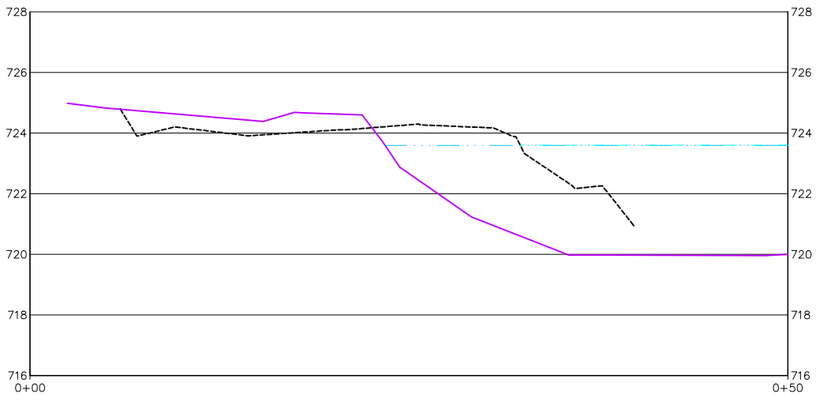
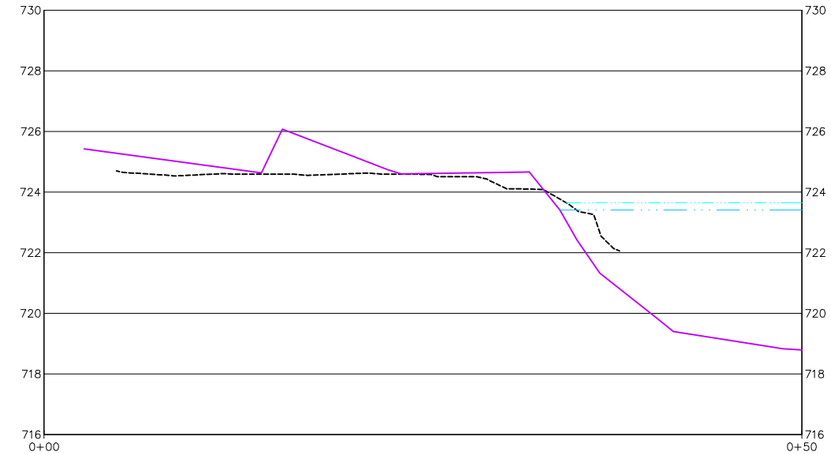
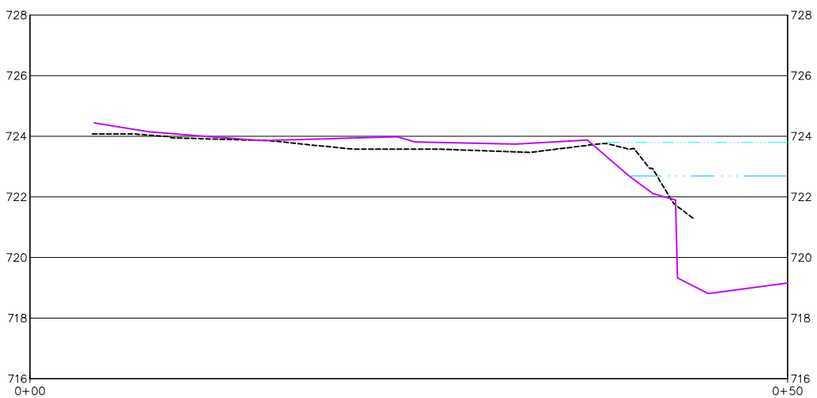
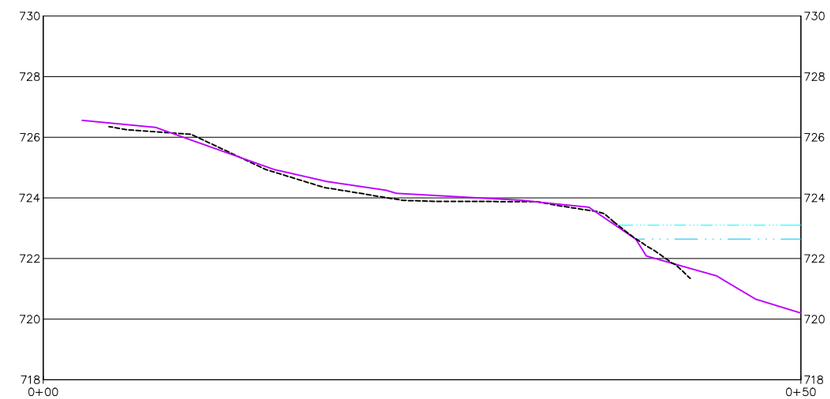
FIGURE
3

The results of bank profile survey (Figure 3) were submitted to USEPA and MDEQ in the Spring 2013 BCMR (ARCADIS 2013a). Based upon review of the bank profile survey cross-sections, Georgia-Pacific and ARCADIS concluded that three of the four bank areas required maintenance to minimize the potential for future erosion (ARCADIS 2013a).

USEPA and MDEQ also identified a fourth area - Removal Area 4B - as exhibiting signs of erosion; however, based upon evaluation of the bank profile survey data, the current bank slope in Removal Area 4B (Figure 3; T-18) is very similar to the post-construction condition. No significant erosion appears to have occurred at this location; and therefore, bank repair is not warranted in this area.

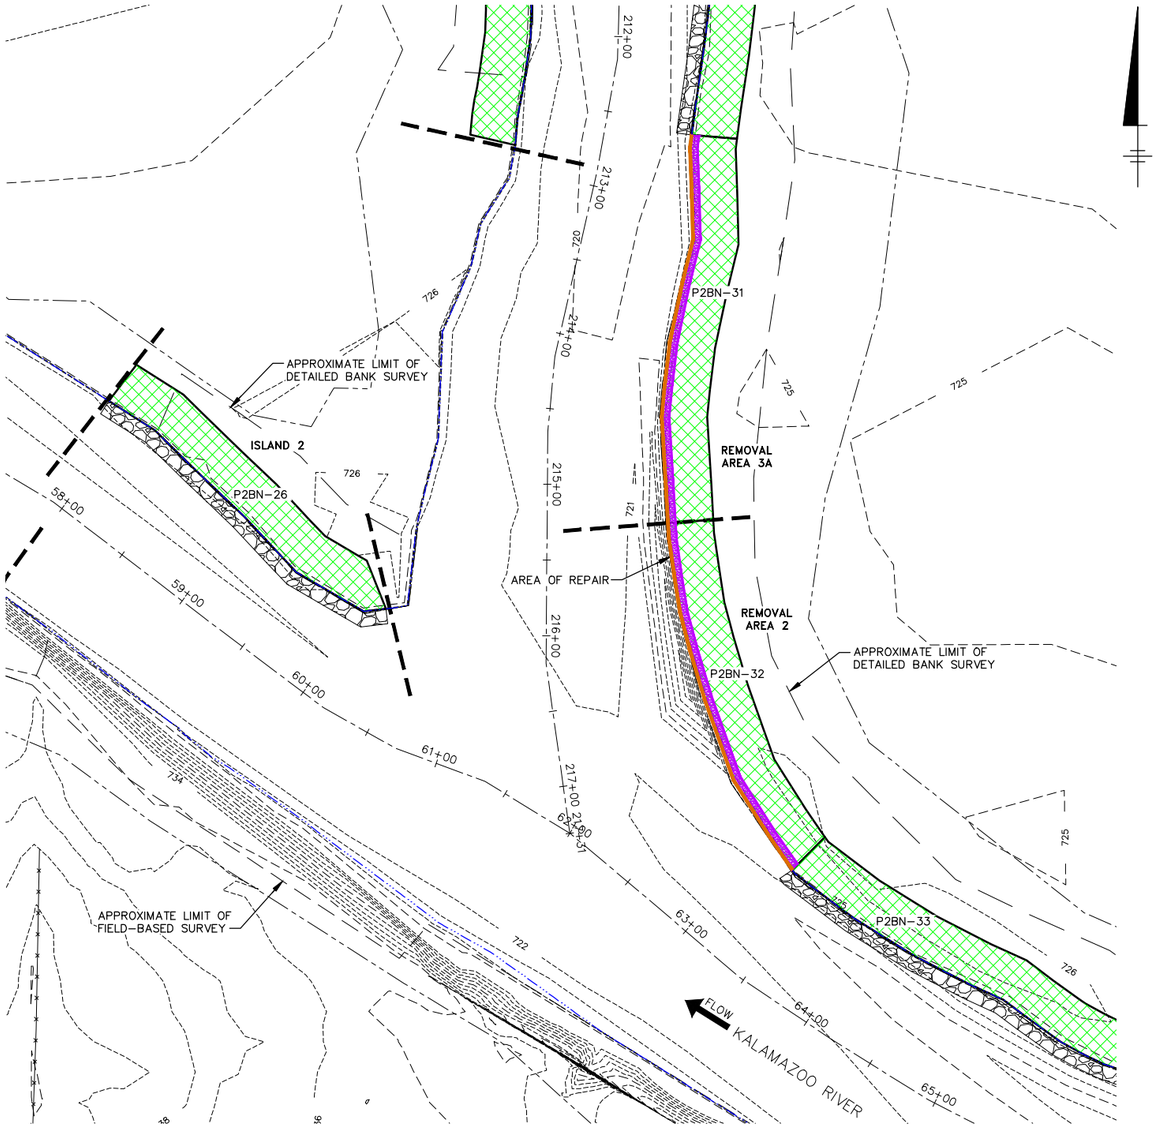
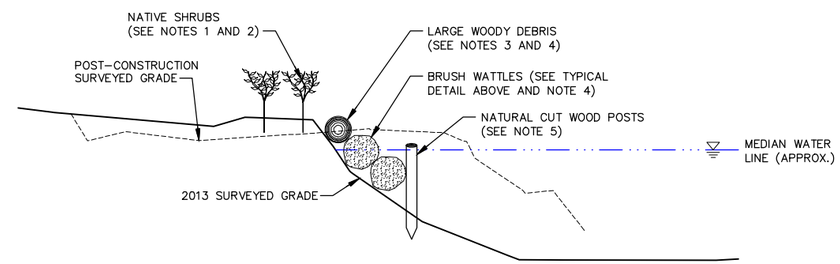
FIGURE
4

During the Agency Annual Site Inspection, four areas were identified by USEPA and MDEQ as exhibiting signs of erosion. Following review of post-construction and newly surveyed bank profiles of these areas, three of the areas (Removal Areas 2, 3A, and 4A) were identified as requiring repairs and are addressed in this memorandum.

Based on the considerations presented above, brush wattles, woody debris, and live woody vegetation will be used to repair banks identified during 2013 monitoring activities. The bank repairs will be implemented in Removal Area 2 (River Station 213+00 to 217+50; Figure 4), Removal Area 3A (River Station 207+00 to 208+50; Figure 5), and Removal Area 4A (River Station 199+00 to 201+00; Figure 6). Details of the bank repair implementation are provided in the following sections and Figures 4 through 6.

Areas designated for bank repair will be stabilized utilizing a combination of brush wattles and large woody debris. Brush wattles will be constructed primarily of dead and downed woody material gathered from the adjacent woodlot. As needed, live material will be selectively harvested in close coordination with the landowner's contracted forester to minimize impacts to desirable timber. Brush wattles will be bundled into groupings of 12 to 18 inches in diameter and 5 to 30 feet long. Wattles shall be placed along the bank and interspersed with large woody debris, which will consist of 6 to 18 inch diameter logs, also harvested from the adjacent woodlot. The total height of the combination of brush wattles and large woody debris will generally match the bank height from the top-of-bank to 2-3 feet below the median water elevation. All brush wattles and woody debris will be secured to the bank with natural cut wood posts installed every 3 feet. Natural ¼-inch biodegradable manila rope will be used to bundle the brush wattles together. Brush wattles and woody debris will be installed in 2013.

Following brush wattle and woody debris installation, 2 rows of native shrubs (in either bare-root or shrub plug form) will be installed and spaced approximately 2 feet on-center. Species shall be primarily *Cornus amomum*, *Cornus sericea*, and *Salix* spp. Shrubs will be installed in the spring of 2014 to maximize the potential for survivability.
