EPA CONTRACT No.: EP-W-06-072
TDD No.: TO-0029-0122
DOCUMENT CONTROL No.: RST 2-02-F-2690
SUBJECT: PHASE IIIC REMOVAL ASSESSMENT SAMPLING TRIP REPORT – PUERTO RICO OLEFINS ASBESTOS SITE, PEÑUELAS, PUERTO RICO

PHASE IIIC REMOVAL ASSESSMENT SAMPLING TRIP REPORT PUERTO RICO OLEFINS ASBESTOS SITE PEÑUELAS, PUERTO RICO

SITE NAME: Puerto Rico Olefins Asbestos Site – (Background Locations)
DC No.: RST 2-02-F-2690
TDD No.: TO-0029-0122
SAMPLING DATES: January 2 and 3, 2014

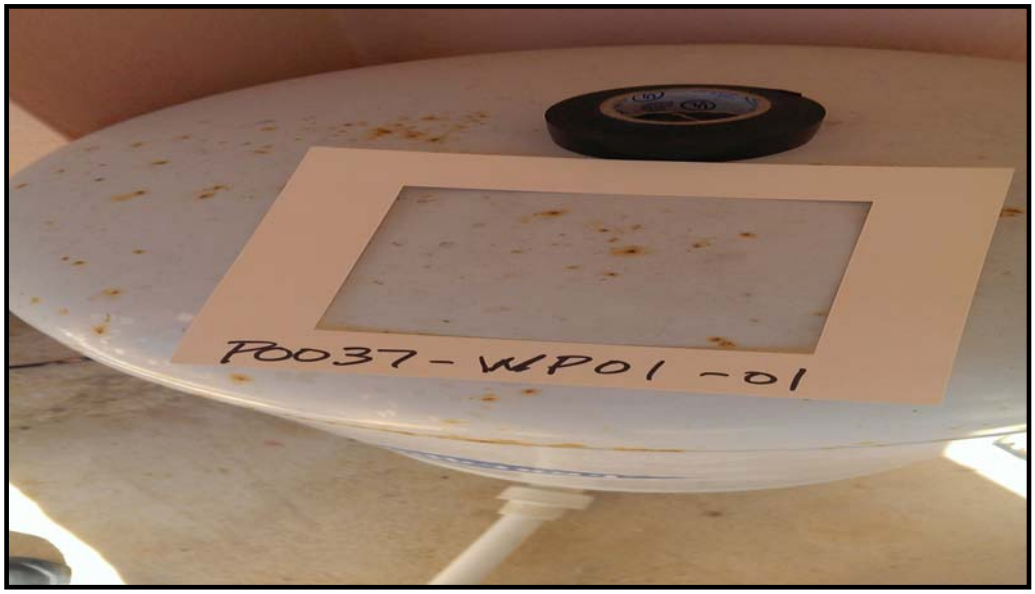
Photo 3: Sample P0037-WP01-01. Sample collected at the exterior of property P0037.
