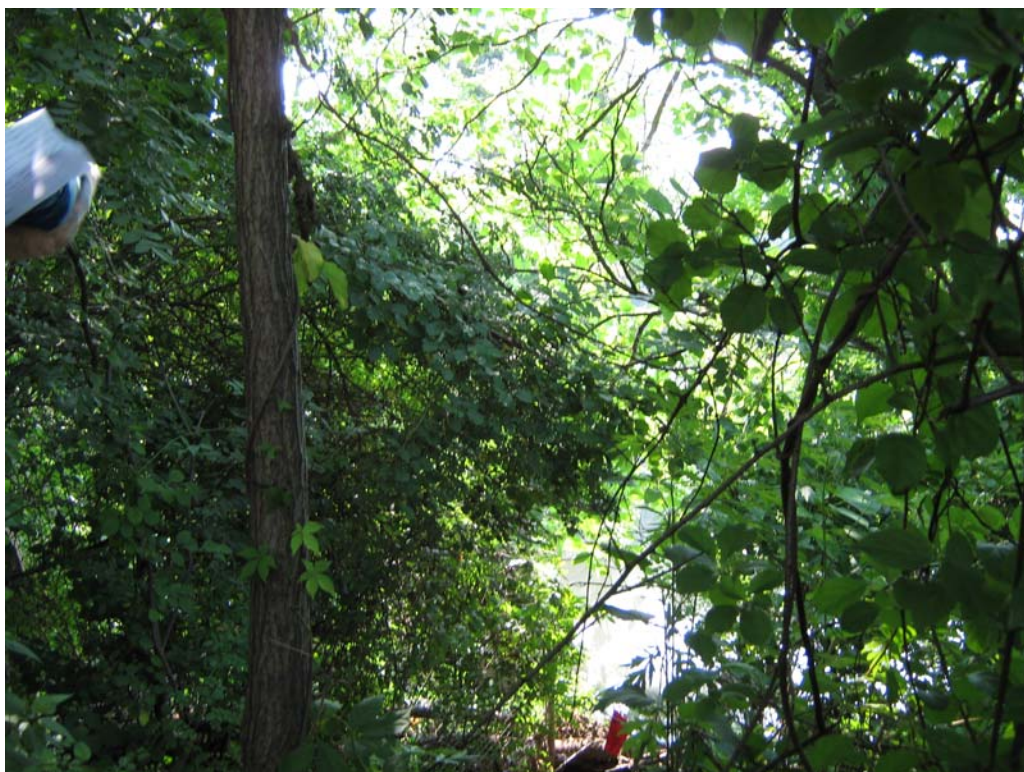
17. ITEM 10 (FOIL) – SOUTH BANK OF REACH 1 IMMEDIATELY UPSTREAM OF THE DOUBLE CULVERT.

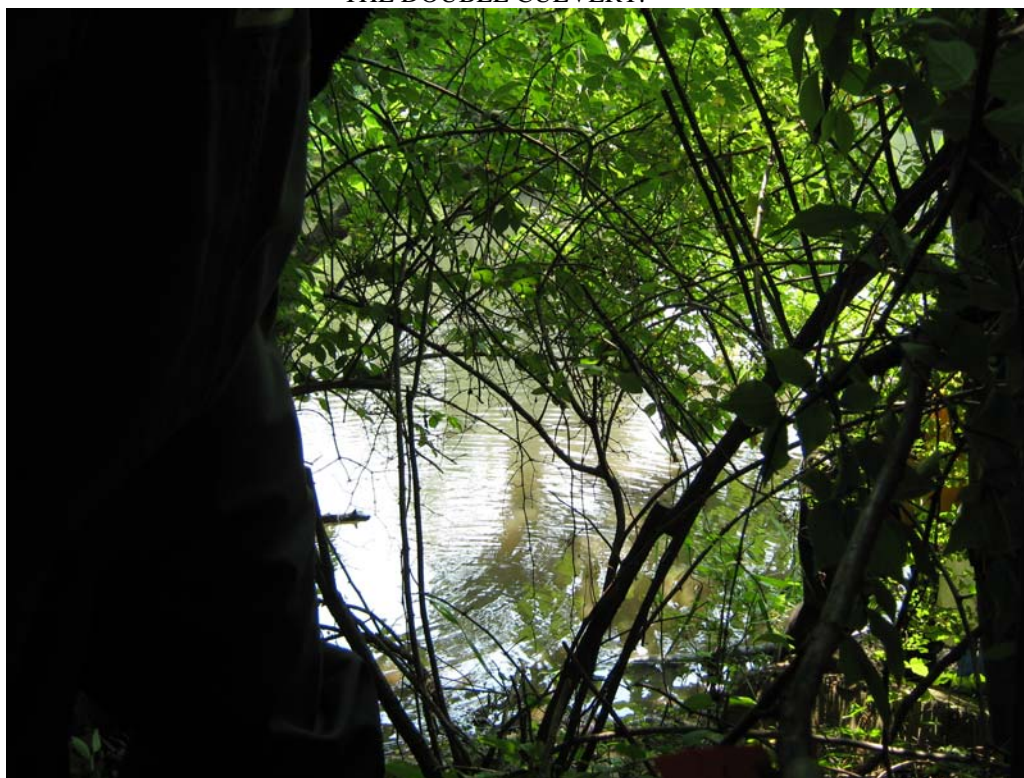
23. ITEM 13 (FOIL) – SOUTH BANK OF REACH 1 IMMEDIATELY UPSTREAM OF THE DOUBLE CULVERT.
