Proposed Riverside Basement Forensic Sampling

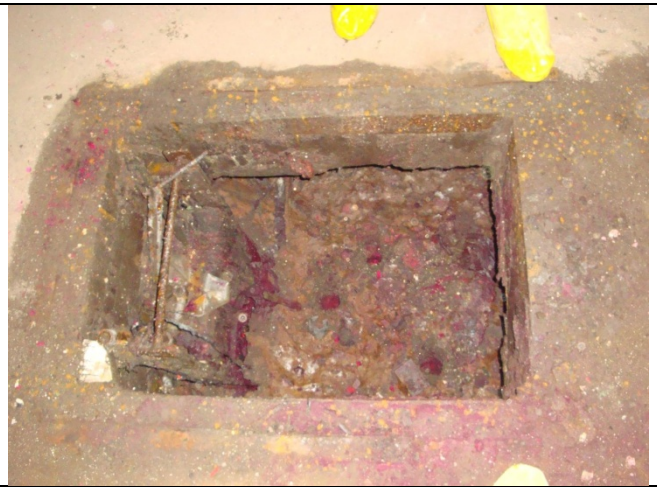
Building #7 Basement Opening-smaller opening on the Southeast side of the building. Located towards the middle of the building. Sludge is piled up close to floor surface.

**Date Taken:** 2/5/2012 **Security Level:** Public **Category:** Site Photo **Latitude:** **Longitude:**	**Sampling:** One (1) DP undisturbed core – assume 8'-10' length – analytes listed below
