Subject: Final Trip Report for the Riverside Avenue Site
Riverside Avenue, Newark, Essex County, New Jersey
EPA Contract No. EP-S7-06-01
TDD No. 0178
Document Tracking No. 1042

FINAL TRIP REPORT
RIVERSIDE AVENUE SITE
NEWARK, NJ

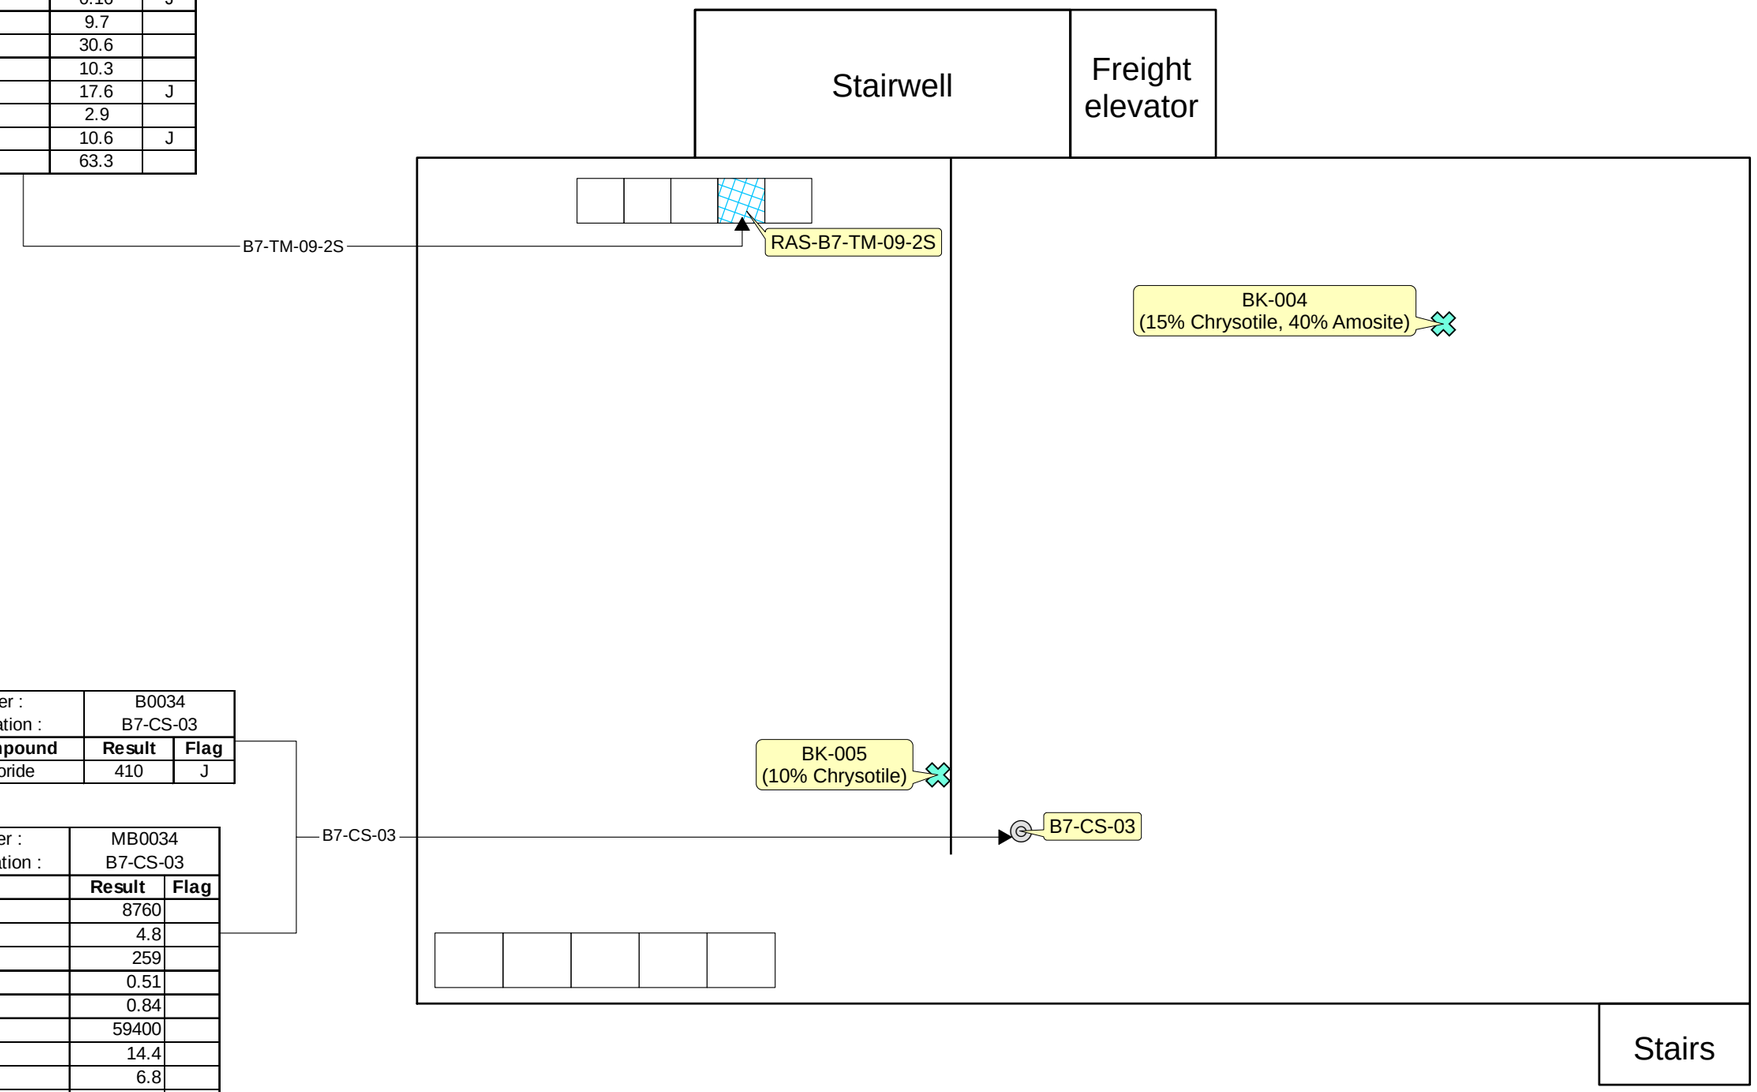
Sample Number :	B0034	
Sampling Location :	B7-CS-03	
Volatile Compound	**Result**	**Flag**
Methylene chloride	410	J

Sample Number :	MB0034	
Sampling Location :	B7-CS-03	
ANALYTE	**Result**	**Flag**
ALUMINUM	8760	
ARSENIC	4.8	
BARIUM	259	
BERYLLIUM	0.51	
CADMIUM	0.84	
CALCIUM	59400	
CHROMIUM	14.4	
COBALT	6.8	
COPPER	23.1	
IRON	6870	J
LEAD	18.1	J
MAGNESIUM	4990	
MANGANESE	812	
MERCURY	0.11	J
NICKEL	27.1	
POTASSIUM	4970	
SELENIUM	1.4	J
SILVER	0.79	J
SODIUM	12900	J
VANADIUM	86.3	
ZINC	156	J

Sample Number :	B0040	
Sampling Location :	B7-DS-02	
Volatile Compound	**Result**	**Flag**
Methylene chloride	380	J
Toluene	4100	J
Ethylbenzene	250000	J
o-Xylene	390000	J
m,p-Xylene	710000	J
Isopropylbenzene	21000	J

Sample Number :	MB0040	
Sampling Location :	B7-DS-02	
ANALYTE	**Result**	**Flag**
ALUMINUM	6.4	J
BARIUM	0.29	J
CALCIUM	161	J
CHROMIUM	6.5	
COPPER	1.1	J
IRON	198	
LEAD	2.5	
MAGNESIUM	31.9	J
MANGANESE	2.5	
ZINC	6.8

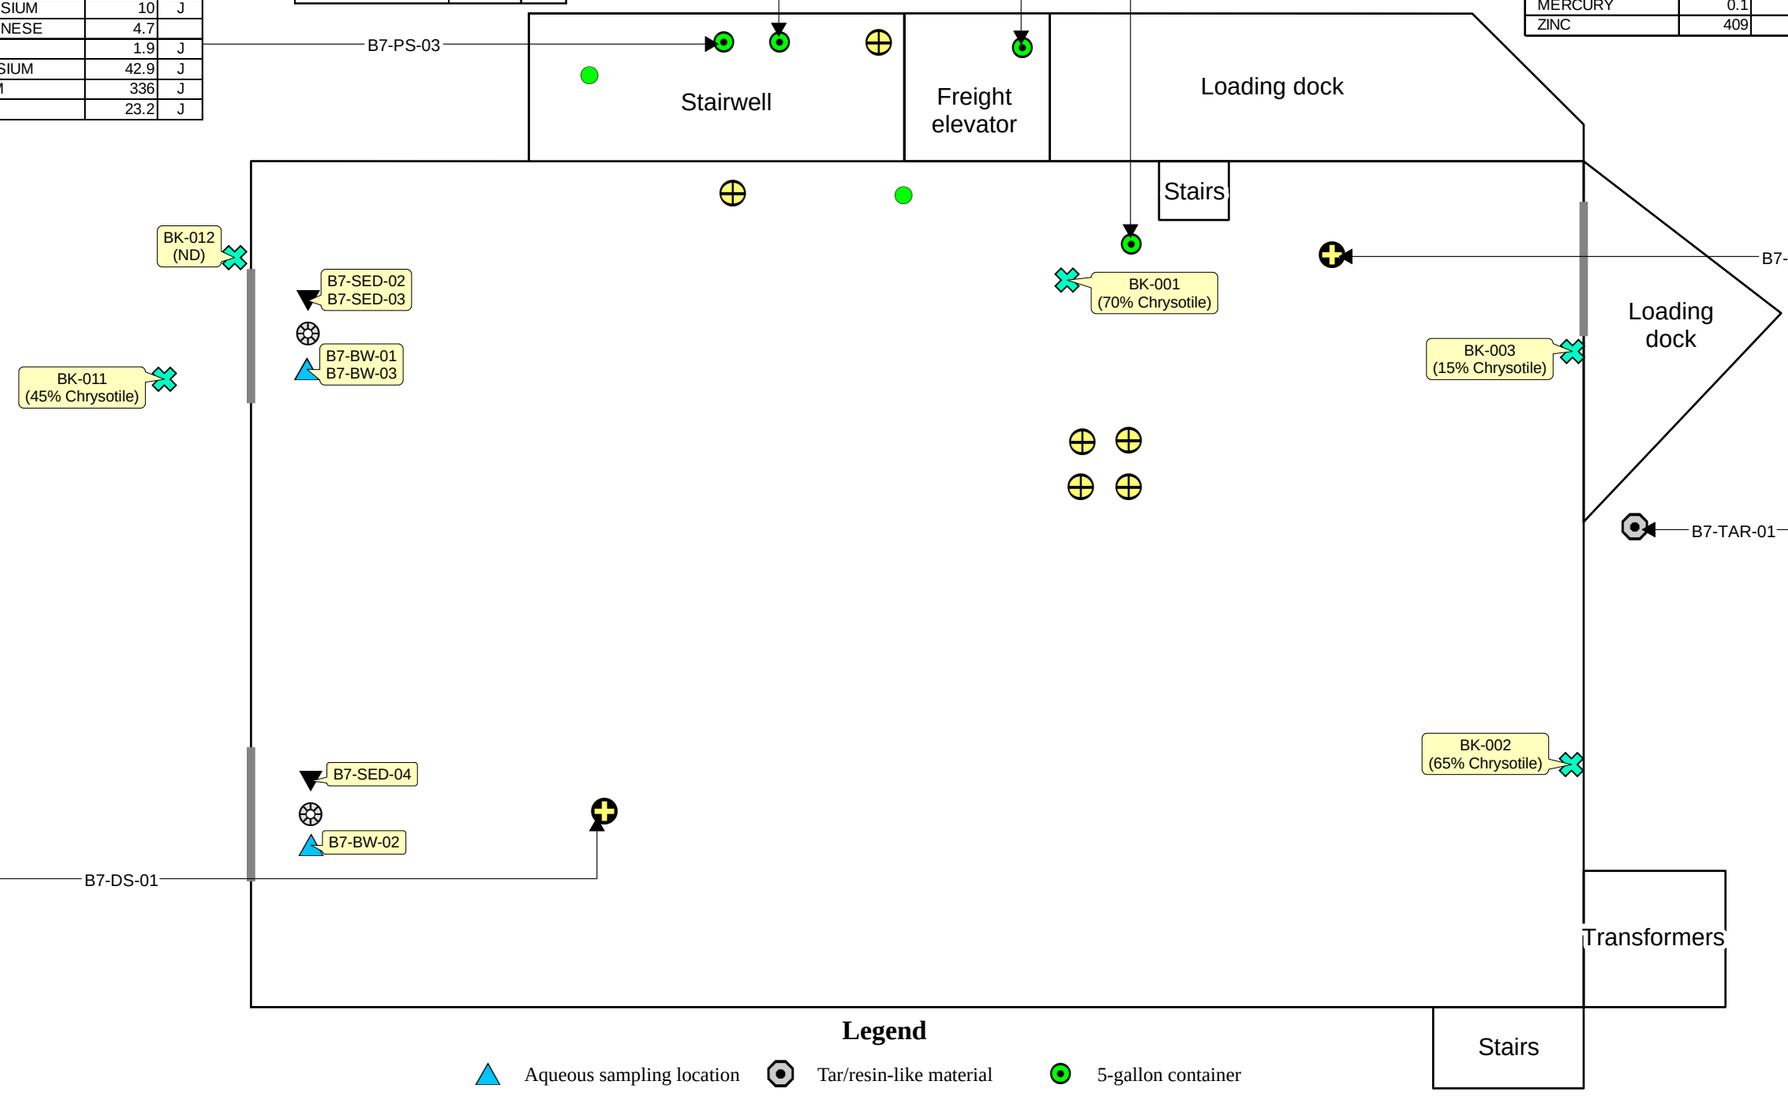
Sample Number :	B0016	
Sampling Location :	B7-TAR-01	
Volatile Compound	**Result**	**Flag**
Acetone	1600	
Methyl acetate	170	J
Methylene chloride	300	
2-Butanone	260	J
Cyclohexane	63	J
Methylcyclohexane	700	
Toluene	130	J
Ethylbenzene	460	
o-Xylene	2700	
m,p-Xylene	2900	
Isopropylbenzene	1000

Sample Number :	B0016	
Sampling Location :	B7-TAR-01	
Semivolatile Compound	Result	Flag
Acetophenone	83000	J
Naphthalene	79000	J
2-Methylnaphthalene	21000	J
4,6-Dinitro-2-methylphenol	11000	J

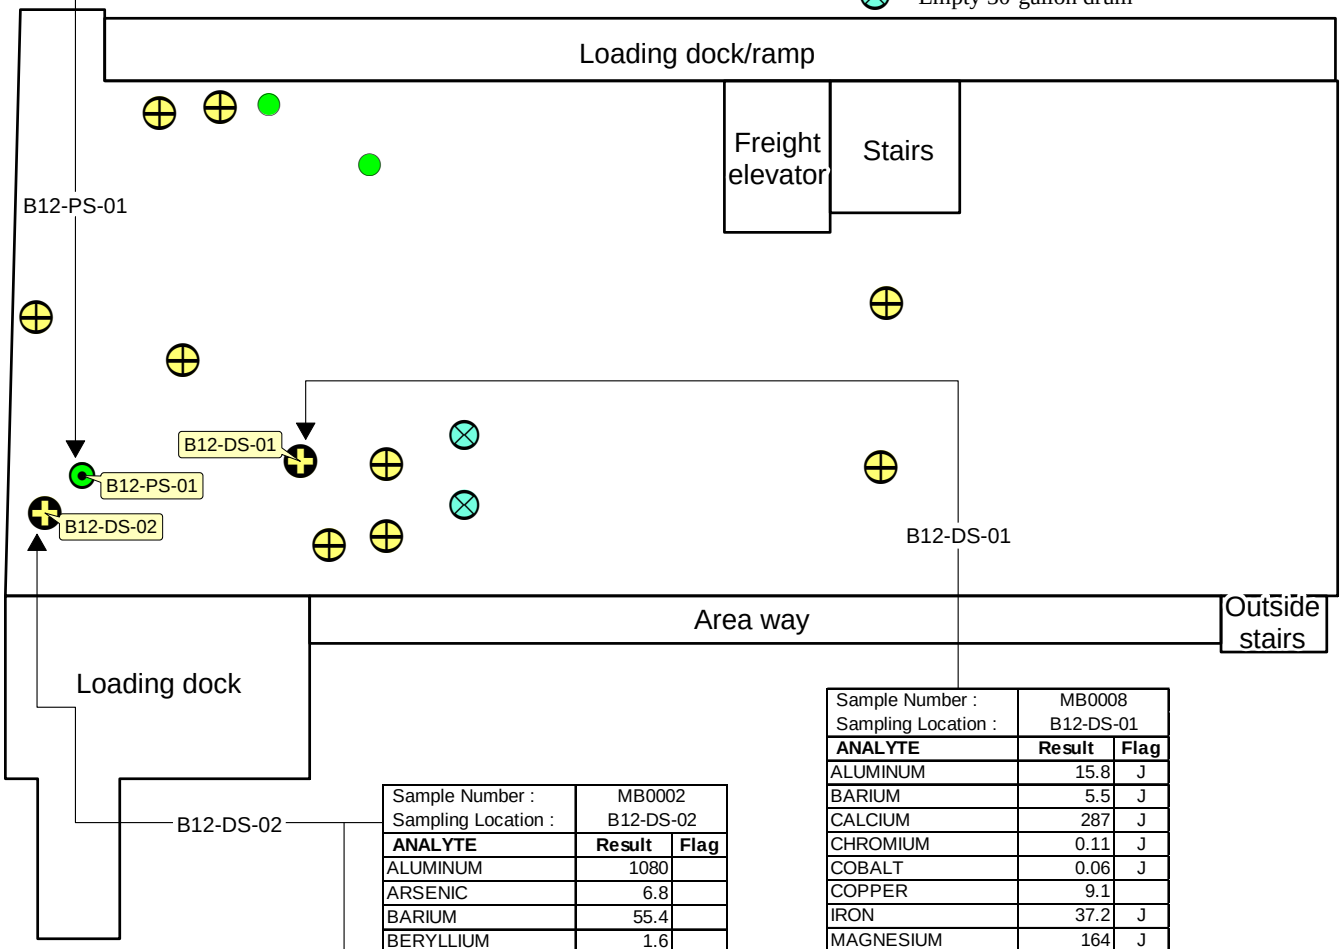
Sample Number :	MB0008
Sampling Location :	B12-DS-01

ANALYTE	Result	Flag
ALUMINUM	15.8	J
BARIUM	5.5	J
CALCIUM	287	J
CHROMIUM	0.11	J
COBALT	0.06	J
COPPER	9.1	
IRON	37.2	J
MAGNESIUM	164	J
MANGANESE	3.8	
MERCURY	0.052	J
NICKEL	0.49	J
POTASSIUM	5510	
SODIUM	428	J

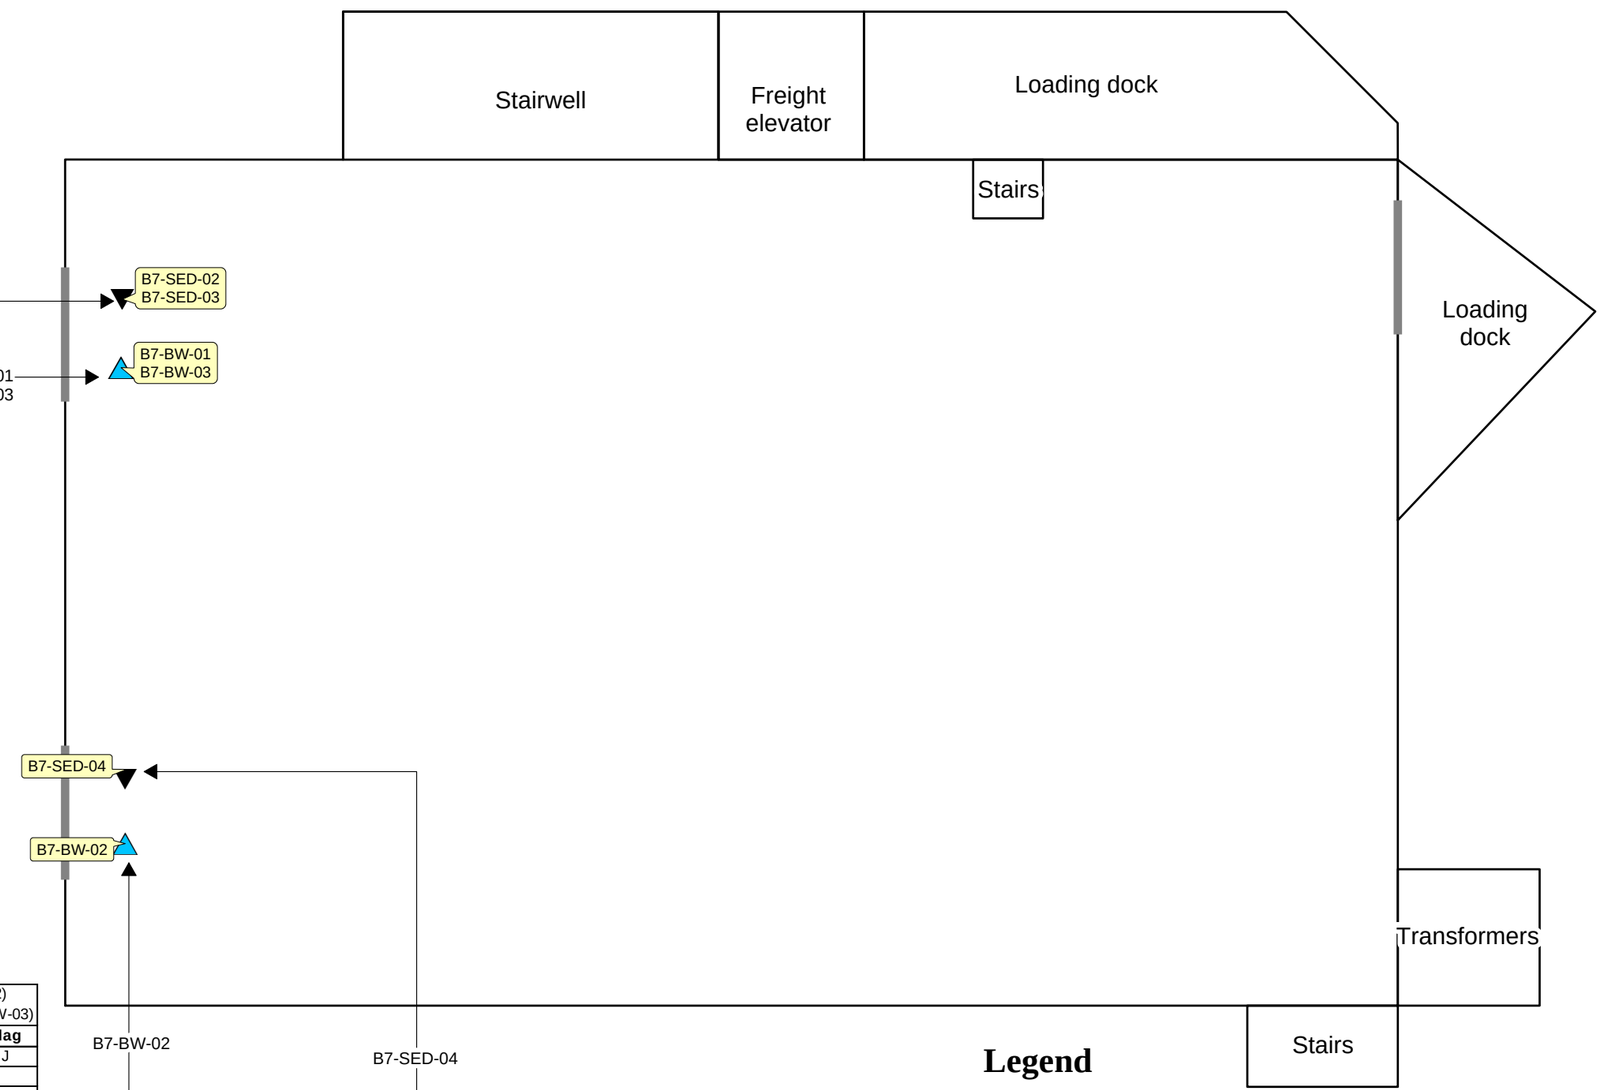
Sample Number :	B0003 (Duplicate of B0012)	
Sampling Location :	B7-BW-01 (Duplicate of B7-BW-03)	
Volatile Compound	**Result***	**Flag**
1,1-Dichloroethene	6.7	J
Acetone	350	
Methyl acetate	13	
Methylene chloride	240	
1,1-Dichloroethane	150	
2-Butanone	370	
Chloroform	10	
1,1,1-Trichloroethane	190	
Carbon tetrachloride	33	J
Benzene	24	
Trichloroethene	19	
4-Methyl-2-pentanone	55	
Toluene	430	
Tetrachloroethene	7.6	J
Chlorobenzene	2.8	J
Ethylbenzene	390	
o-Xylene	74	
m,p-Xylene	110	
Styrene	40	
Isopropylbenzene	15	
1,4-Dichlorobenzene	4.2	J
1,2-Dichlorobenzene	23	
1,2,4-Trichlorobenzene	55	
1,2,3-Trichlorobenzene	14

Sample Number :	B0015	
Sampling Location :	B7-SED-04	
Semivolatile Compour	**Result**	**Flag**
Phenol	2200000	
2-Methylphenol	4700000	
Acetophenone	430000	J
4-Methylphenol	1400000	
2,4-Dimethylphenol	430000	J
1,1'-Biphenyl	56000	J
2-Chloronaphthalene	110000	J
Diethylphthalate	240000	J
Bis(2-ethylhexyl)phthalate	230000	J

Sample Number :	B0010	
Sampling Location :	B7-BW-02	
Semivolatile Compound	**Result**	**Flag**
Phenol	13000	
2-Methylphenol	13000	
4-Methylphenol	4700	
2,4-Dimethylphenol	670	J
Diethylphthalate	250	J

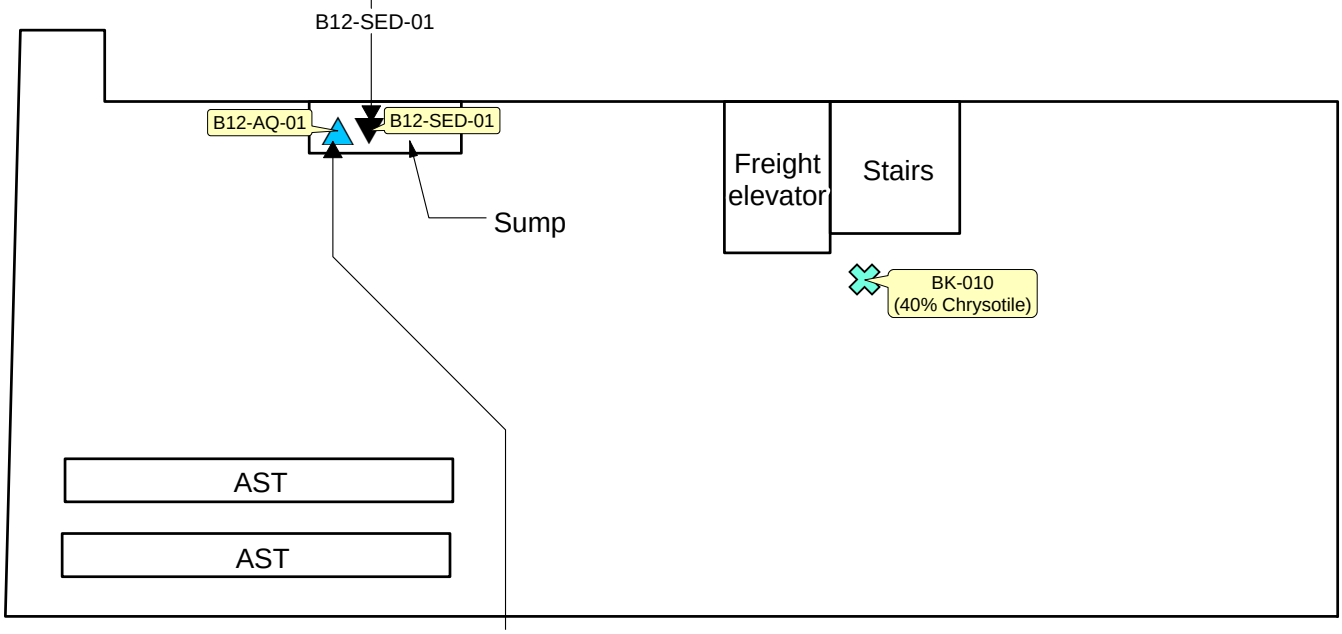
Sample Number :	B0009	
Sampling Location :	B12-SED-01	
Semivolatile Compound	**Result**	**Flag**
2-Methylphenol	7100	J

Sample Number :	B0009	
Sampling Location :	B12-SED-01	
Volatile Compound	**Result**	**Flag**
Methylene chloride	11000	J
m,p-Xylene	5800	J
Bromoform	15000	
1,3-Dichlorobenzene	4400	J
1,2,4-Trichlorobenzene	2600000	
1,2,3-Trichlorobenzene	1300000

Sample Number :	B0004	
Sampling Location :	B12-AQ-01	
Volatile Compound	**Result**	**Flag**
Acetone	8.7	J
Methylene chloride	13	
1,1,1-Trichloroethane	5.5	
Toluene	1.6	J
m,p-Xylene	0.86	J
1,4-Dichlorobenzene	0.58	J
1,2,4-Trichlorobenzene	1.2	J

Sample Number :	B0004	
Sampling Location :	B12-AQ-01	
Semivolatile Compound	**Result**	**Flag**
Di-n-butylphthalate	0.55	J
Bis(2-ethylhexyl)phthalate	2.1	J

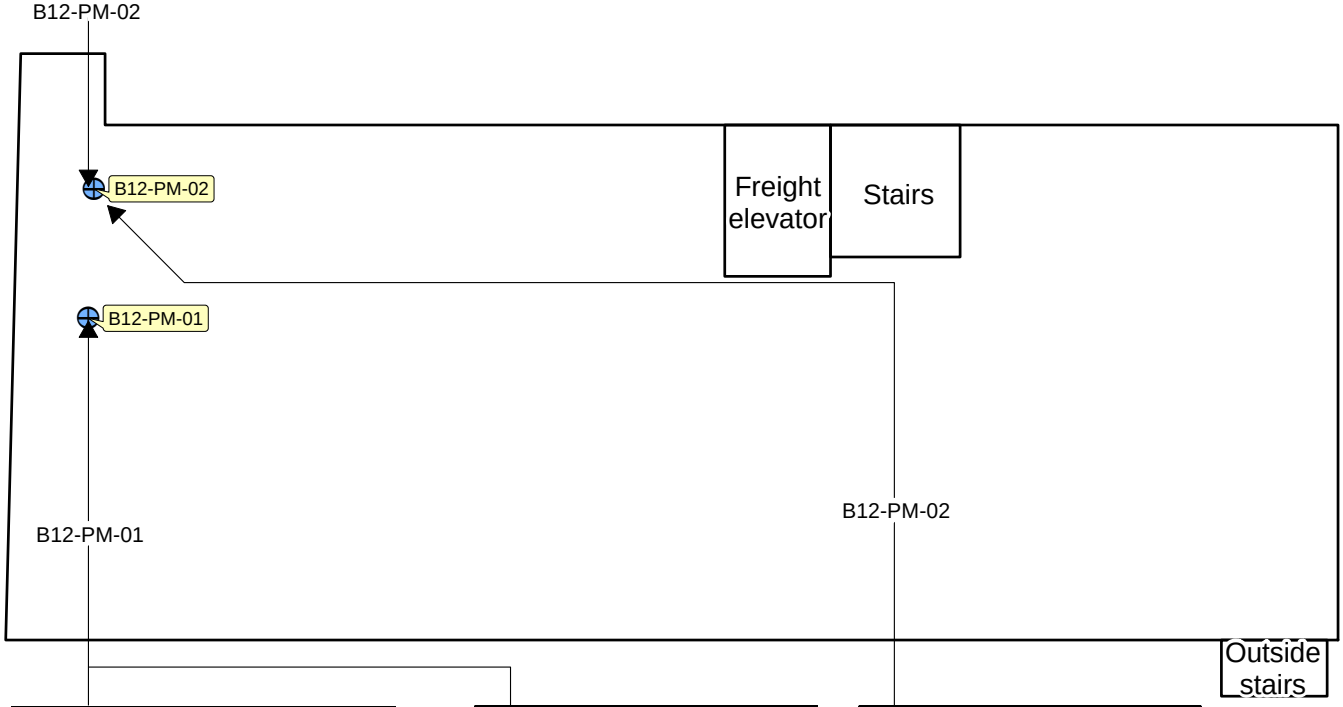
Sample Number :	B0006	
Sampling Location :	B12-PM-02	
Semivolatile Compound	**Result**	**Flag**
Di-n-butylphthalate	1300	J

Sample Number :	B0006	
Sampling Location :	B12-PM-02	
Volatile Compound	**Result**	**Flag**
Acetone	270	J
Methyl acetate	380	
Methylene chloride	210	J
m,p-Xylene	91	J

Sample Number :	B0005	
Sampling Location :	B12-PM-01	
Semivolatile Compound	**Result**	**Flag**
Bis(2-ethylhexyl)phthalate	34000	J

Sample Number :	B0005	
Sampling Location :	B12-PM-01	
Volatile Compound	**Result**	**Flag**
Acetone	710	
Methyl acetate	230	J
Methylene chloride	300	
Toluene	4300

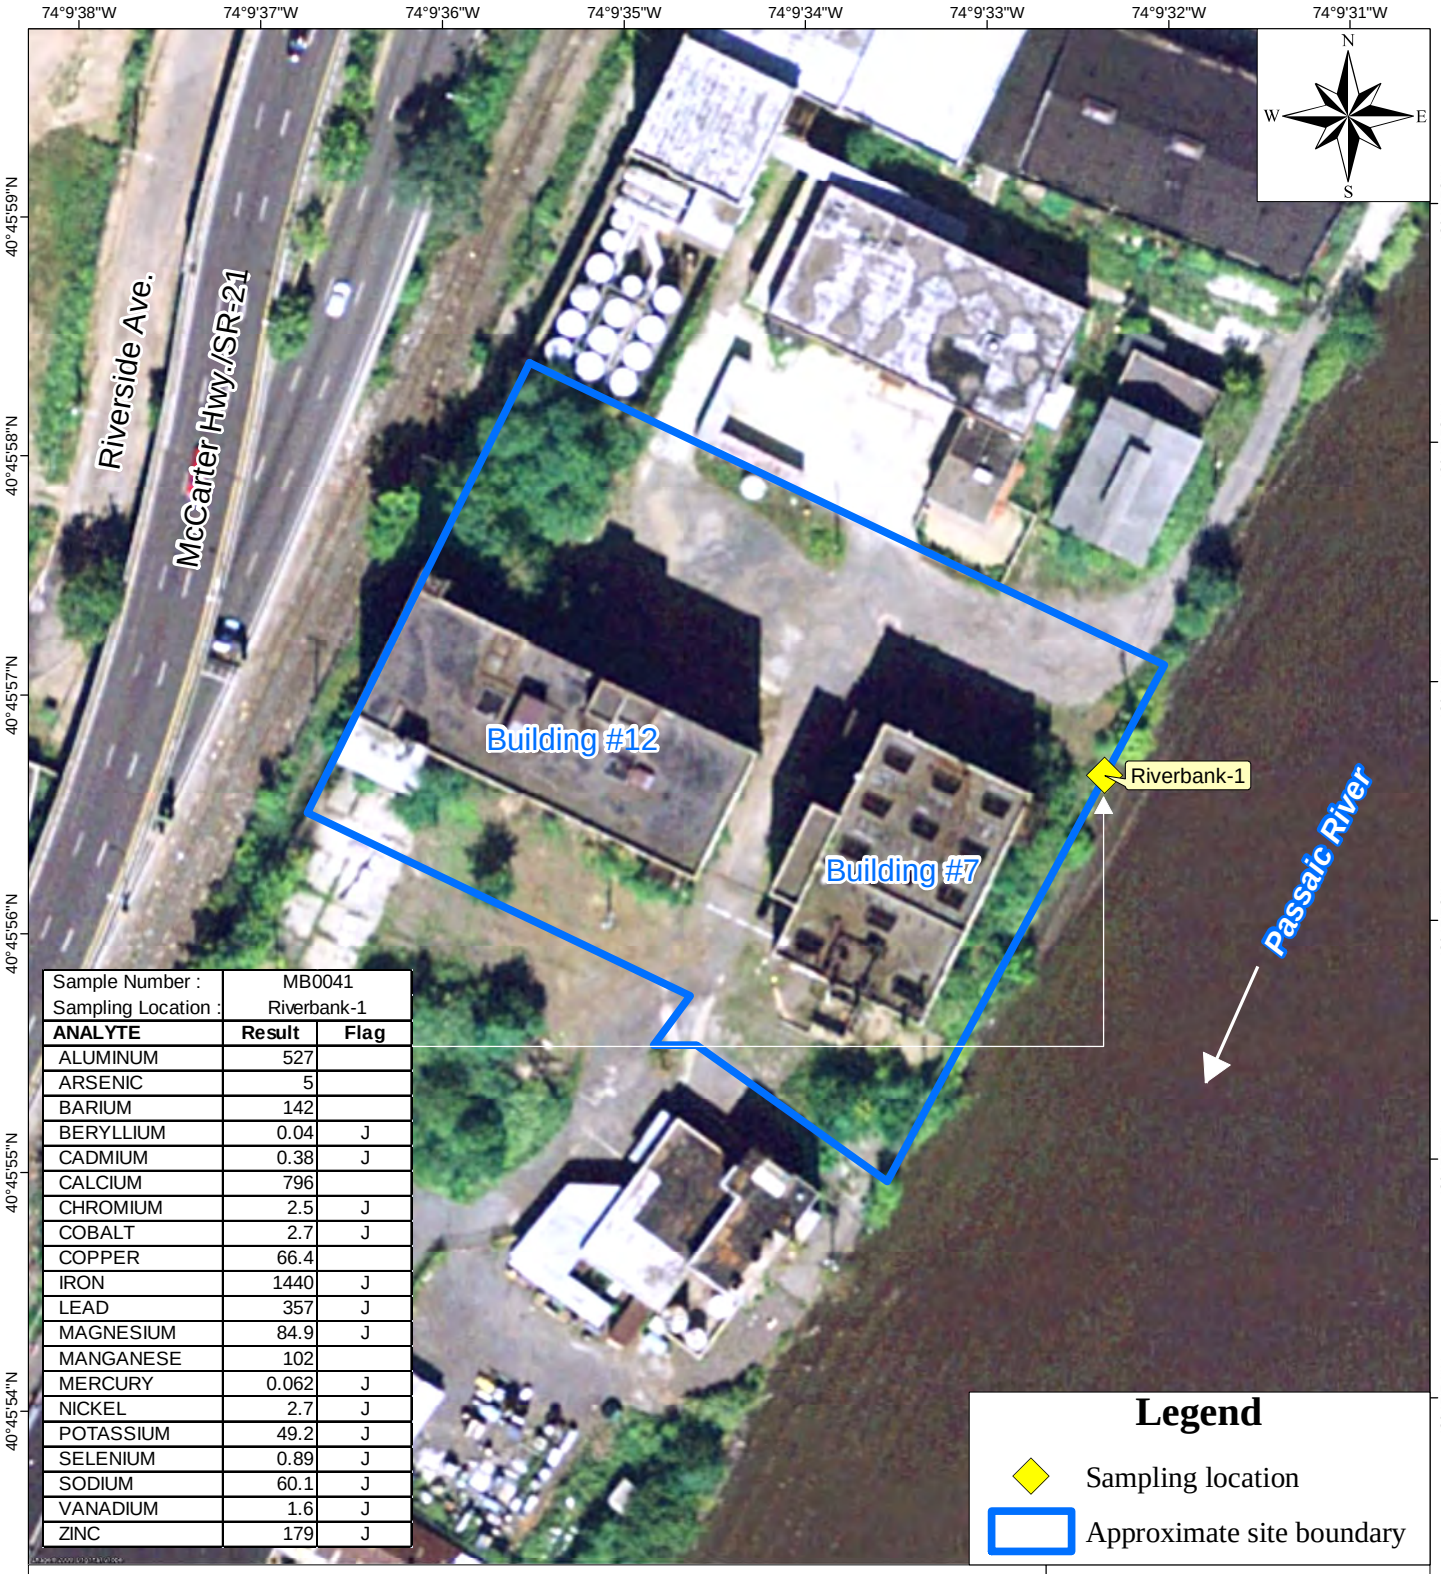
Sample Number :	MB0041	
Sampling Location :	Riverbank-1	
ANALYTE	**Result**	**Flag**
ALUMINUM	527	
ARSENIC	5	
BARIUM	142	
BERYLLIUM	0.04	J
CADMIUM	0.38	J
CALCIUM	796	
CHROMIUM	2.5	J
COBALT	2.7	J
COPPER	66.4	
IRON	1440	J
LEAD	357	J
MAGNESIUM	84.9	J
MANGANESE	102	
MERCURY	0.062	J
NICKEL	2.7	J
POTASSIUM	49.2	J
SELENIUM	0.89	J
SODIUM	60.1	J
VANADIUM	1.6	J
ZINC	179	J

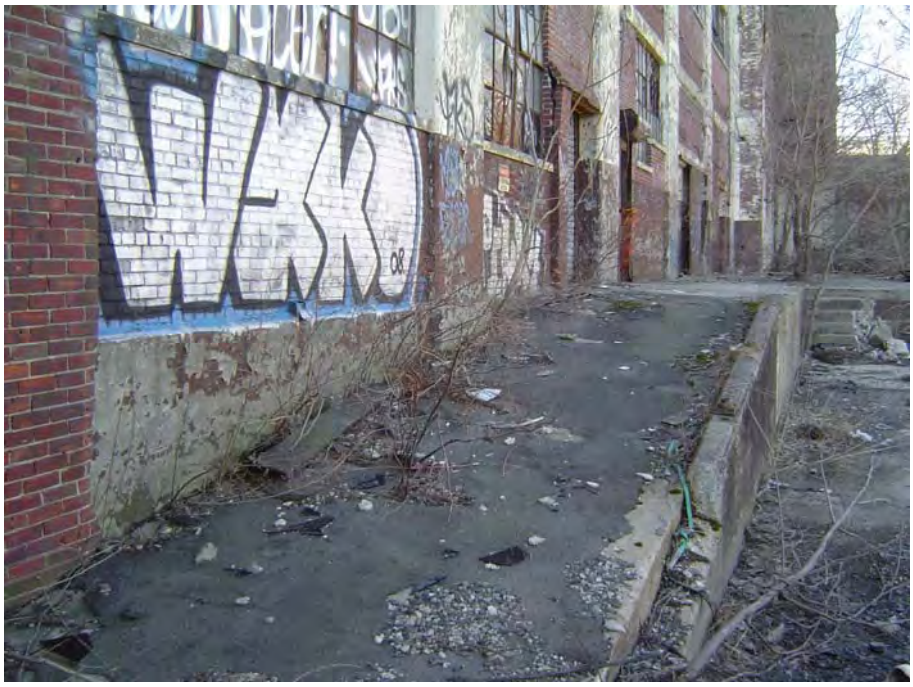
Photograph No. 3

Description: View of ramp/loading dock area of Building #12.
