SAMPLING TRIP REPORT AND SITE ASSESSMENT

SITE NAME: Central Steel And Drum Site
DCN: START-02-F-001068
TDD #: 02-97-05-0010

SAMPLING DATE: 14, 15 and 23 May 1997

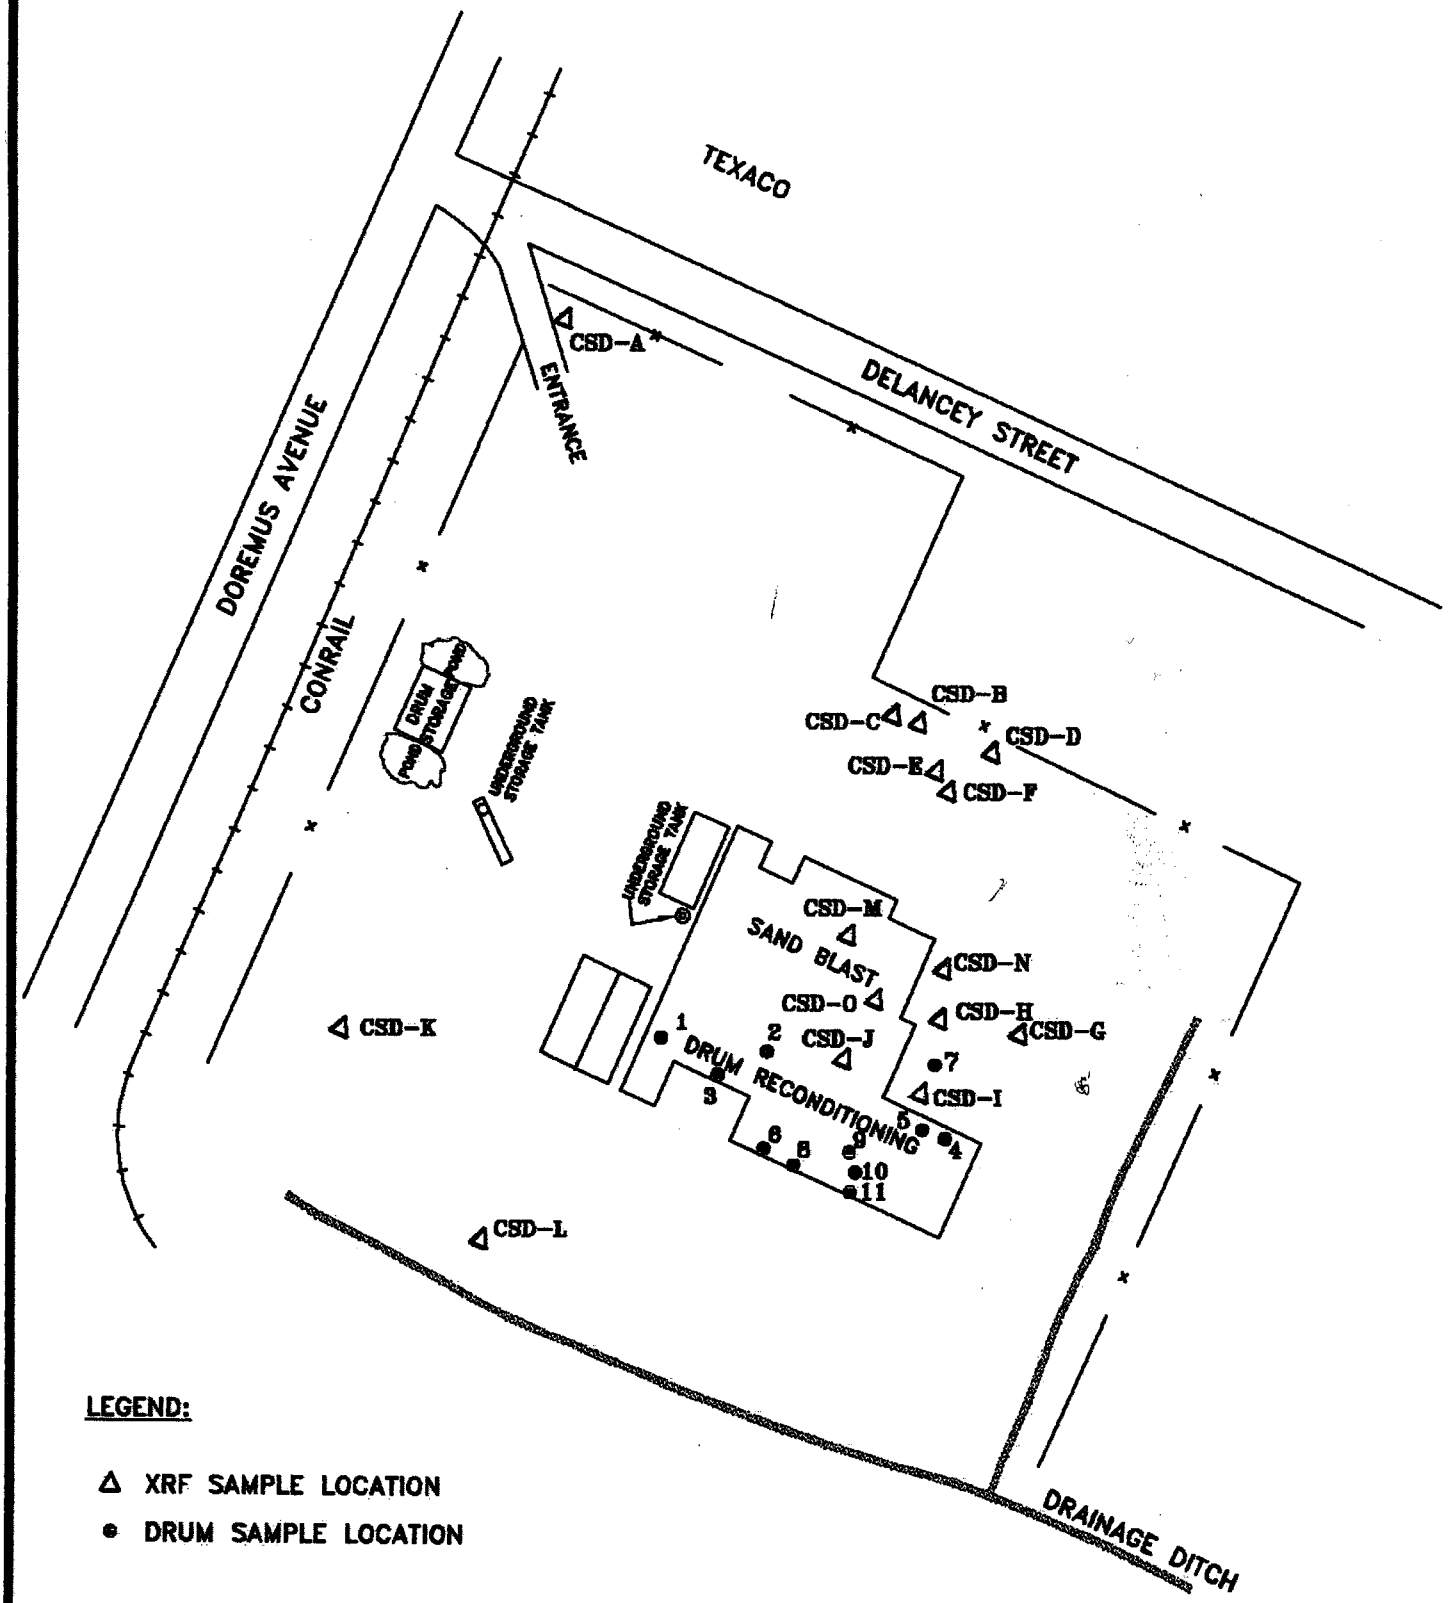
FIGURE 2 - SITE LAYOUT AND SAMPLING LOCATIONS
CENTRAL STEEL DRUM
NEWARK, NEW JERSEY
JUNE 1997

- Lead was found to exceed the NJDEP Non-Residential Soil Cleanup Criteria of 1,000 mg/kg in nine of the fifteen samples.
