Report No.: 8003-253
Work Assignment No.: 019-2JZZ
Contract No.: 68-W9-0051
August 31, 1993

RE: Maunabo Solid Waste Disposal Site Inspection Prioritization Evaluation

The following is a summary of the Site Inspection Prioritization evaluation for the Maunabo Solid Waste Disposal site (CERCLIS ID No. PRD980512420) (Ref. No. 1).

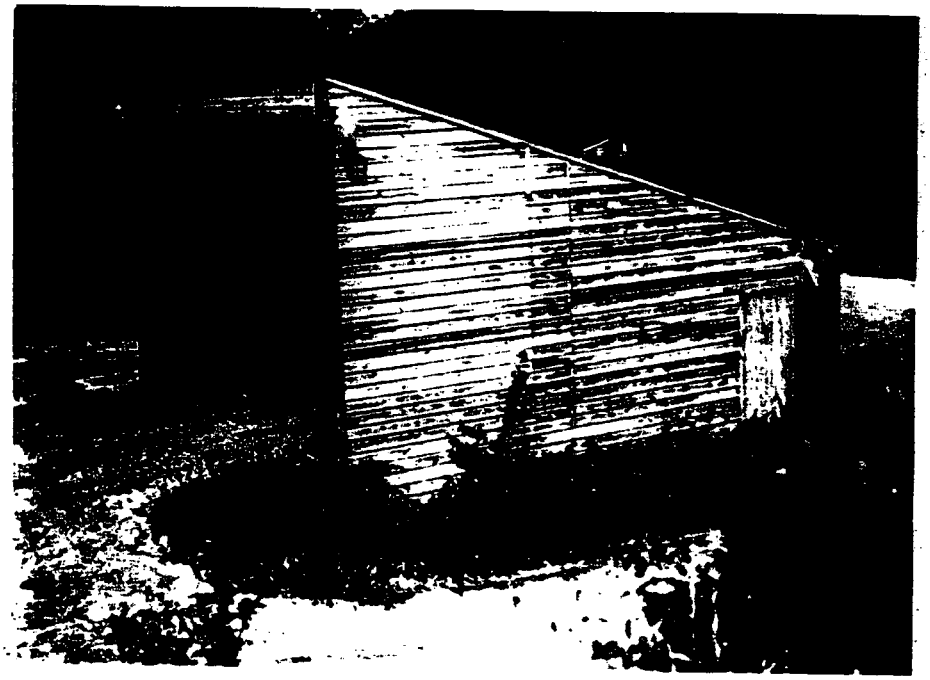
1P-11 February 2, 1989 1105
Looking west at the old shack on the lower portion of the site.

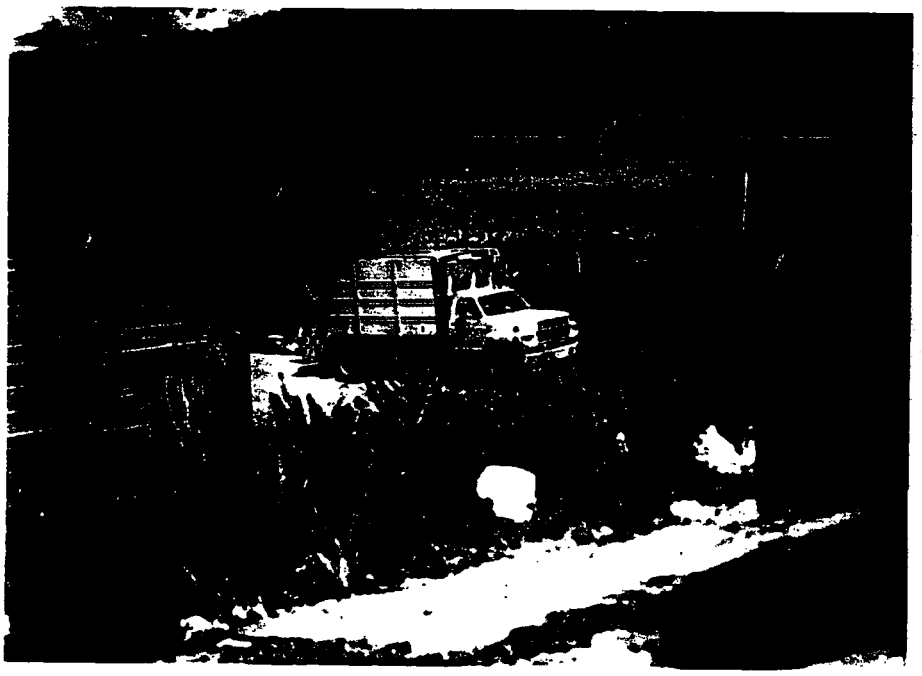
1P-12 February 2, 1989 1105
Looking northwest at a garbage truck entering the landfill.

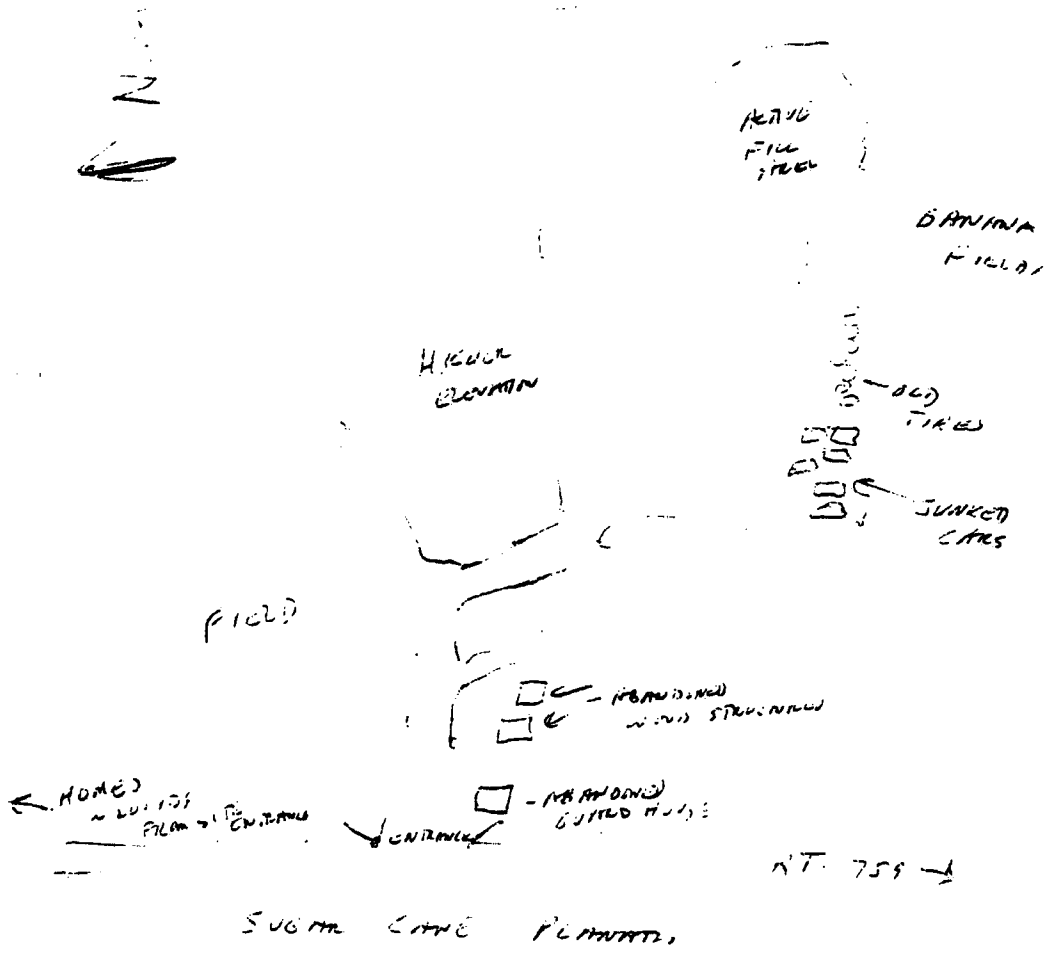
ACTIVE FILL AREA
BANANA FIELD
HIGHER ELEVATION
OLD TIRES
JUNKED CARS
FIELD
ABANDONED WOOD STRUCTURES
HOMES
ABANDONED GUARD HOUSE
ENTRANCE
RT. 759
SUGAR CANE PLANTATION

RESIDENTIAL AREA ~ 200 YARDS OF THE ROAD, NORTH OF SITE.

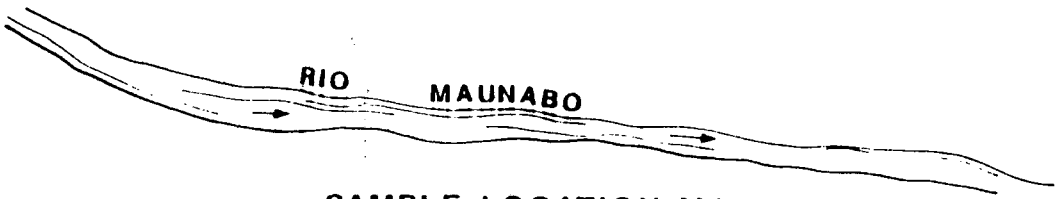
FIGURE 2

NOTE: ALL SAMPLE NUMBERS ARE PRECEDED BY PR22.

SAMPLE LOCATION MAP
