WORTSBORO LEAD
MINE
A25U

SEPT 22, 2015 TUESDAY

1230 – 1700 – TOURED THE SITE
- INSPECTION STARTED AT THE UPPER MINES
- 3 TAILINGS PILES EXIST, 1 LARGE 2 SMALLER.
- SEVERAL MINE OPENINGS ARE STILL OPEN AND WILL NEED TO BE SECURED/SEALED.
- TERRAIN IS VERY STEEP/ROADS NARROW-WINDY

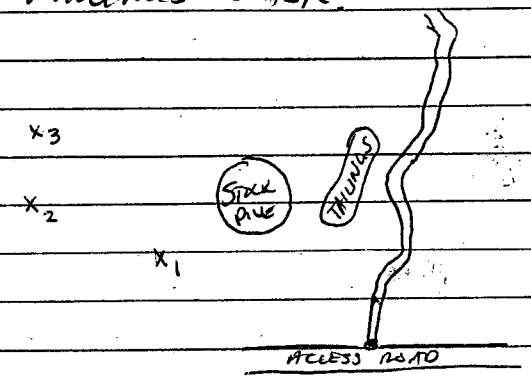
- COLLECTED WATER SAMPLES OF WATER ENTERING SHALLOW HAND DUG HOLES WITHIN MINING WASTE.

OMA-W1 H_2O @ 6"

OMA-W2 H_2O @ 1.0'

OMA-W3 H_2O @ 2.0'

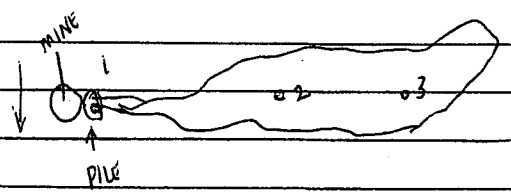
– COLLECTED 3 0-5' SAMPLES AND .5-1' AT THE CENTER LOCATION.

XRF'S (RANGE)

#1 700-900 ↑

#2 12,200 - 15,800 ppm
