SITE SKETCH
BISHOP TUBE COMPANY
FRAZER, CHESTER COUNTY, PENNSYLVANIA

MAY 1995

EPA Notification of Hazardous Waste Site

The Bishop Tube Company operates a stainless steel tube manufacturing plant in Frazer, Pennsylvania. The Pennsylvania Department of Environmental Resources (DER) instructed Bishop Tube to conduct a hydrogeologic study of surface water and groundwater conditions at the plant. Betz•Converse•Murdoch•Inc. (BCM) of Plymouth Meeting, Pennsylvania, was retained to conduct the investigation, which was performed with the approval of the DER. This report describes the work performed and the results obtained, and contains recommendations for future action.

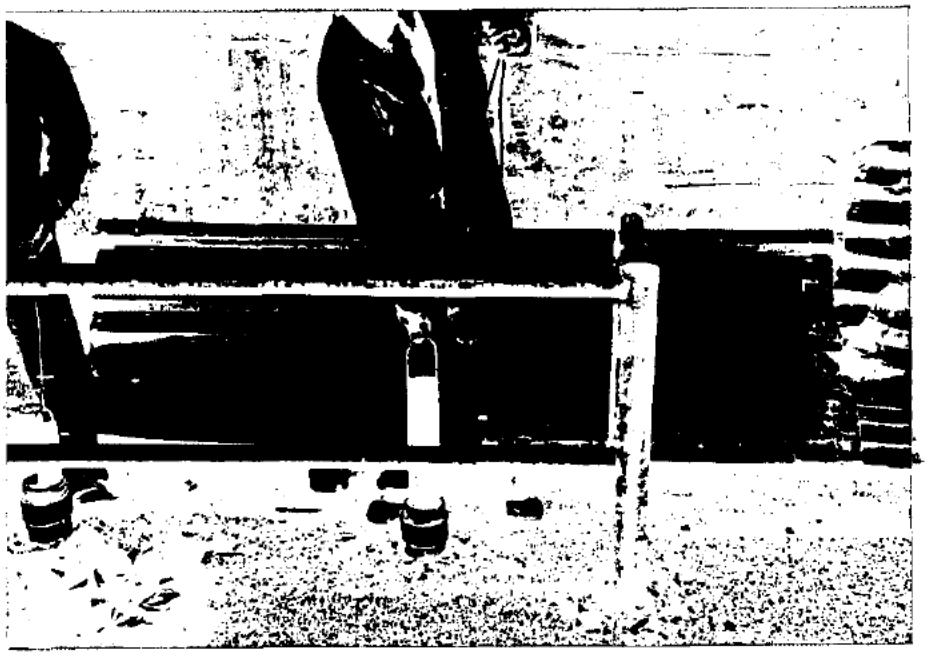
Photo 1 -
Monitoring well no. 1 - samplers are (b) (4)
(b) (4)(b) (4)(b) (4)

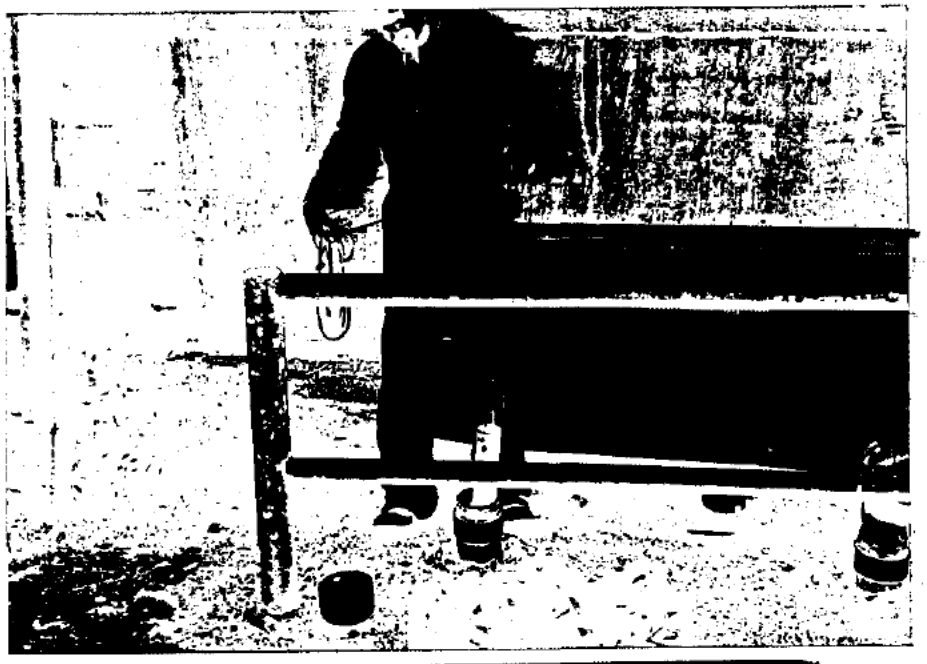
Photo 2 -
Monitoring well no. 2 - sampler is (b) (4)
(b) (4)

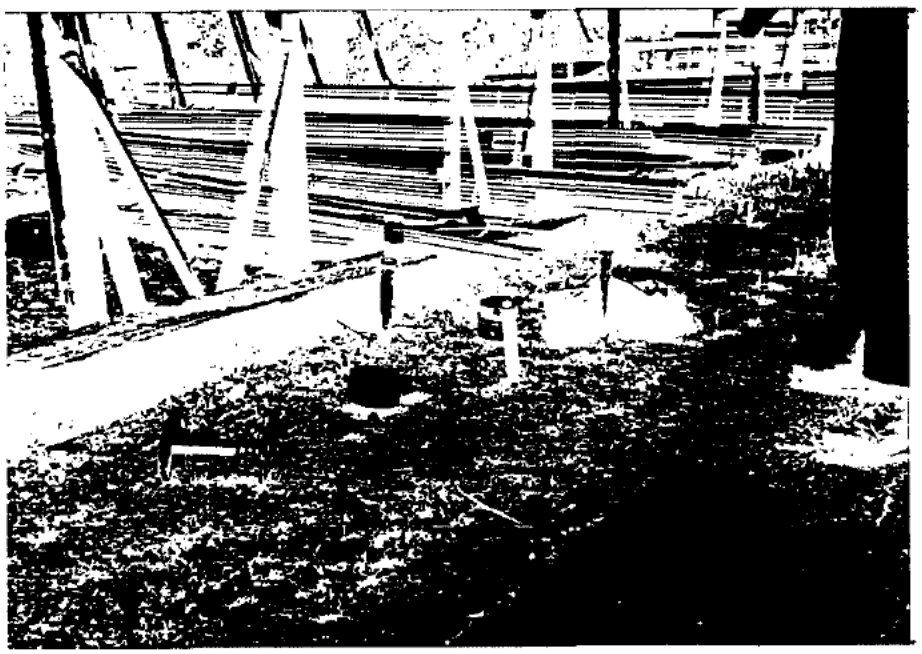
Photo 3 -
Monitoring well no. 3 - sampler is (b) (4)
(b) (4)(b) (4)
