Streamlined Remedy Assessment
Barite Hill Pit
Barite Hill Mine
McCormick, South Carolina

Prepared For: EPA Region 4
Atlanta, Georgia

U.S. Department of the Interior
Bureau of Reclamation
Technical Service Center
Denver, Colorado

September 14, 2007

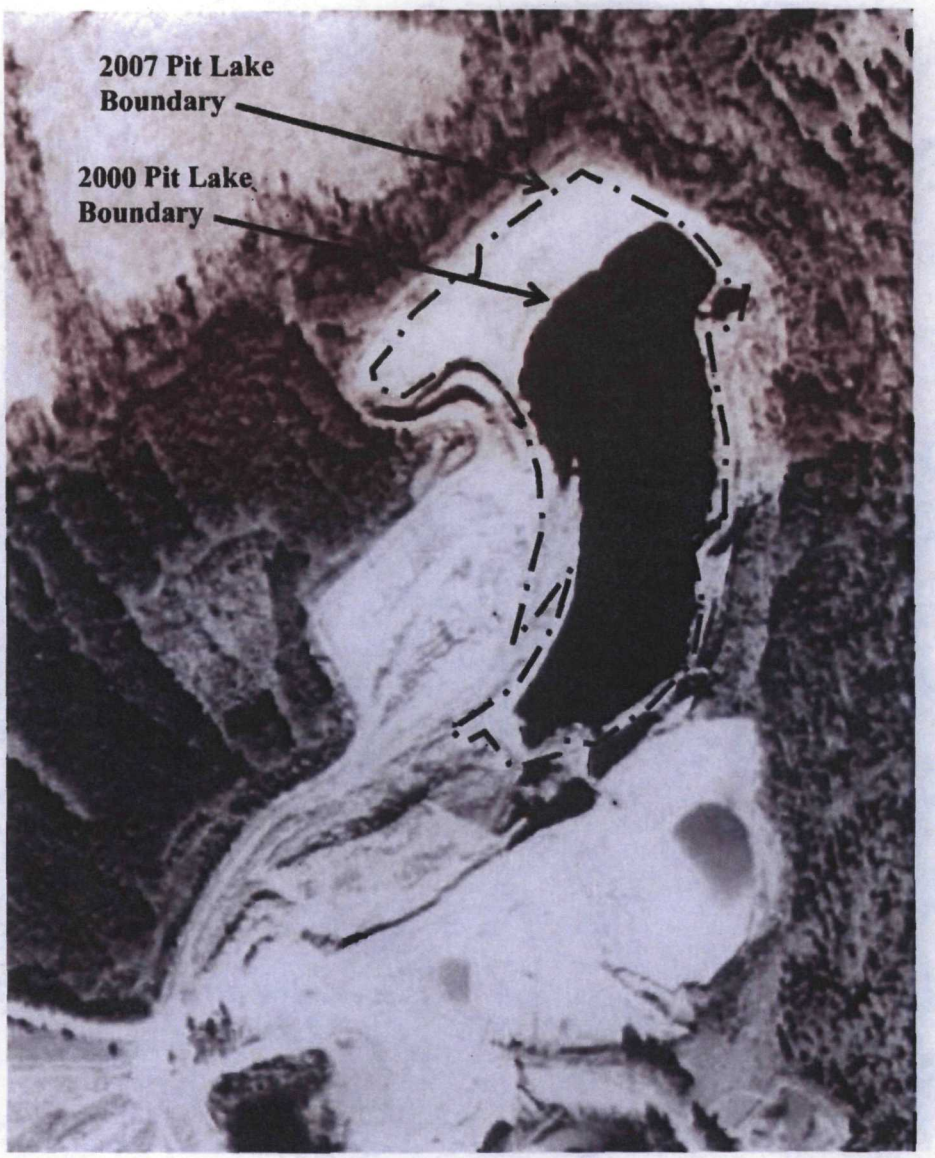
At Barite Hill the water level in the pit is believed to have been rising since the mining activity ceased in mid-October, 1994. It is presumed that the pit began filling as soon as mining ended. There would be no incentive to keep water out of the pit after all of the ore had been extracted. The aerial photograph shown in Figure 8, shows the pit lake as it appeared in the year 2000 which would have been 6 years after the end of mining. Also, water in the pit appears to have increased up to the present time. The approximate extent of the pit lake as it was observed in March 2007 has been added to the aerial photograph shown in Figure 8.

Figure 8. Aerial photograph of the Barite Hill Pit in the year 2000 showing the pit lake about 6 years after mining ended. The pit lake boundary in March 2007 (about 12 years after mining ended) has been drawn onto the image.
