Re: Soil Sampling Data Summary Report for
266 Dove Place, Social Circle, GA
BBL Project #: 85533

SAMPLE LOCATION MAP FOR 266 DOVE PLACE

Attachment 1
Photographs of 266 Dove Place, Social Circle, GA

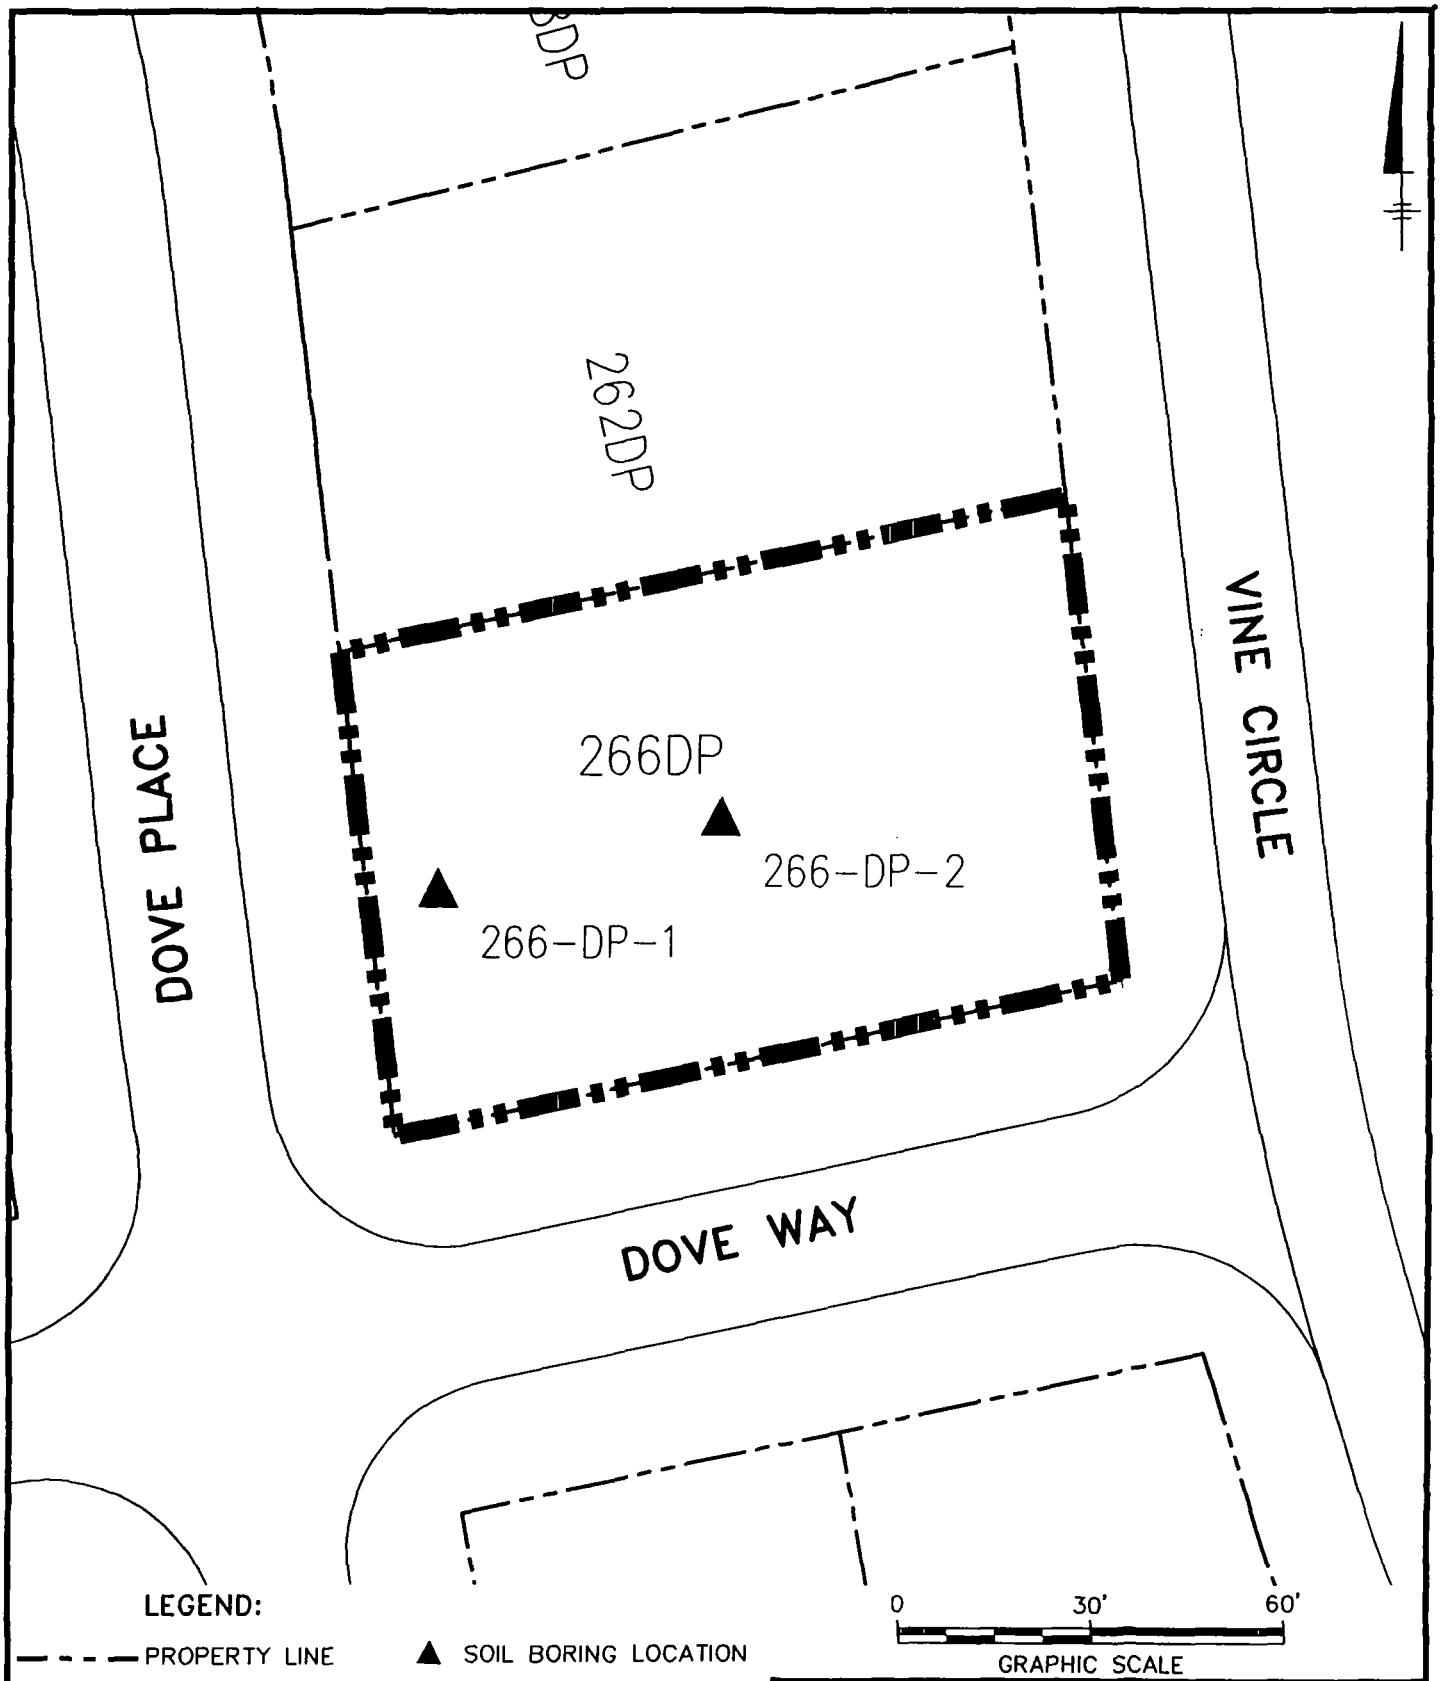
FIGURE
266DP

- Deeper soil samples were collected from one location in the front yard and one location in the back yard. The locations of these deeper soil samples are shown on Figure 1. Samples were collected using hand augers or by pushing hollow steel tubes into the ground to the required sample depth. At each location, soil samples were collected from 0.5 to 2 feet, 2 to 4 feet, 4 to 6 feet, and 6 to 8 feet below ground surface. These samples were tested in the field using the XRF device described above to determine the approximate concentrations of arsenic and lead. Based on these results, select samples were sent to the laboratory and analyzed for metals (including arsenic and lead) and pH (soil acidity).
