Re: Soil Sampling Data Summary Report for
507 Dove Way, Social Circle, GA
BBL Project #: 85533

SAMPLE LOCATION MAP FOR 507 DOVE WAY

Attachment 1
Photographs of 507 Dove Way Social Circle, GA

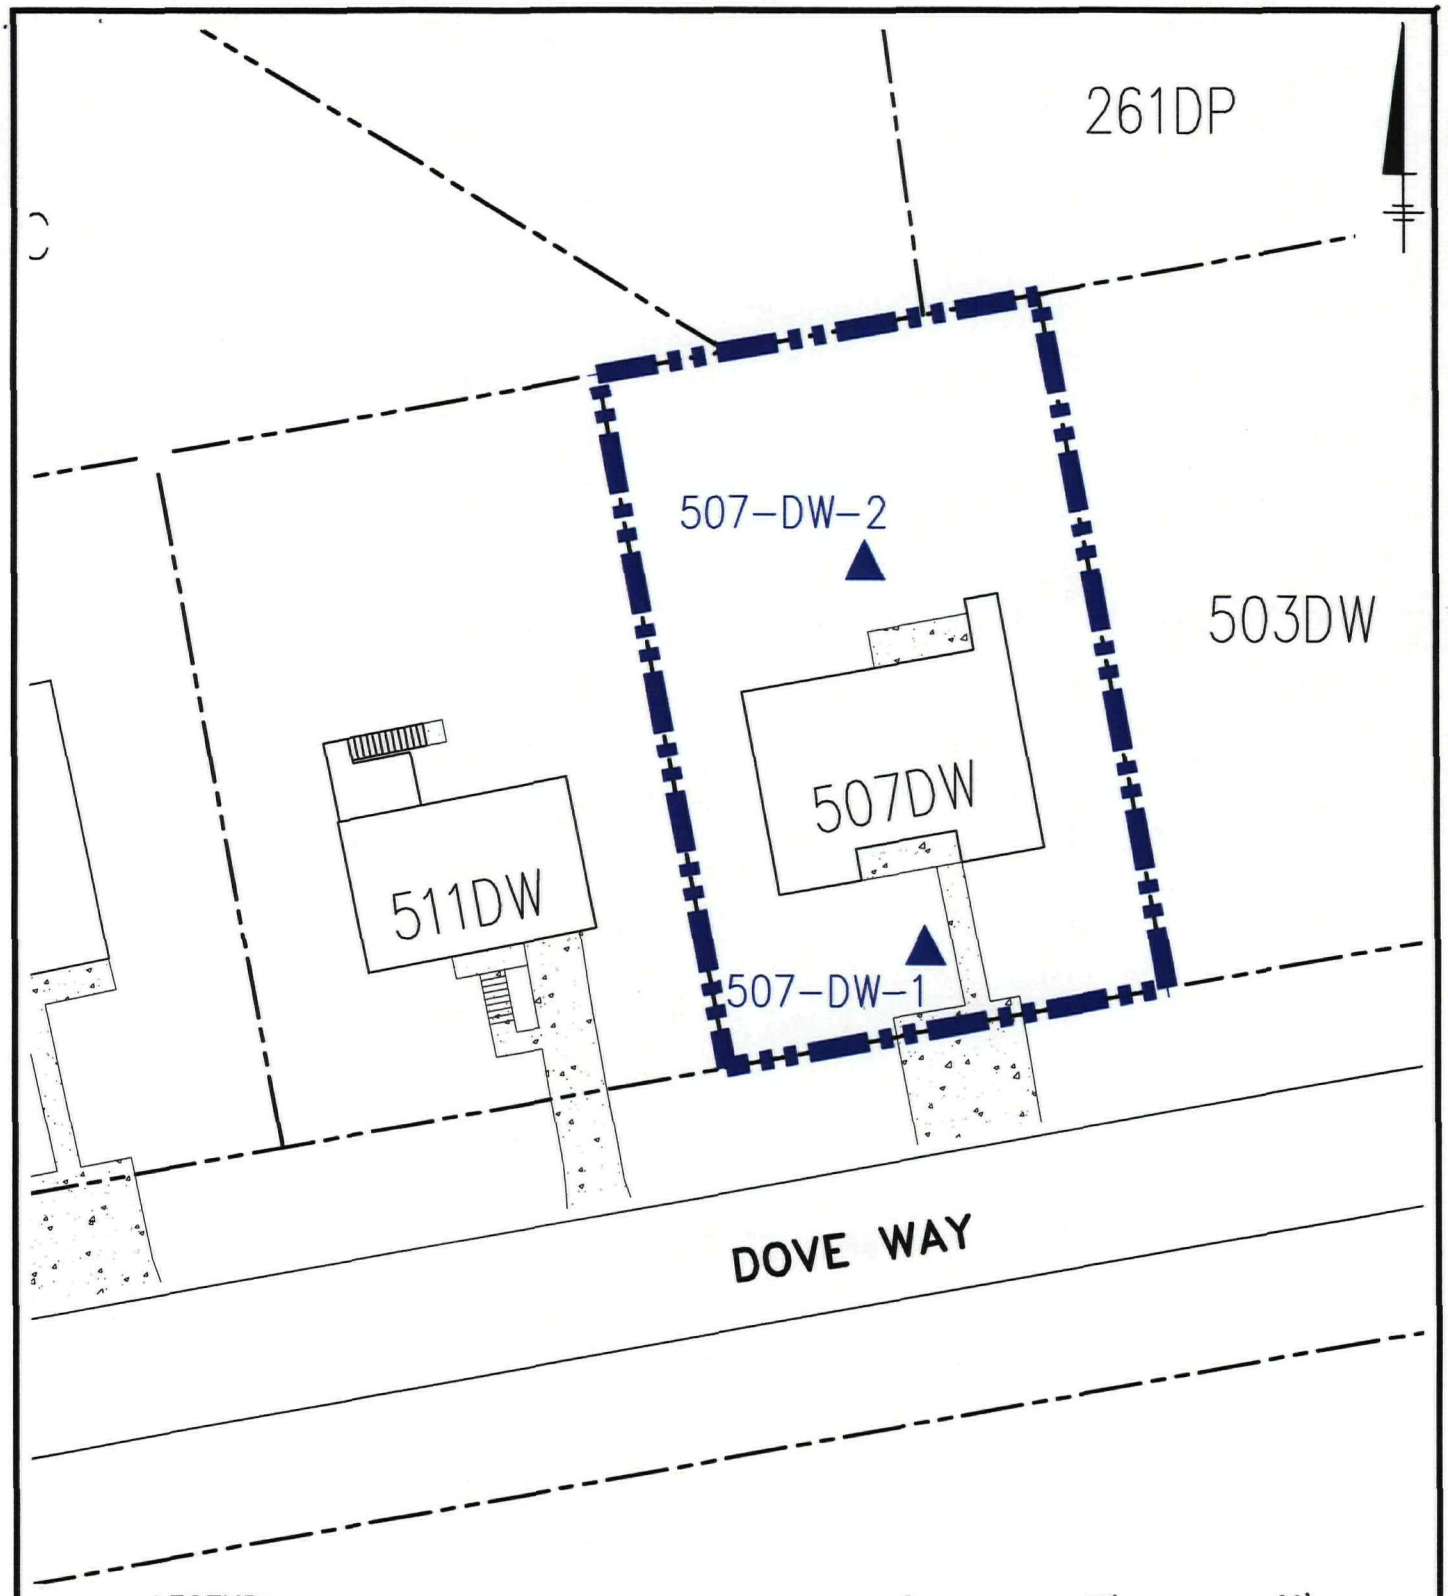
FIGURE
507DW

- Deeper soil samples were collected from one location in the front yard and one location in the back yard. The locations of these deeper soil samples are shown on Figure 1. At each location, soil samples were collected from 0.5 to 2 feet, 2 to 4 feet, 4 to 6 feet, and 6 to 8 feet below ground surface. These samples were tested in the field using the XRF device described above to determine the approximate concentrations of arsenic and lead. Based on these results, select samples were sent to the laboratory and analyzed for metals (including arsenic and lead) and pH (soil acidity).
