RE: Draft RCRA Facility Assessment (RFA) Report for
U.S. Pipe and Foundry, Chattanooga, Tennessee
Soil Pipe Division - EPA I.D. No. TND 074 893 777
Valve and Fitting Plant - EPA I.D. No. TND 980 316 301

RE: RCRA Facility Assessment (RFA) Report
U.S. Pipe and Foundry Co., Chattanooga, Tennessee
Soil Pipe Division - EPA I.D. No. TND 074 893 777
Valve and Fitting Plant - EPA I.D. No. TND 980 316 301

INTERIM RCRA FACILITY ASSESSMENT REPORT
UNITED STATES PIPE AND FOUNDRY COMPANY

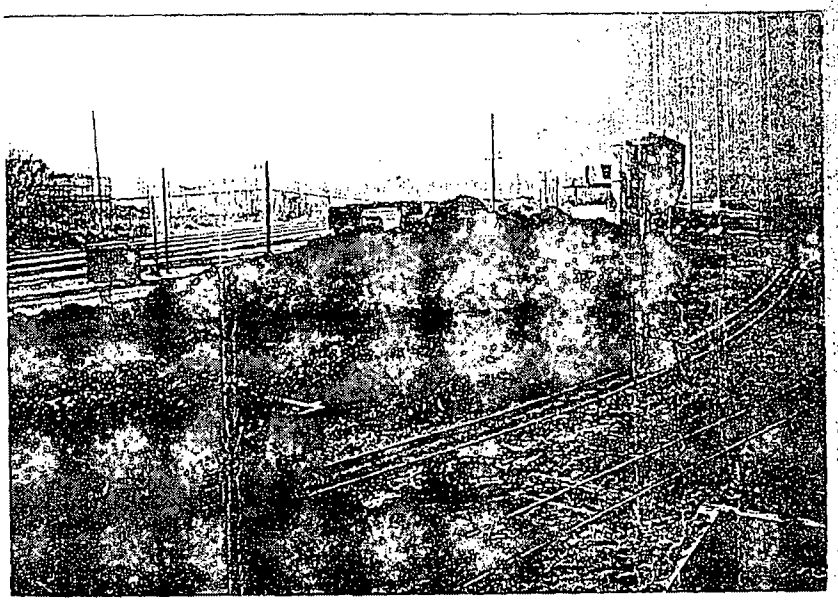
F-1 View of the Frag Pile (SWMU F-1) facing south. Note the scrap metal is transported to the facility by railcar as shown in the lower left corner of the photograph.

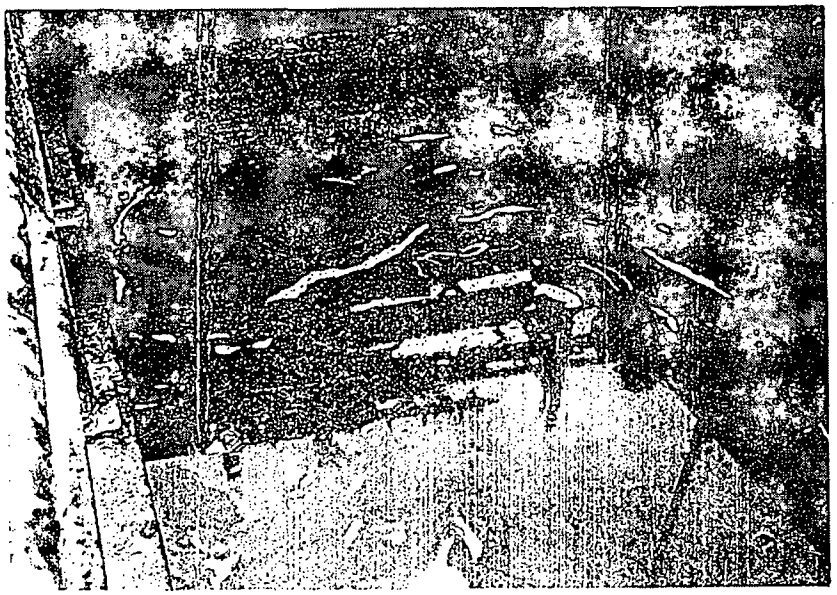
F-4.1 View of the Vehicle Wash Area Sump (SWMU F-4), facing west. Note the oily sheen on the water surface and the oil stains on the concrete sides.

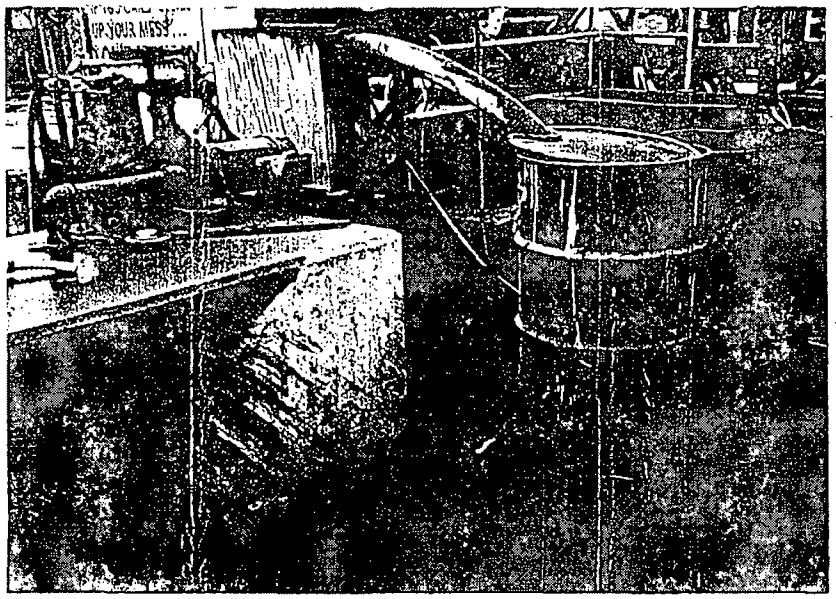
F-4.2 View of the drums used for the collection of skimmed oil from the Vehicle Wash Area Sump (SWMU F-4), facing southwest. Note the staining around the base of the concrete dike and on the concrete adjacent to the drums.

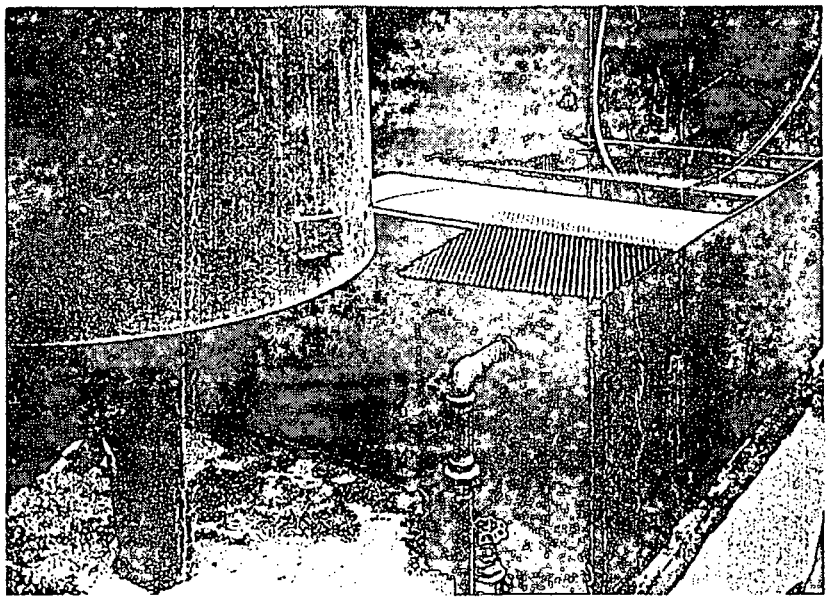
F-5.1 Overview of the Oil/Water Separator (SWMU F-5), facing southwest. Note the sorbent material around the base of the unit.

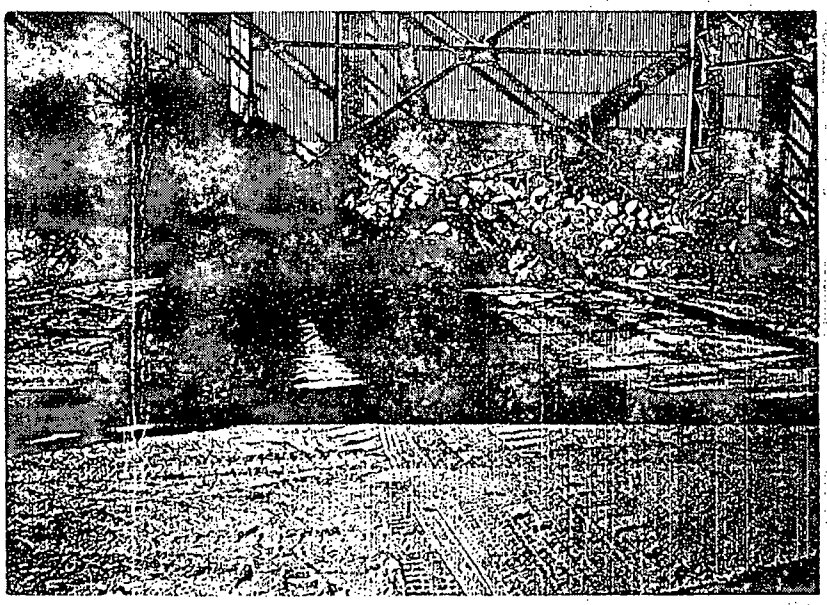
F-7.1 View of the Breaker Waste Pile (SWMU F-7), facing west. Note the pink material is casting sand and the remaining material is a mixture of sand and core butts.

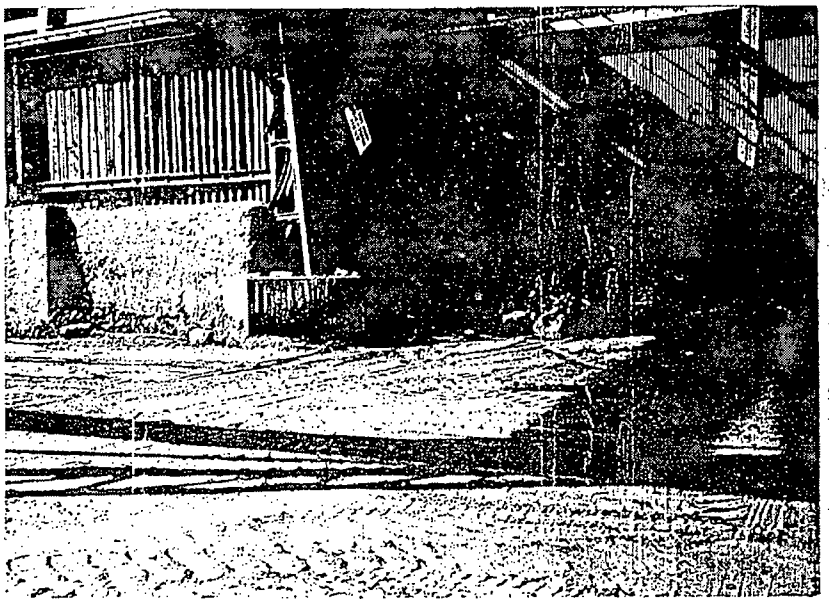
F-7.2 View to the left of the Breaker Waste Pile (SWMU F-7), facing southwest. The building to the left is where a steel ball crushes residual iron and slag.

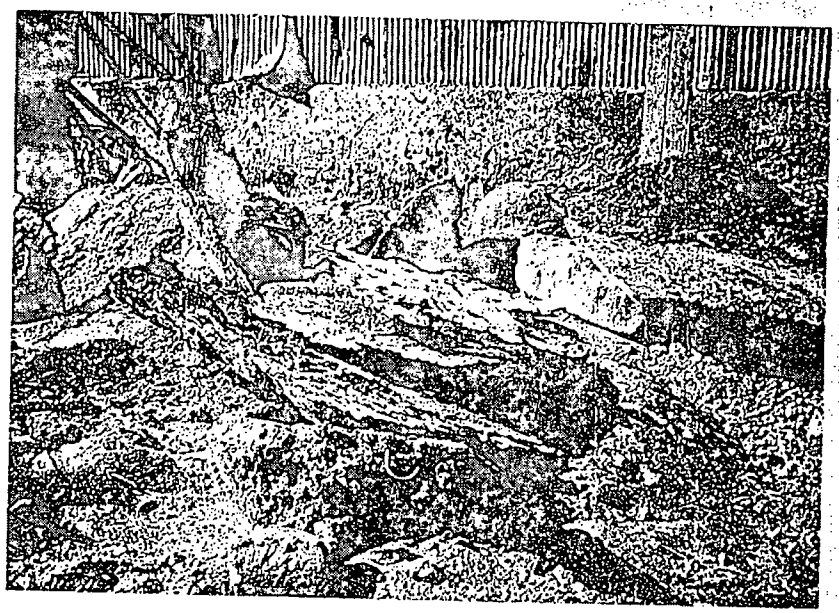
F-7.3 Close-up view of the Breaker Waste Pile (SWMU F-7), facing west. The material consists of iron and some slag which will be recycled in the cupola furnace.

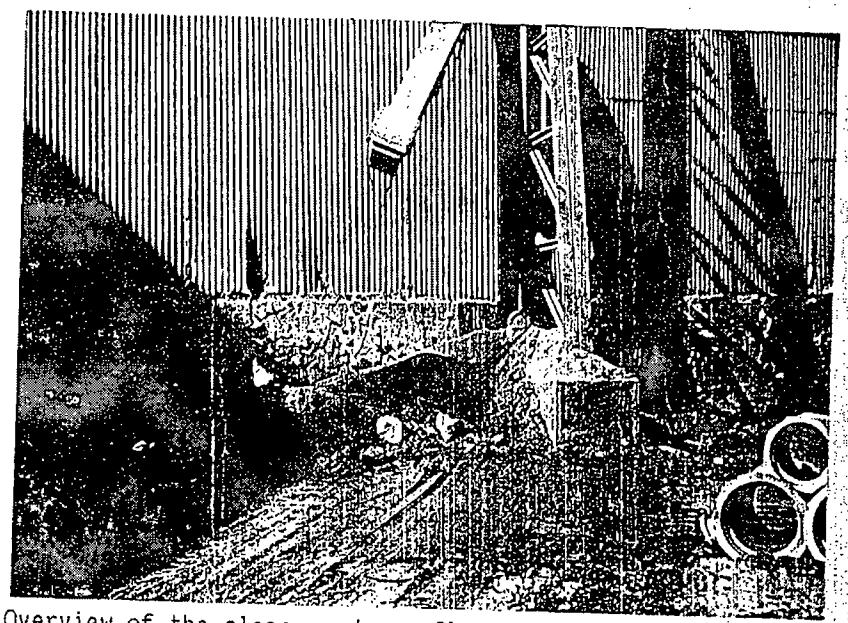
F-7.4 Overview of the clean sand overflow chute for the Breaker Waste Pile (SWMU F-7), facing west. The material is clean sand which will be disposed of in the Landfill (SWMU F-27) with the other waste material in the area.

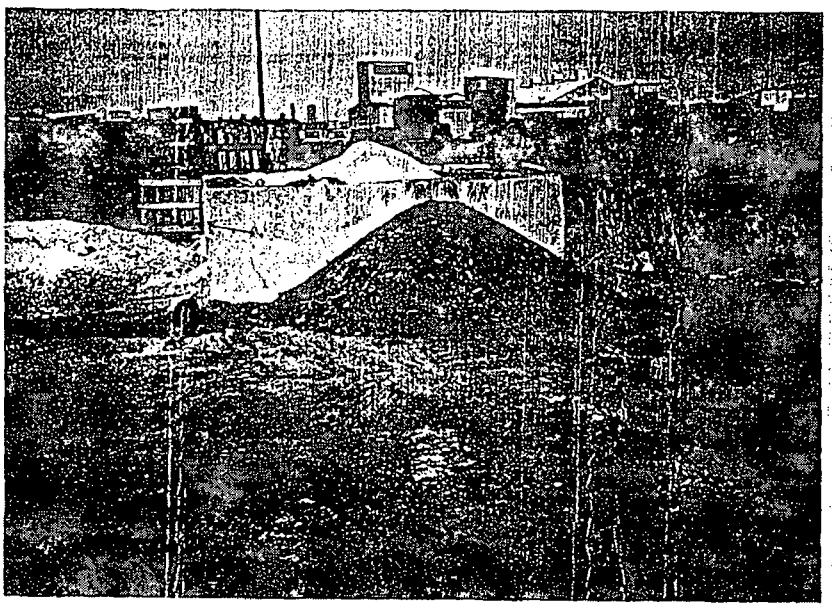
F-8 View of the Cement Waste Pile (SWMU F-8), facing north. The waste is the material in the foreground, and the clean sand is within the concrete bin in the background. The material is staged on bare soil.

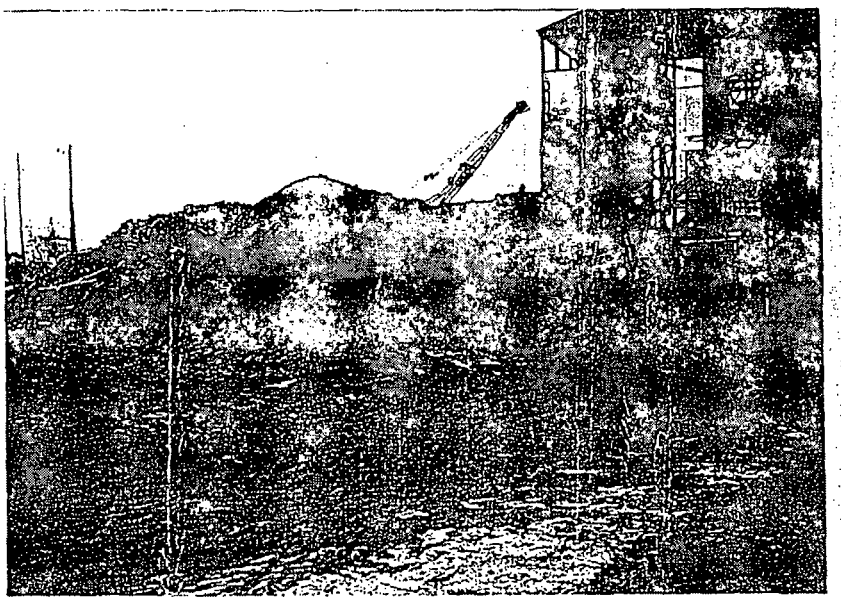
F-10 View of the Excess System Sand Pile (SWMU F-10), facing west. The sand will either be returned to the process or disposed of in the Landfill (SWMU F-27). The material is on bare soil.

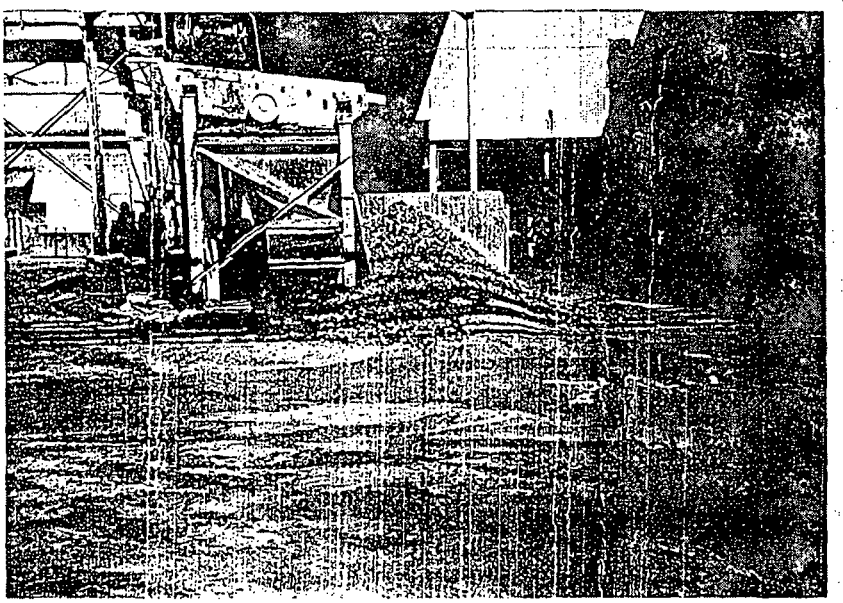
F-11 View of the Green Sand and Core Butt Discharge (SWMU F-11), facing north. This material is located on bare soil and will be disposed of in the Landfill (SWMU F-27).

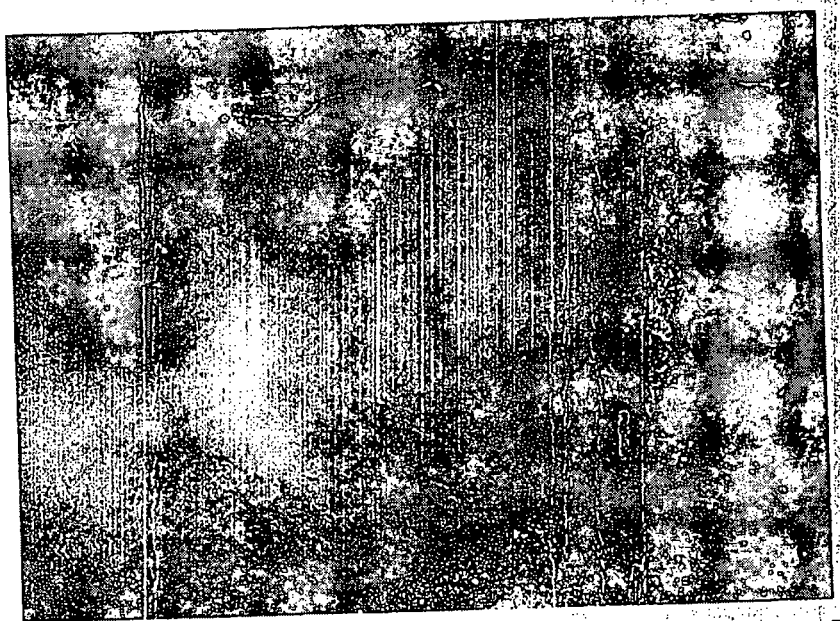
F-13 View of the Slag Accumulation Area (SWMU F-13), facing west. The steam emanating from the area is normal and results from the addition of water to the molten slag.

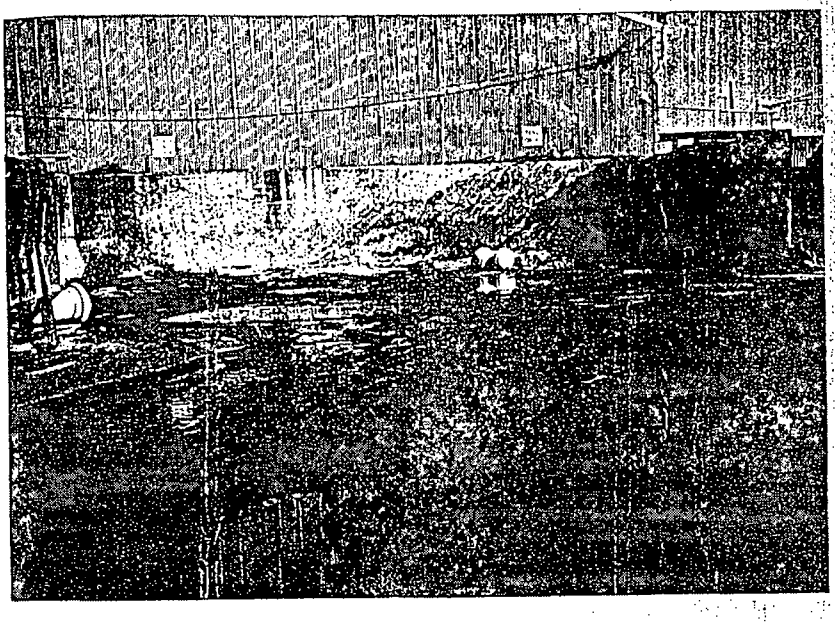
F-14.1 Overview of the Staging Area (SWMU F-14), facing north. The material consists of sand and waste coke and is positioned on concrete. Note the area drainage appears to flow toward the foreground of the photograph.

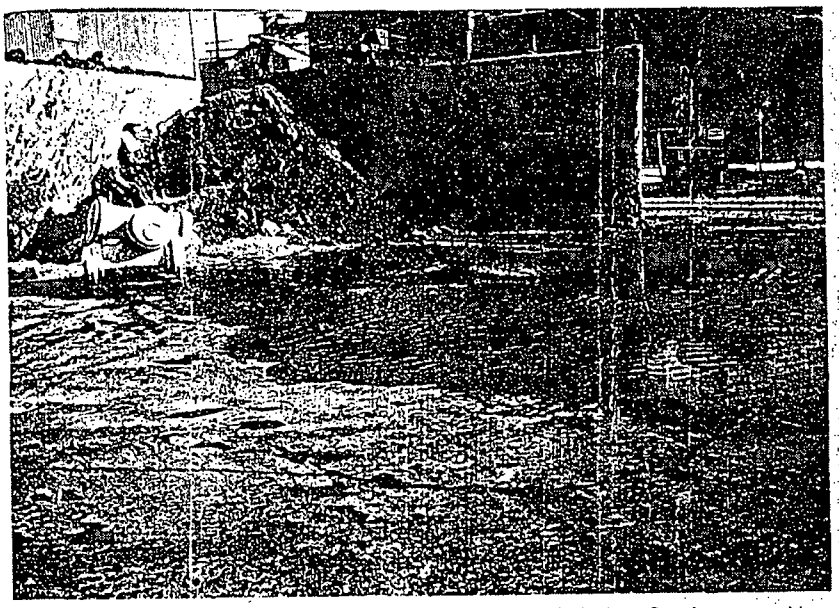
F-14.2 Close-up view of the Staging Area (SWMU F-14), facing northeast. Note the liquid drains southward towards the photographer, away from the area.

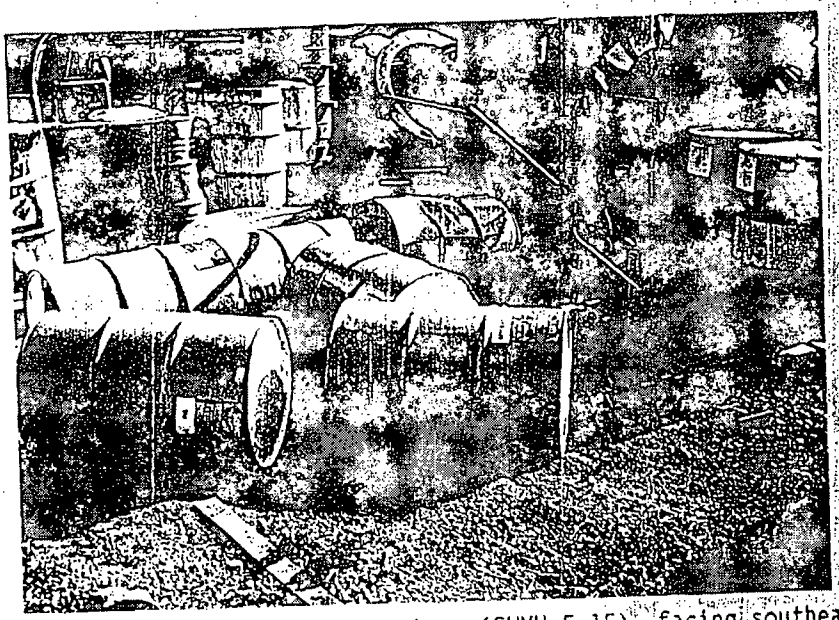
F-15.1 View of the Empty Drum Storage Area (SWMU F-15), facing southeast. Note the horizontal drums formerly contained 1,1,1-trichloroethane and are located on bare soil.

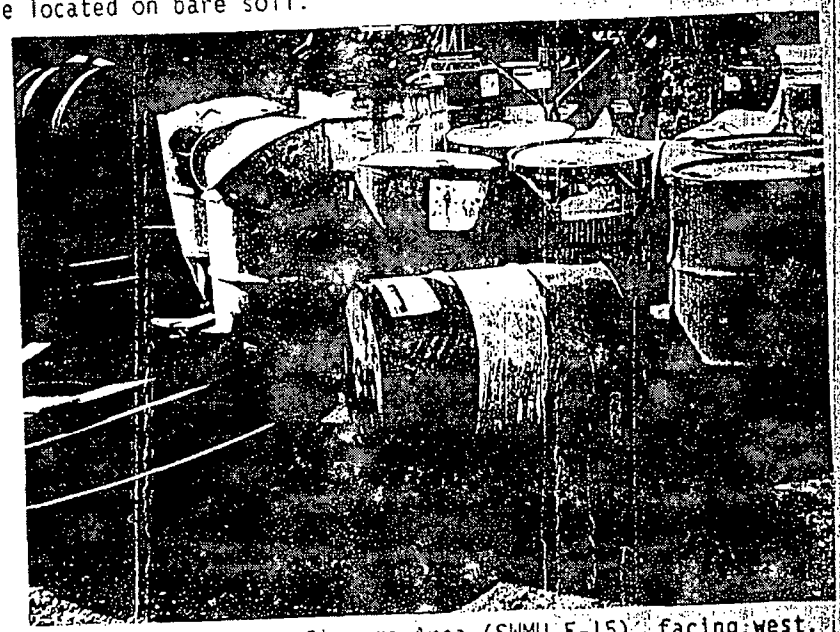
F-15.2 View of the Empty Drum Storage Area (SWMU F-15), facing west. The drums are in poor condition, formerly contained water-based coolant and are located on bare soil.

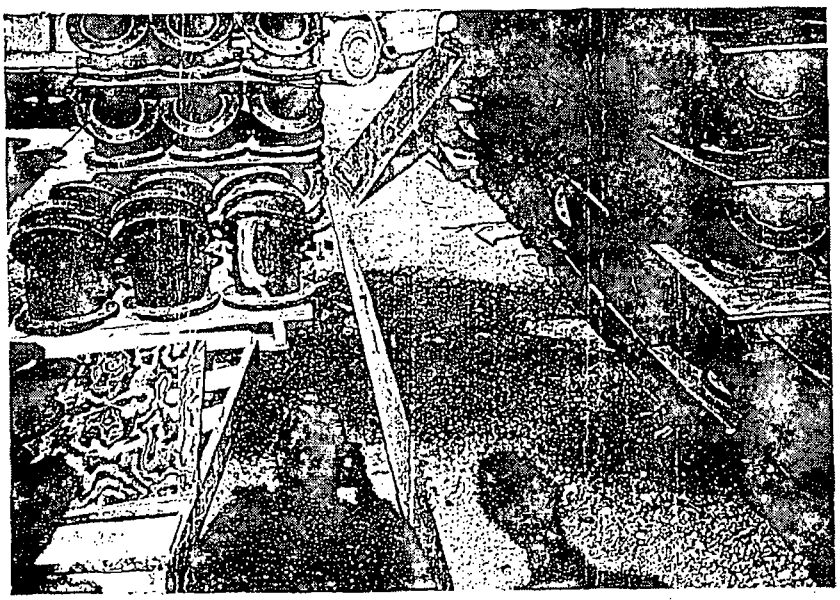
F-15.3 View of the area in the vicinity of the Empty Drum Storage Area (SWMU F-15), facing west. The soil and gravel were stained and appeared to receive runoff from the Empty Drum Storage Area (SWMU F-15).

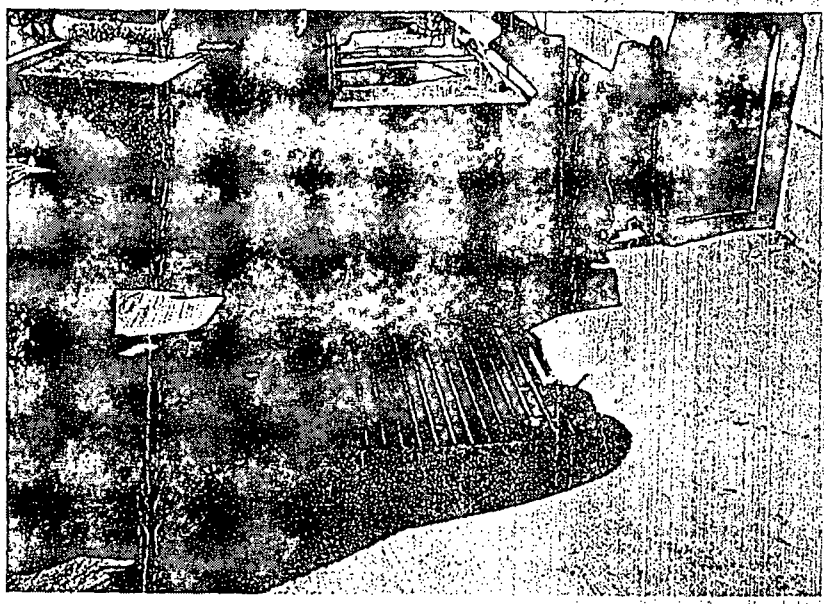
F-17 View of a representative grate for the Storm Sewer (SWMU F-17), facing west. Note the unit receives stormwater runoff from the driveways and parking areas.

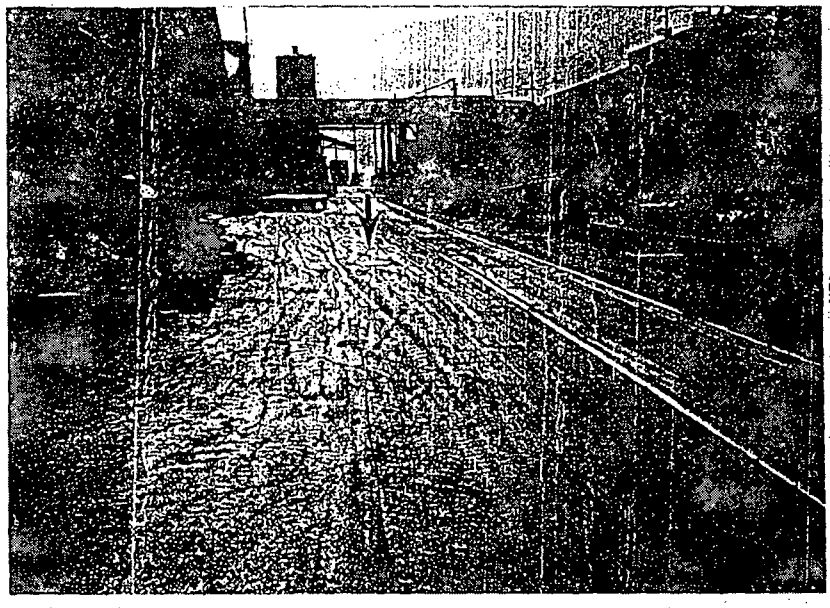
F-18 Overview of the driveway on the west side of the Fittings Plant, facing south. The manhole cover for the Sanitary Sewer (SWMU F-18) is located in the center of the photograph (indicated by an arrow).

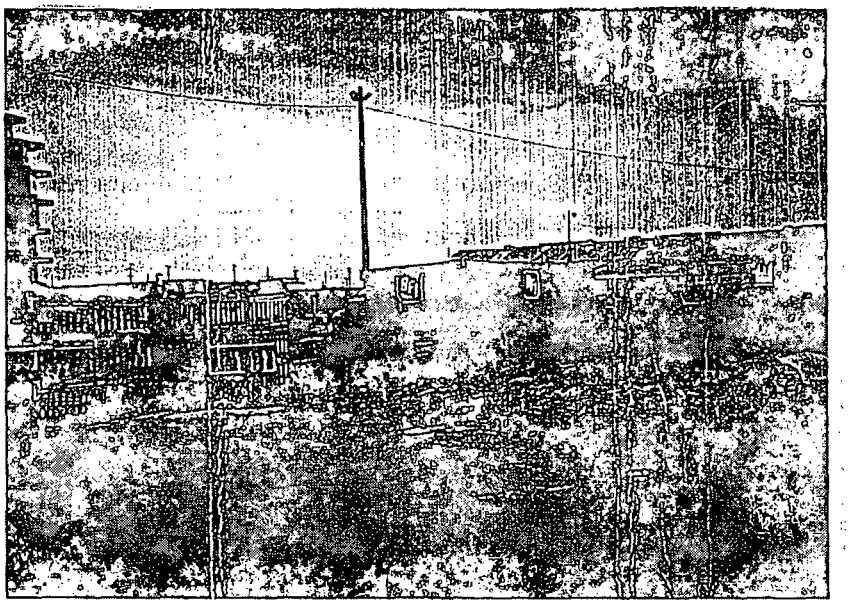
F-19 View of a representative Roll-off Box (SWMU F-19), facing northeast. Note the container is elevated above the ground.

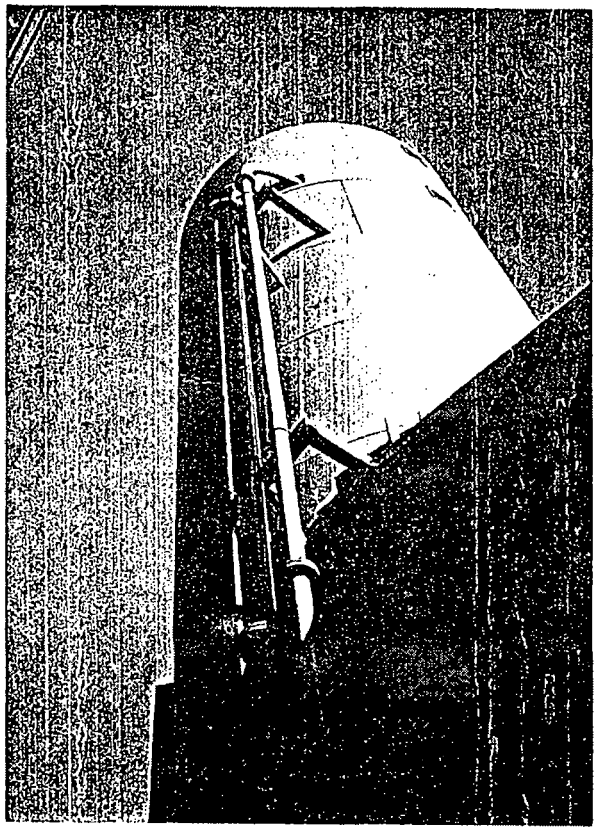
F-20.1 View of the Cupola Baghouse Silo (SWMU F-20), facing northwest. Note the unit is new and appears in good condition.

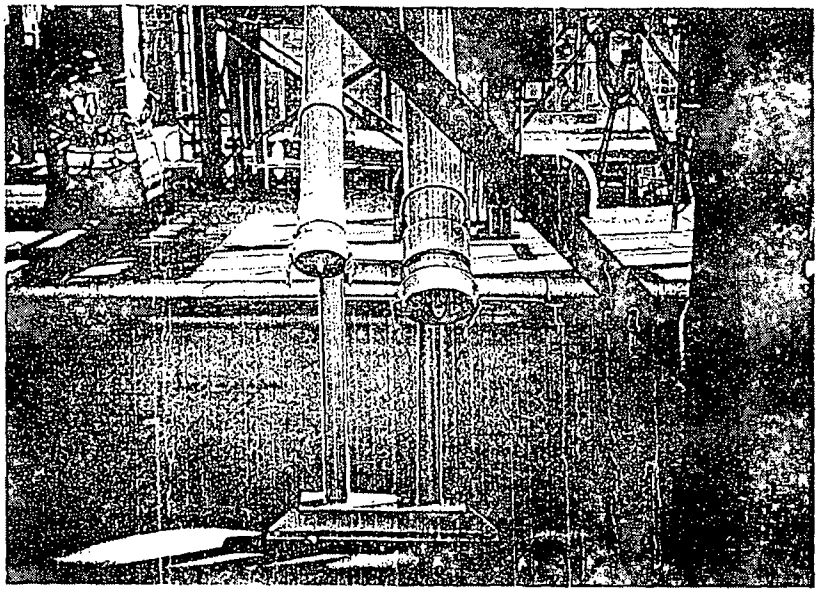
View of the vacuum truck discharge pipe for the baghouse dust from the Soil Pipe Cupola Baghouse (SWMU S-11) to be treated in the Cupola Baghouse Silo (SWMU F-20), facing north. Hoses from trucks are connected to the pipe; dust is discharged to the silo for treatment.

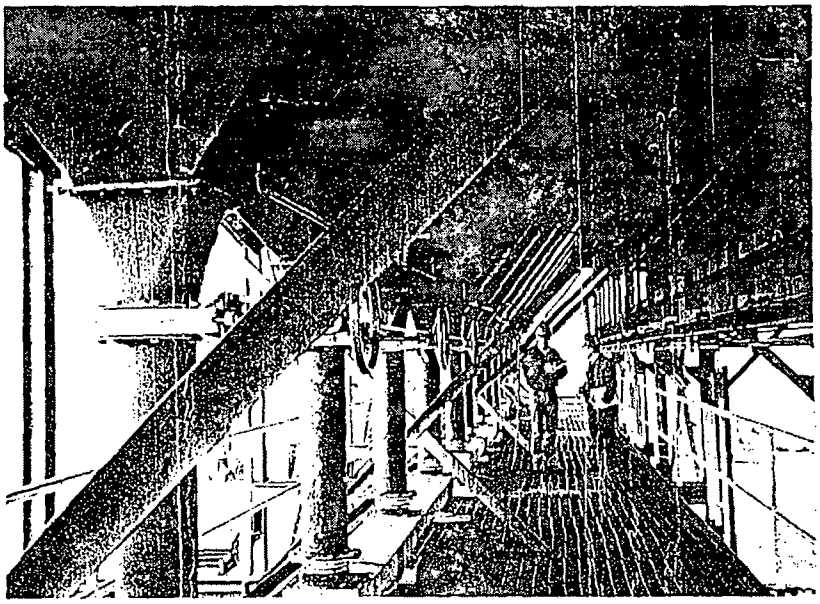
View of the Cupola Baghouse (SWMU F-21) system, facing west. Note the system is new and appears in good condition.

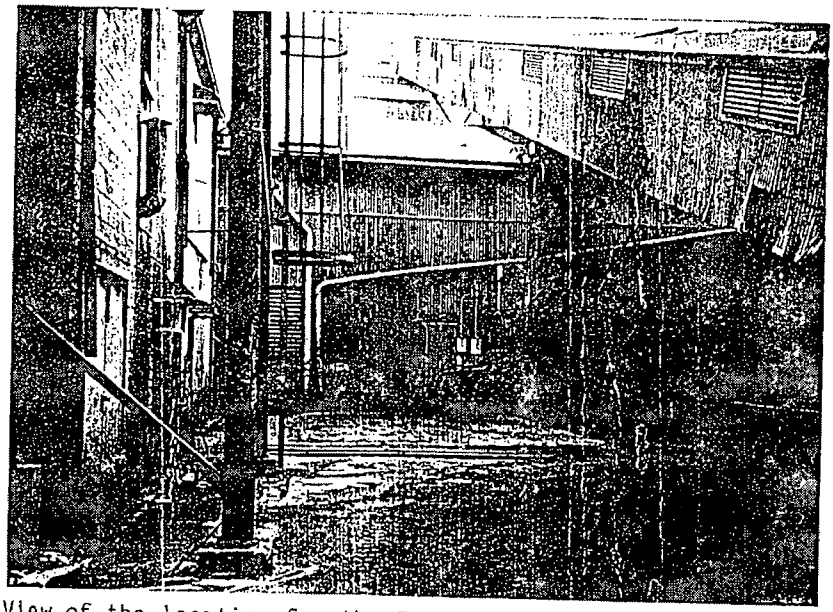
F-23 View of the location for the Former Scrubber (SWMU F-23), facing north. The scrubber was positioned on the concrete pad in the center of the photograph.

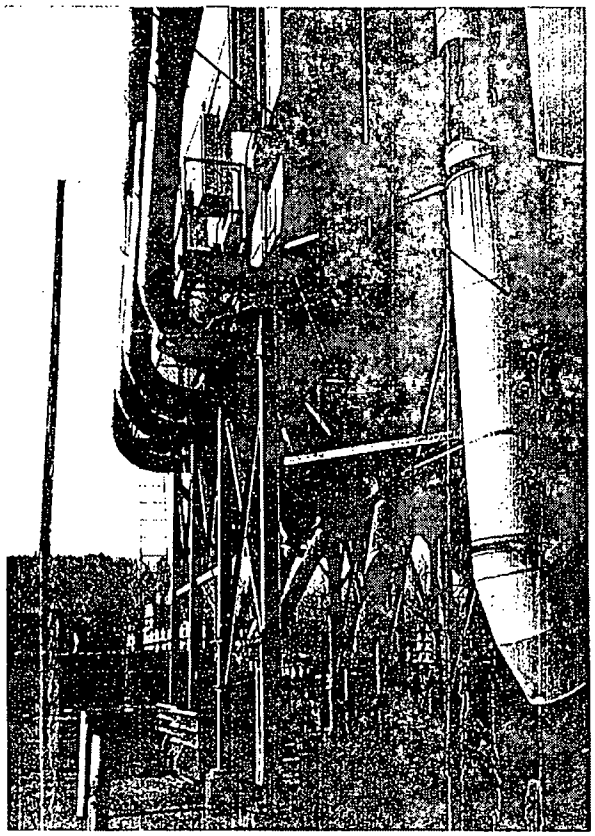
F-24 View of the Griffin Baghouse (SWMU F-24), facing west. Note the unit is underlain by concrete and appears in good condition.

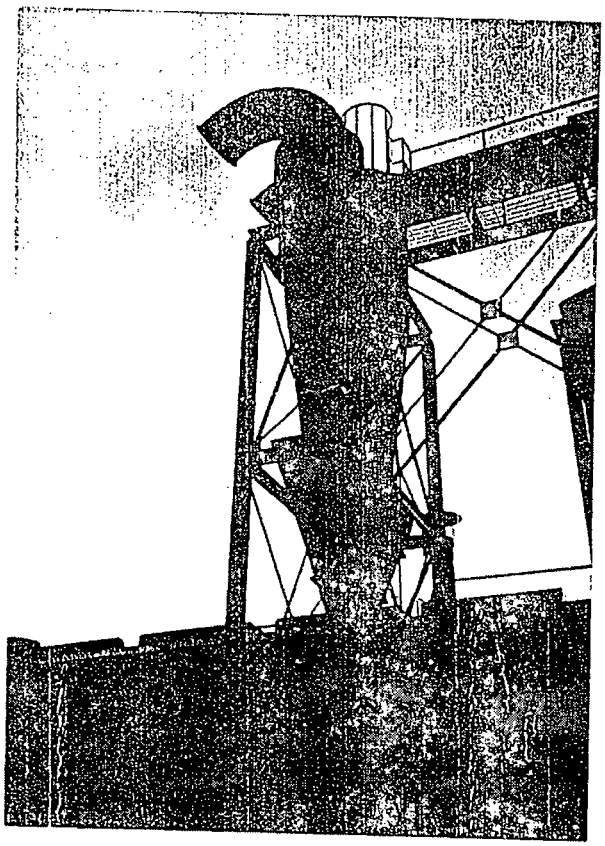
-25 View of the Number 9 Cyclone (SWMU 25), facing east. Note moisture and some sand is emanating from the stack.

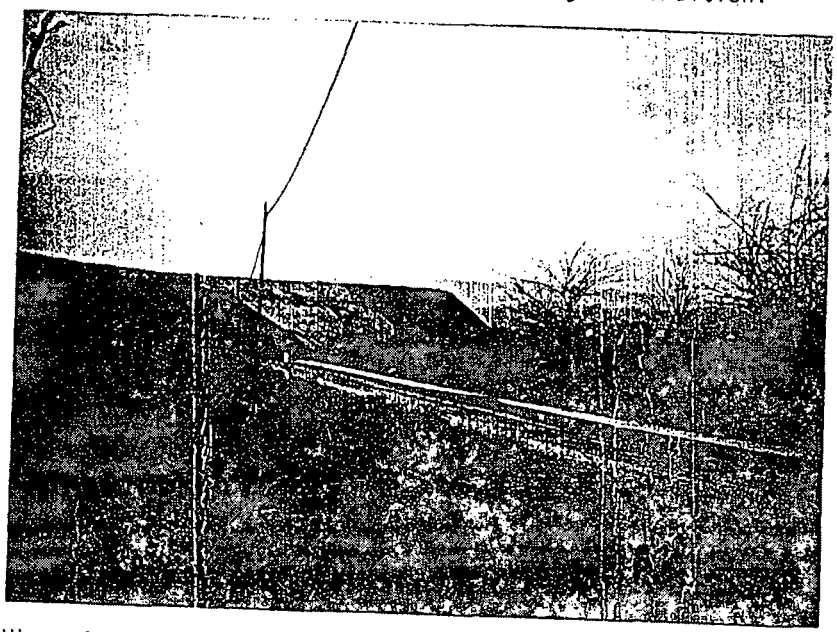
-27.1 View of the Landfill's (SWMU 27) active face, facing west. The Tennessee River is on the back side of the landfill.

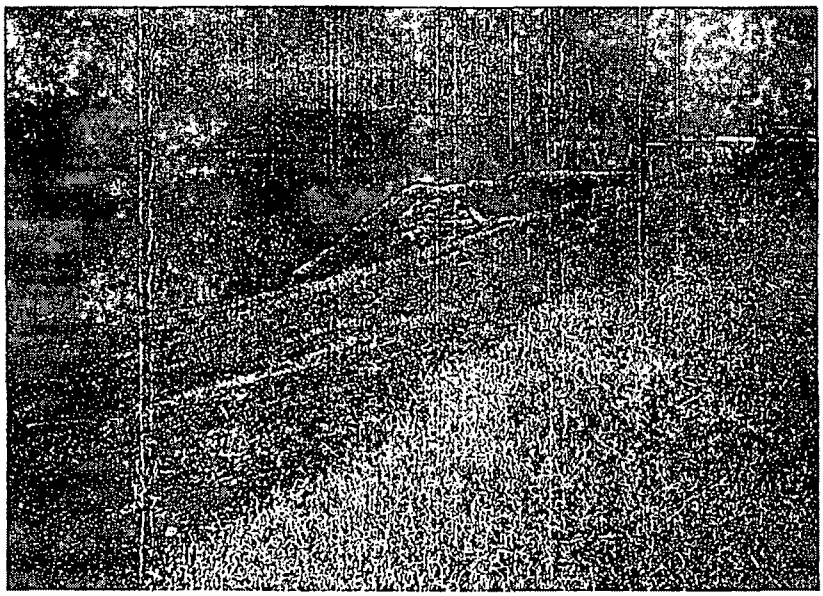
-27.2 View of the Tennessee River from the top of the north side of the Landfill (SWMU 27), facing northwest. Note the vegetative cover appears adequate.

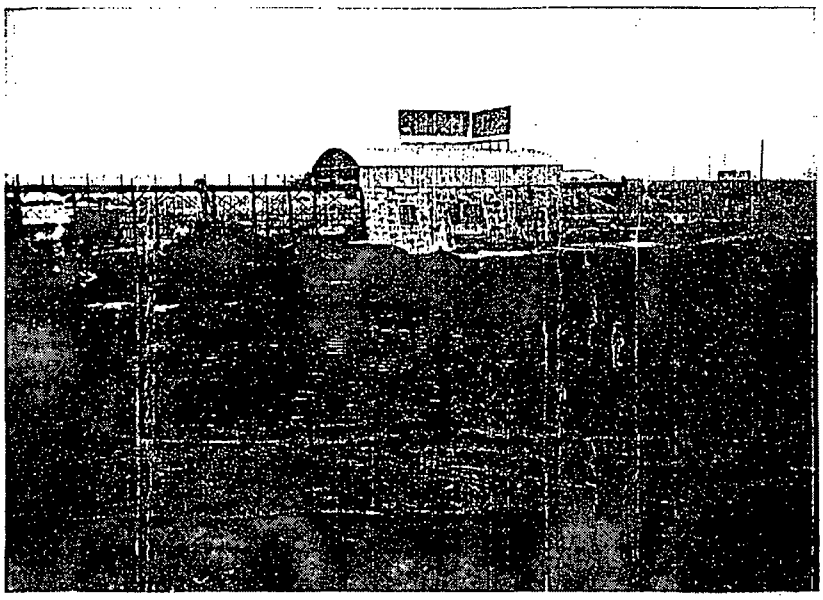
-27.3 Recently graded material on the Landfill (SWMU F-27), facing north. Note the current active face is on the north side of the Landfill.

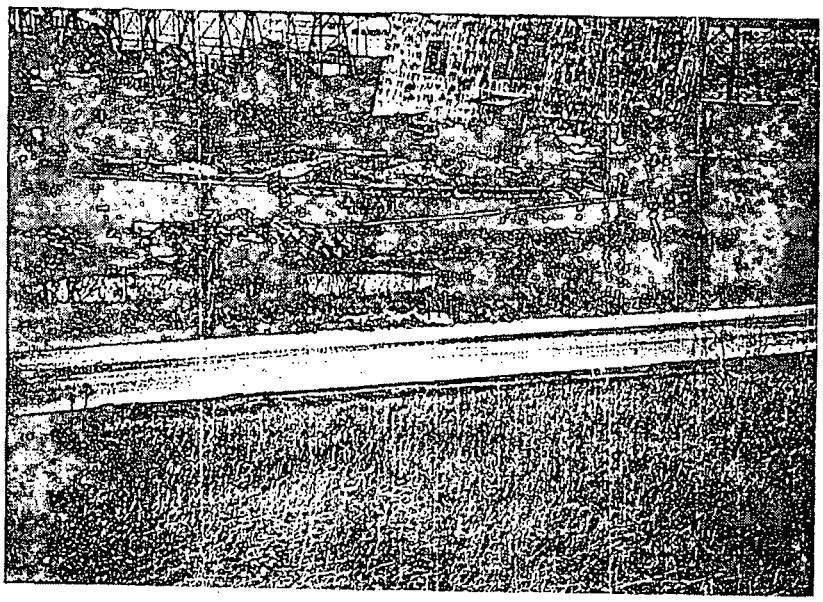
7.4 View of the vegetated slope on the northeast side of the Landfill (SWMU F-27), facing northeast. One of the monitoring wells is visible in the center of the photograph.

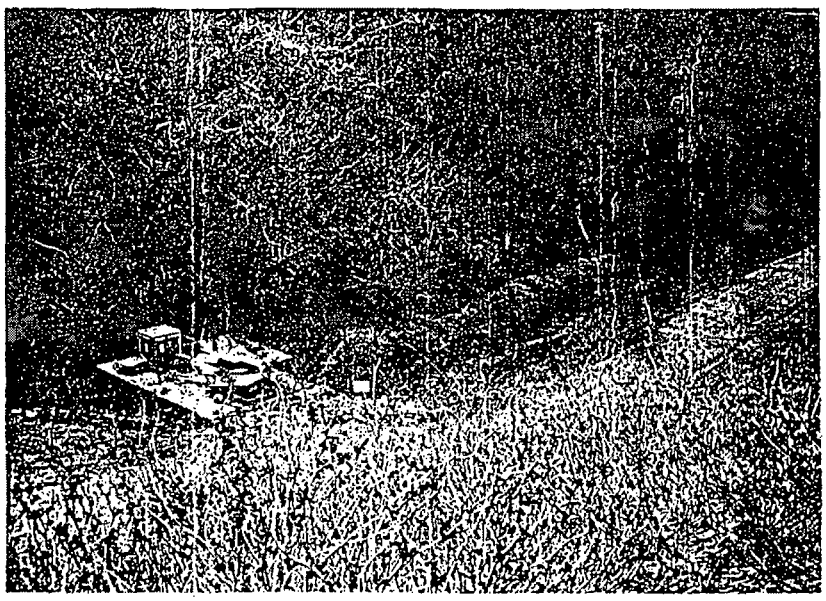
F-29 Overview of the Landfill Discharge Ditch/Pipe (SWMU F-29), facing southeast. Note the photograph was taken from the top of the east side of the Landfill (SWMU 27).

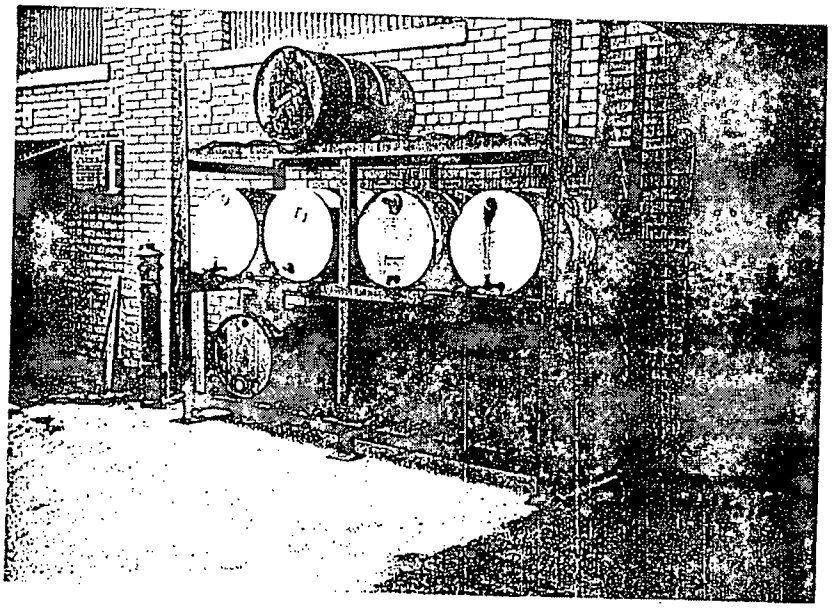
F-A View of the Hydraulic Oil Storage Area (AOC F-A), facing southeast. Note the sorbent on the asphalt surrounding the drum rack.

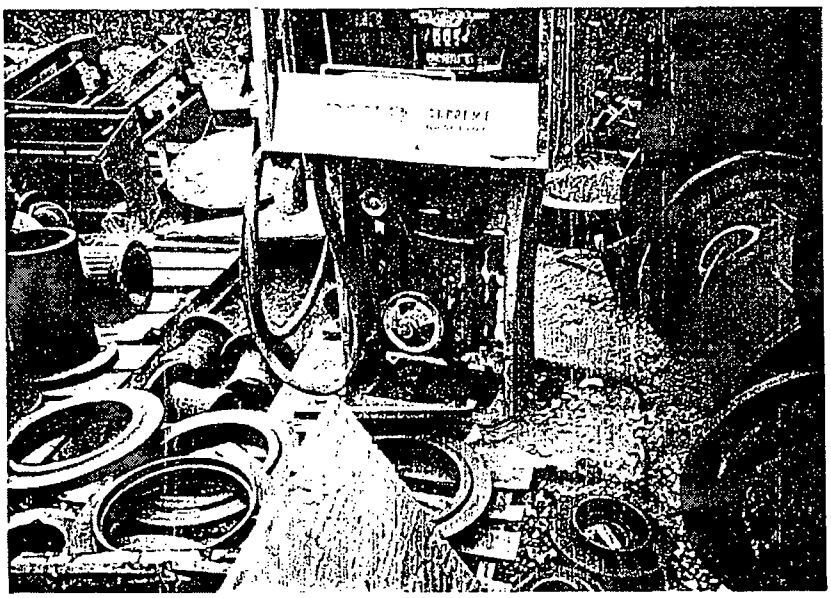
F-D View of the location for former Fuel Underground Tank No. 3 (AOC F-D), facing west. Note the tank is no longer in use.

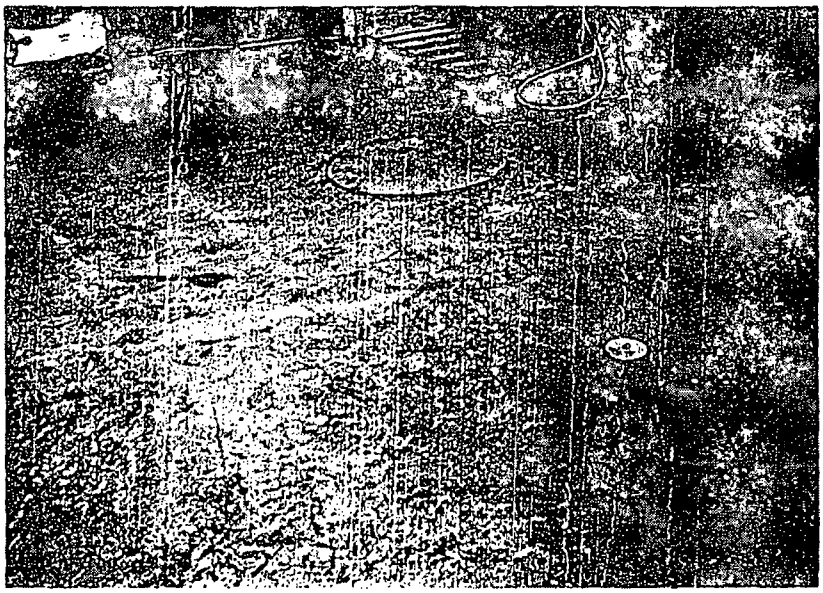
F-E.1 View of the location for Underground Tank No. 4 (AOC F-E), facing east. Note the concrete is stained around the fill pipe.

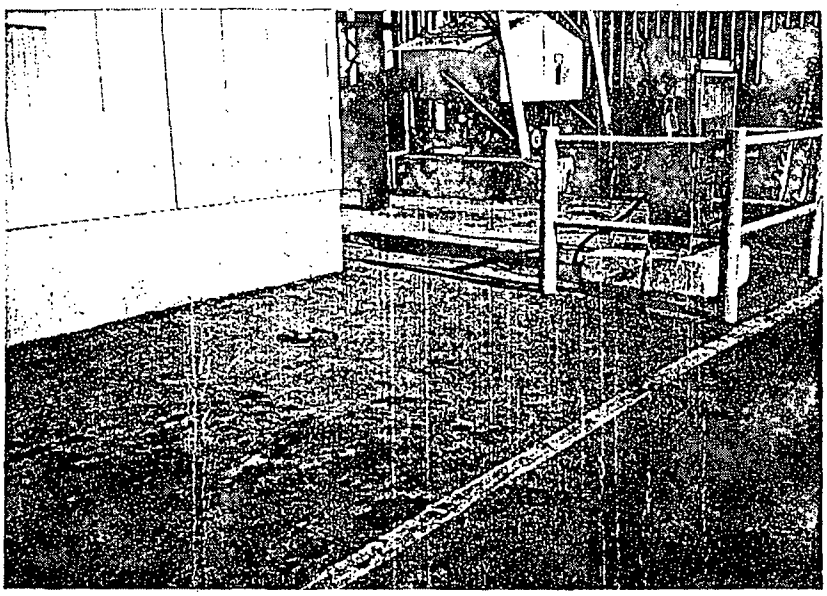
F-F View of the location for Underground Tanks Nos. 5 and 6 (AOC F-F and AOC F-G), facing northeast. Note the minor staining is probably from leaking transmission housings or oil pans.

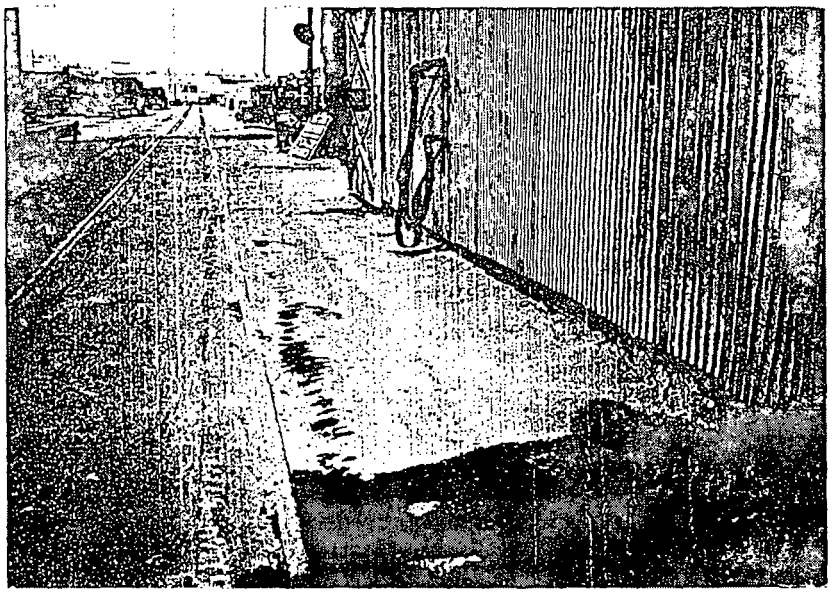
F-H.1 Outside view of the Coating Area (AOC F-H), facing north. Note the asphalt coating mixture is pumped from the truck to the tank inside the building via the hoses in the middle of the photograph.

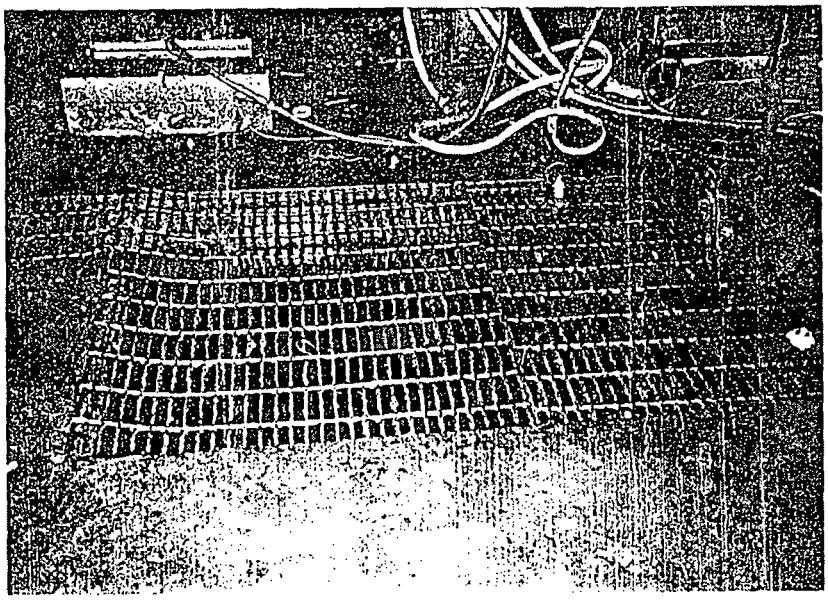
V-2.1 View of the Hydrant Testing Sump (SWMU V-2), facing east. Note the sump extends to the left beyond the area depicted in the photograph.

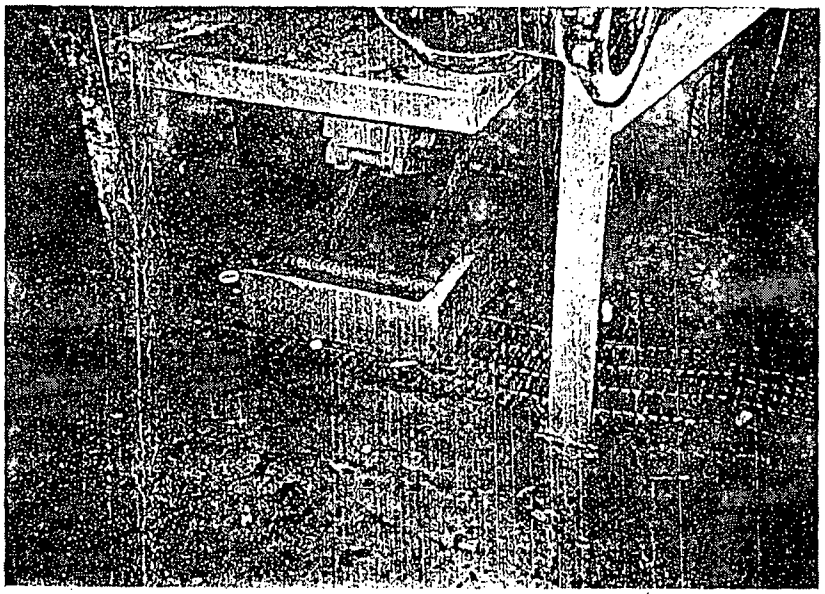
V-2.2 View of the Hydrant Testing Sump (SWMU V-2), facing west. Note the liquid in the foreground is water from the hydrant testing operation.

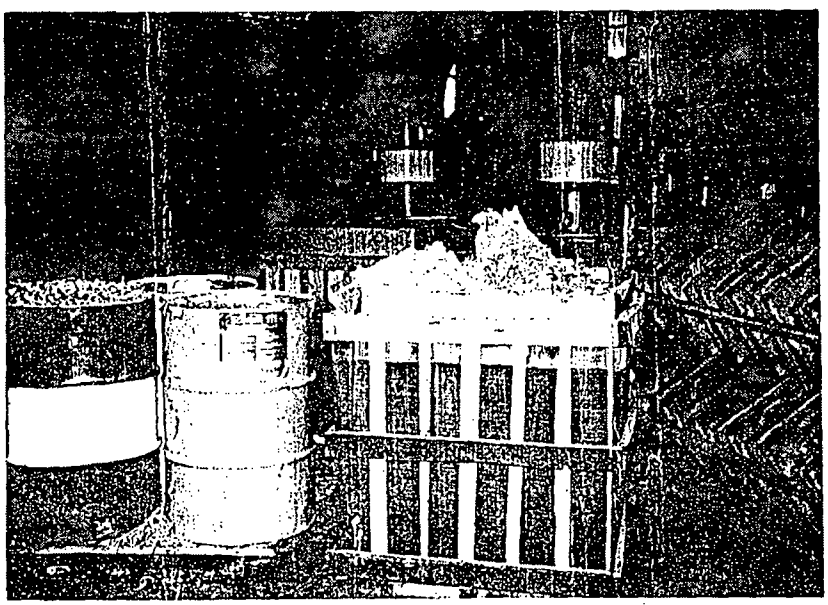
V-3 View of the Lead Dross Drum Area (SWMU V-3), facing southeast. Note the drums to the left contain brass shavings and the bin in the middle contains the lead dross.

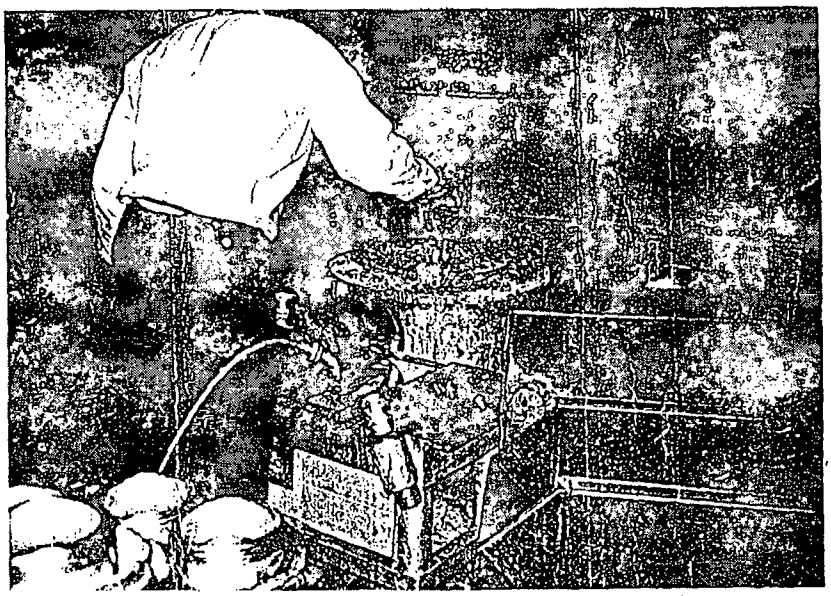
V-4 Overview of the Lead Melting Pot Area (SWMU V-4), facing north. Note the exhaust hood in the middle top portion of the photograph exhausts fumes from lead melting to the atmosphere.

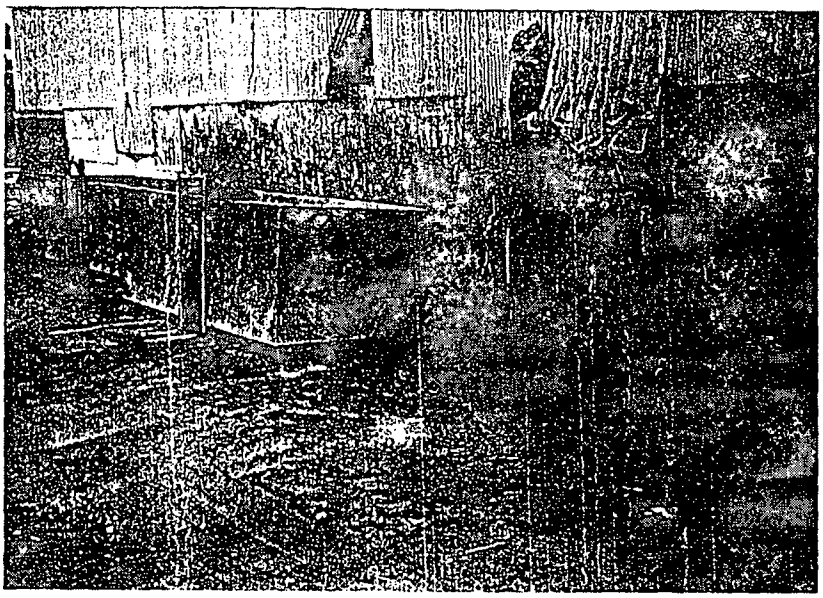
V-5.2 View of the Transfer Dumpsters (SWMU V-5), facing northwest. The spent foundry sand is disposed of in the units following molding operations.

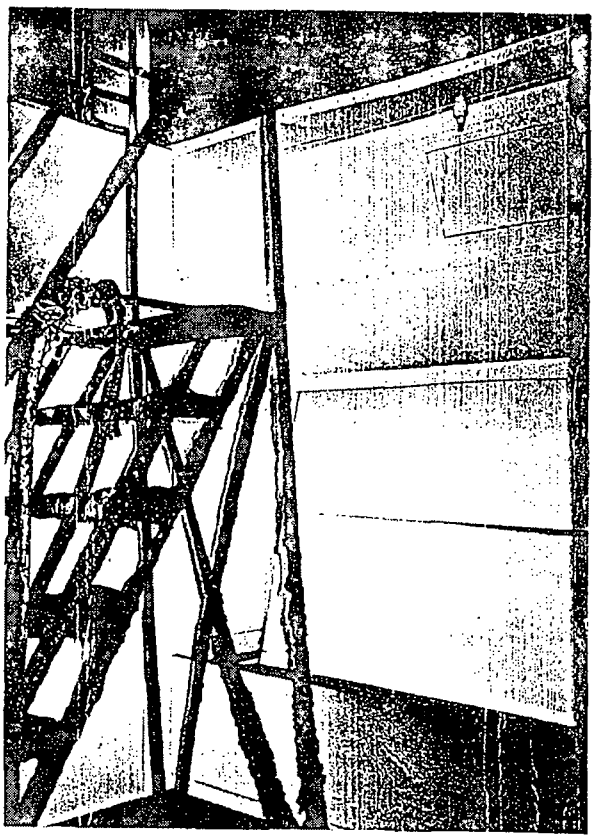
V-6.2 View of the water curtain for a representative Paint Booth (SWMU V-6), facing east. Note the unit is inside a building and appeared in good condition.
