RE: Draft RCRA Facility Assessment (RFA) Report for
U.S. Pipe and Foundry, Chattanooga, Tennessee
Soil Pipe Division - EPA I.D. No. TND 074 893 777
Valve and Fitting Plant - EPA I.D. No. TND 980 316 301

RE: RCRA Facility Assessment (RFA) Report
U.S. Pipe and Foundry Co., Chattanooga, Tennessee
Soil Pipe Division - EPA I.D. No. TND 074 893 777
Valve and Fitting Plant - EPA I.D. No. TND 980 316 301

INTERIM RCRA FACILITY ASSESSMENT REPORT
UNITED STATES PIPE AND FOUNDRY COMPANY

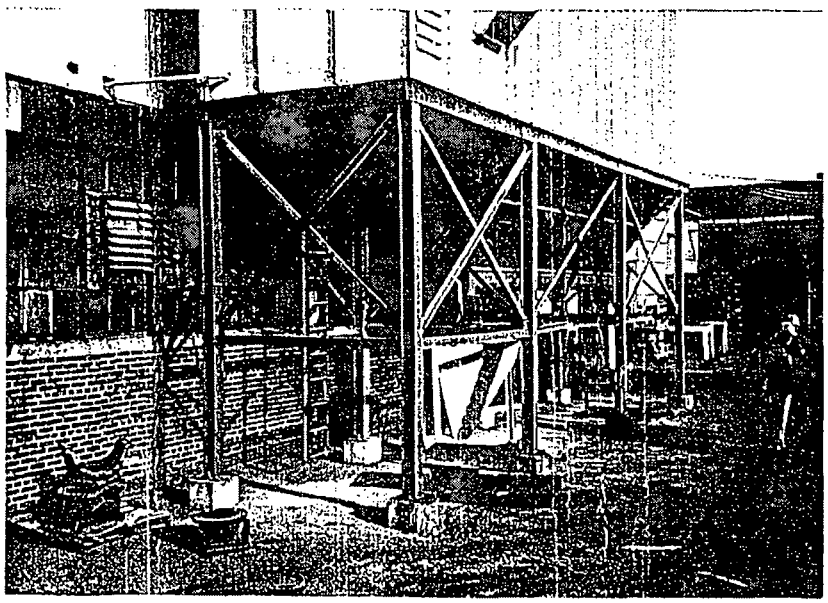
V-7.1 View of the Brass Foundry Baghouse (SWMU V-7), facing northeast. Note the baghouse dust on the concrete beneath the unit.

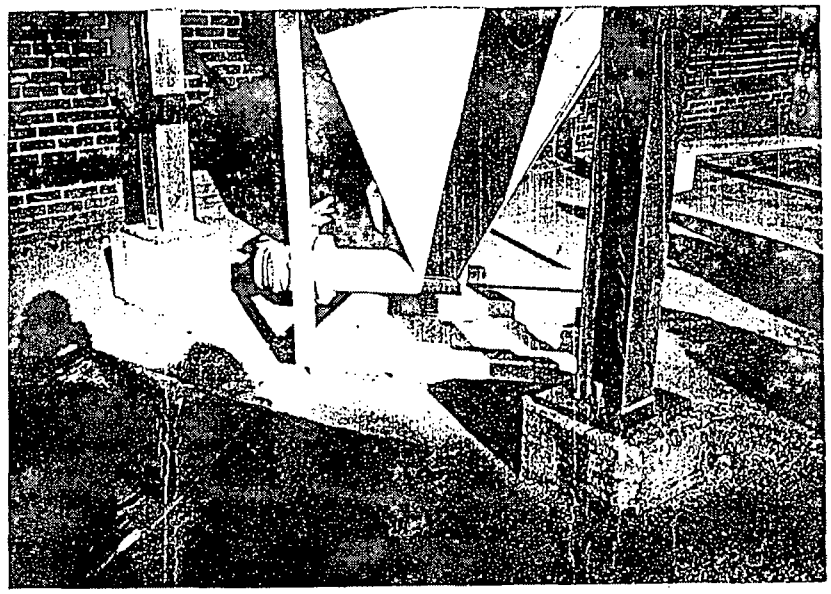
V-7.2 Close-up view of the Brass Foundry Baghouse (SWMU V-7), facing northeast. Note the dust around the base of the chute.

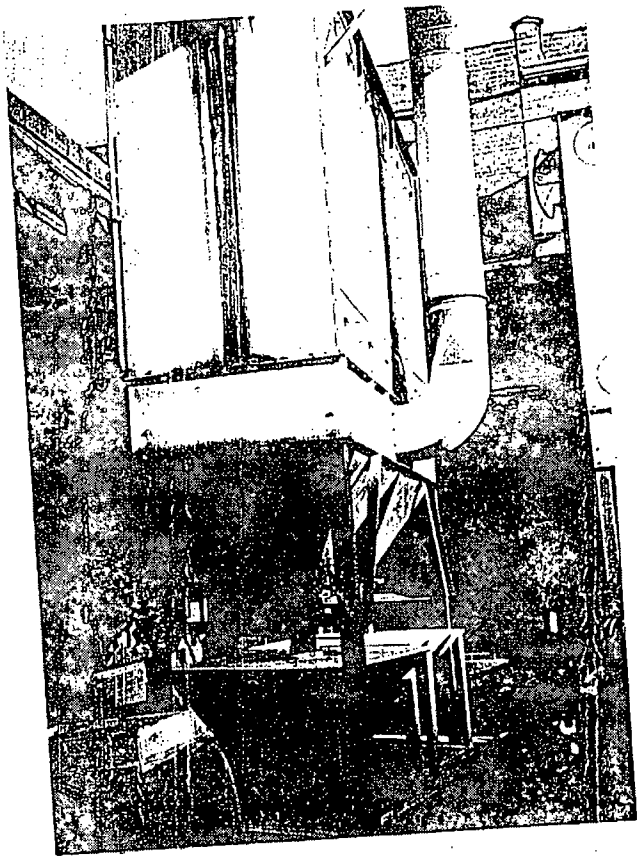
V-9 View of the Brass Shot-Blast Baghouse (SWMU V-9), facing east. Note the Brass Grinding Baghouse (SWMU V-8) is to the extreme right of the photograph.

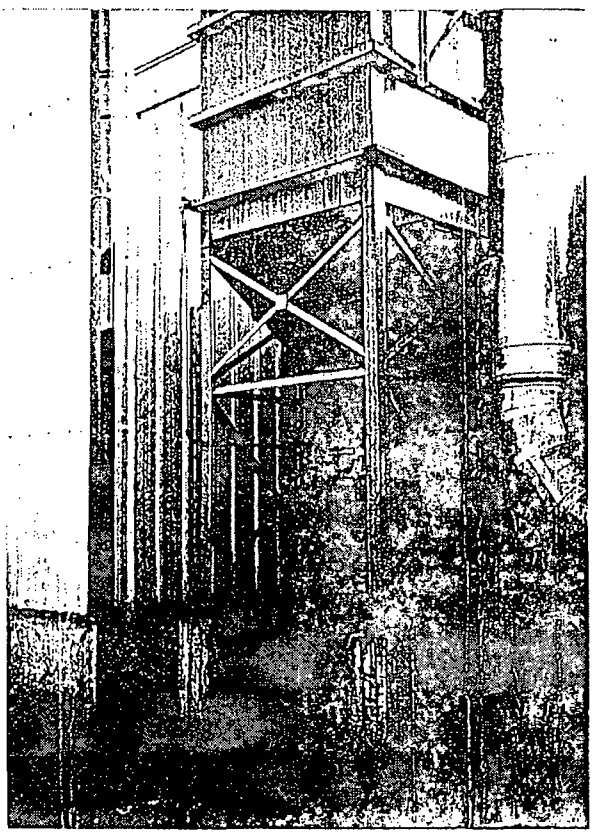
V-10 View of the Cabinet Cleaning Baghouse (SWMU V-10), facing southeast. Note the unit is elevated above the ground and the integrity appears adequate.

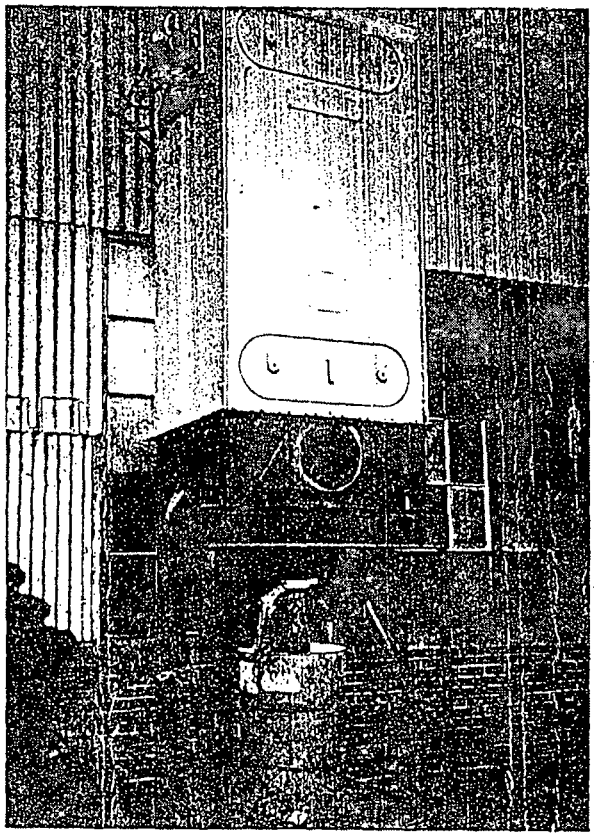
Overview of the Shell Mold Baghouse (SWMU V-11), facing north. Note this unit is elevated above the ground and the collection drum is positioned on a wooden pallet.

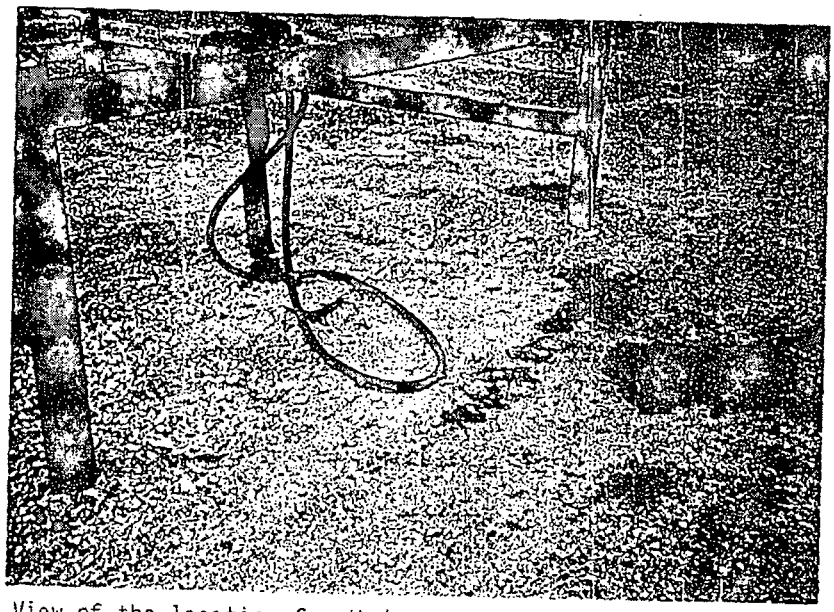
V-A View of the location for Underground Storage Tank No. 8 (AOC V-A), facing northwest. Note the gravel is stained in the vicinity of the fueling area.

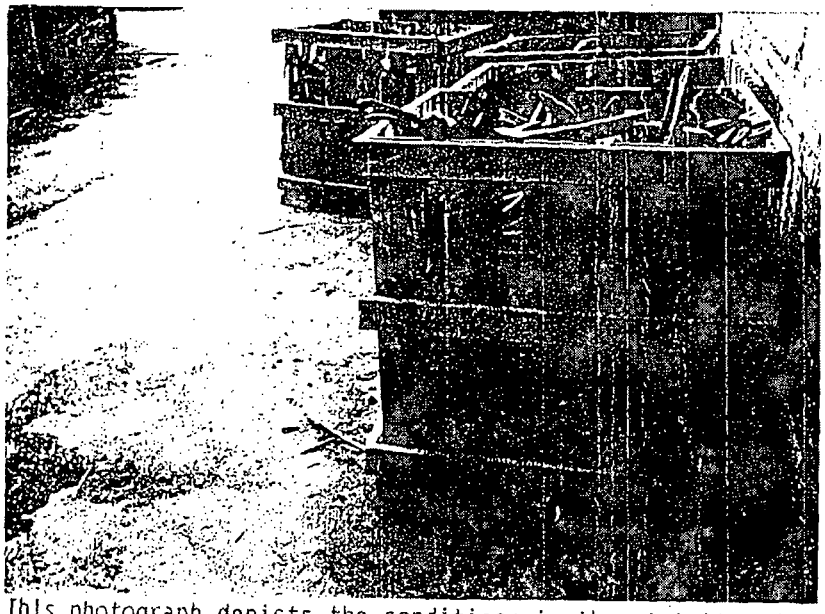
V-B This photograph depicts the conditions in the vicinity of the Compressor Area (AOC V-B), facing west. Note the staining on the asphalt.

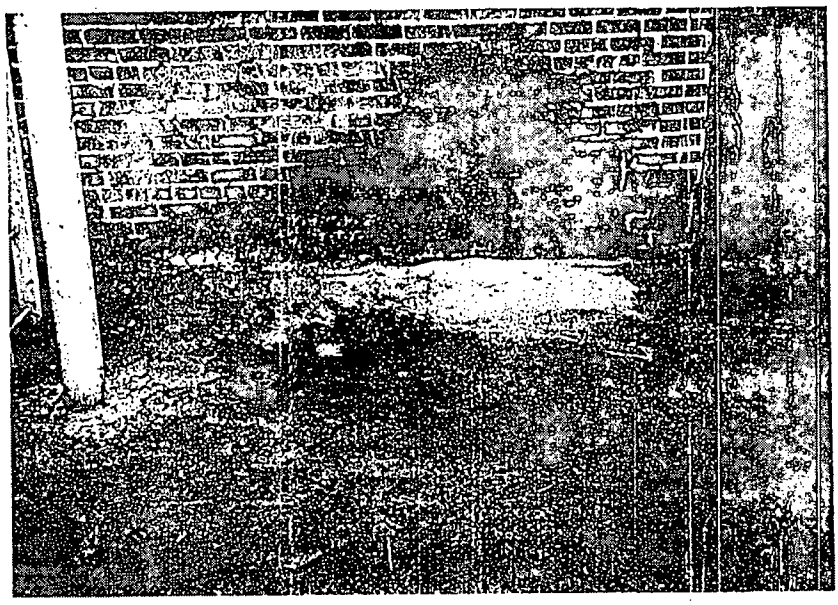
V-B.2 View of the staining observed on the bricks and the asphalt in the vicinity of the Compressor Area (AOC V-B), facing south. Note the sorbent material on the asphalt.

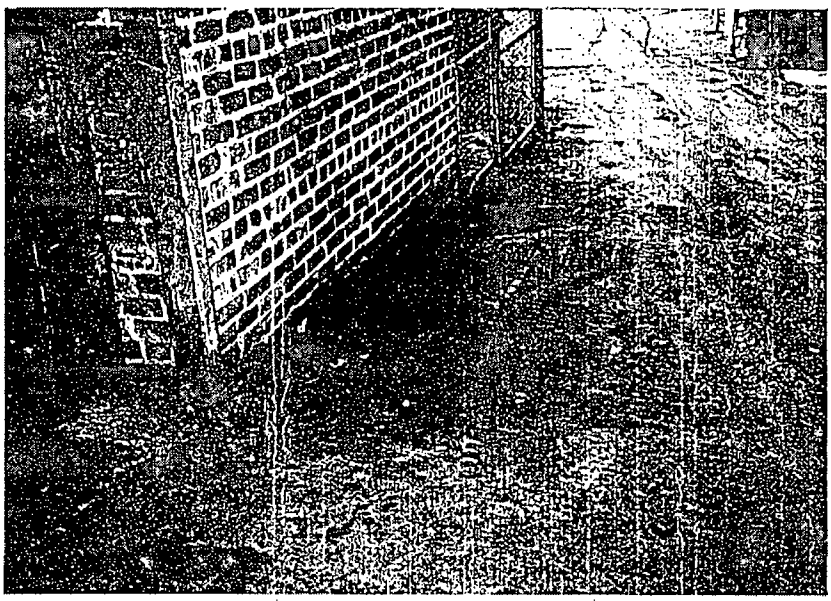
V-B.3 View of the stained asphalt in the vicinity of the Compressor Area (AOC V-B), facing west. Note runoff would flow downgradient from this area.
