October 18, 2005

Re: Remedial Action Monitoring Letter Report **(Incident No. 579286-00)**
DP&L Transportation Center
Dryden Road, Dayton, Ohio

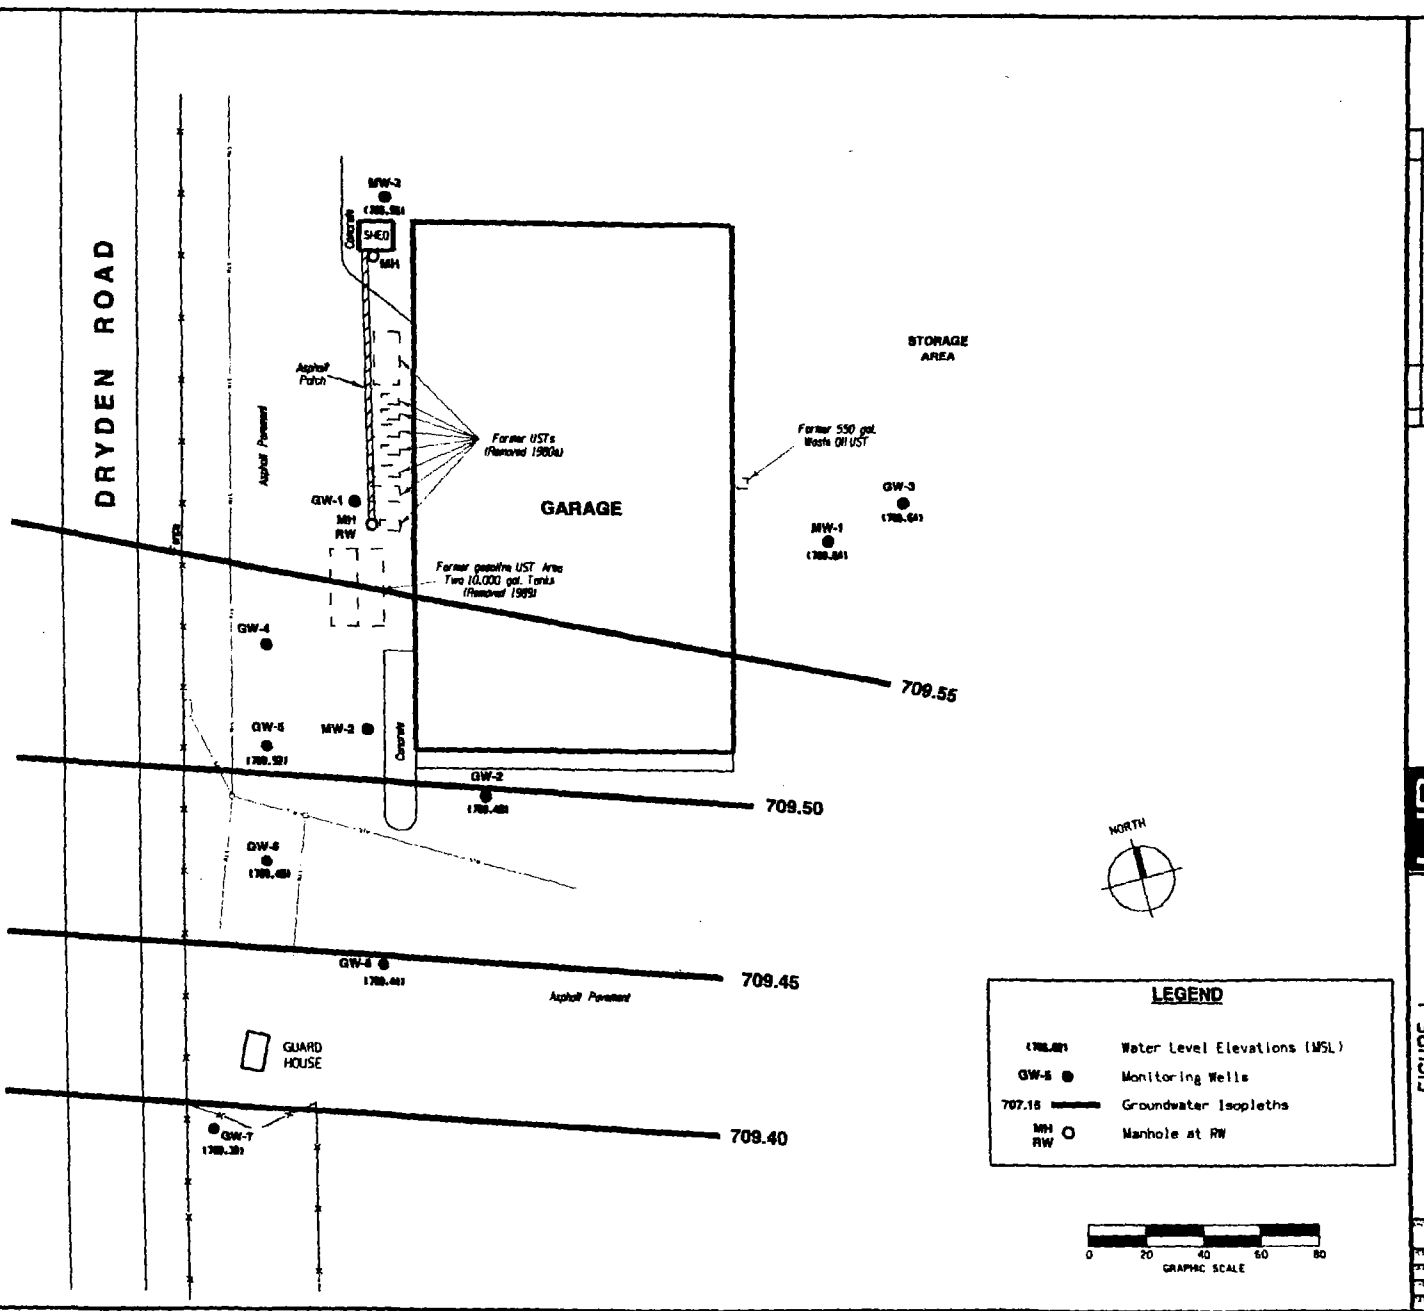
FIGURE 1
REPRESENTATIVE GROUNDWATER CONTOUR MAP (3/28/05)

Water levels and a summary table of the analytical data are included in Tables 1 through 5. The laboratory analytical data sheets are attached to this letter report. Water levels are also illustrated in Figure 1.

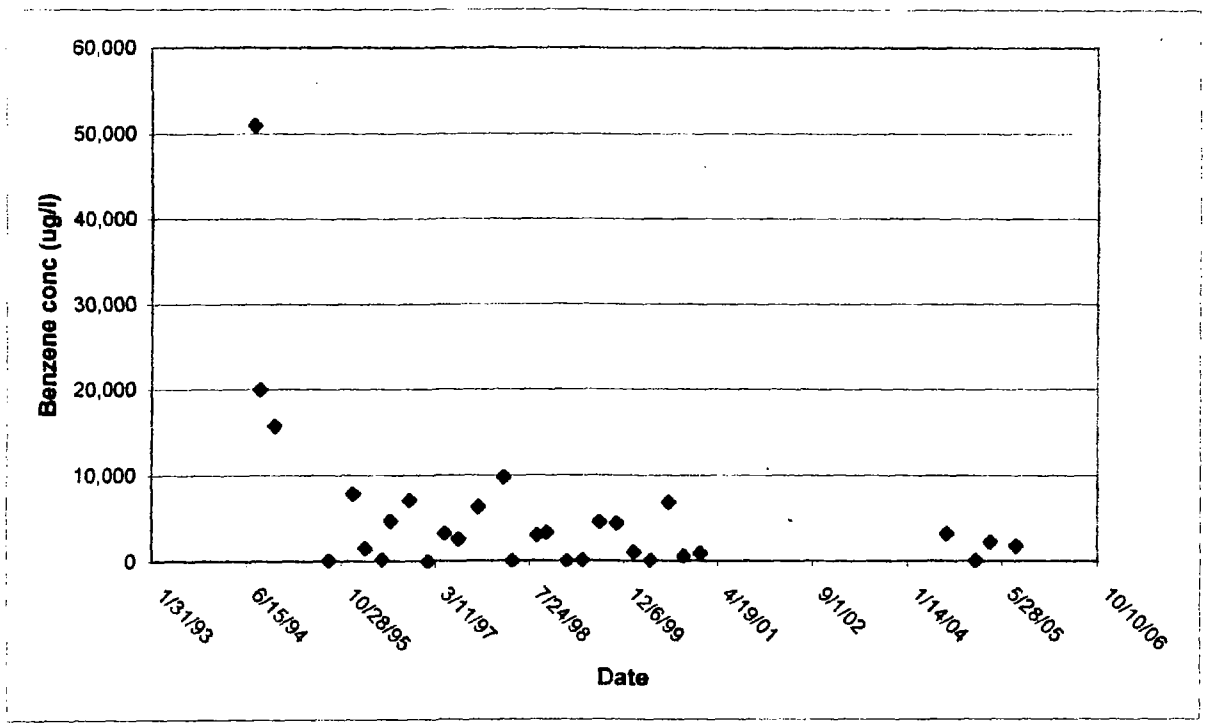
Figure 2. Cumulative Benzene Levels in the Four Treatment Wells; GW-5, GW-6, GW-7 & GW-8

Based on the 2004 and 2005 sampling/analysis events the remaining groundwater contaminant at the Site is benzene. Toluene and total xylenes have been reduced to below corrective action levels and ethylbenzene levels are slightly above the corrective action level (700 µg/l). Figure 2 illustrates the reduction in benzene levels through time. Based on this data, the levels of benzene are decreasing, but remain above the action level of 5 µg/l.

Data in Figure 2 represents the sum of the benzene levels in all four of the performance wells (see column 6 Table 2).
