VAPOR INTRUSION INVESTIGATION SUMMARY REPORT

SOUTH DAYTON DUMP AND LANDFILL SITE
MORAINE, OHIO

Prepared by:
Conestoga-Rovers & Associates

DECEMBER 2012
REF. NO. 038443 (17)

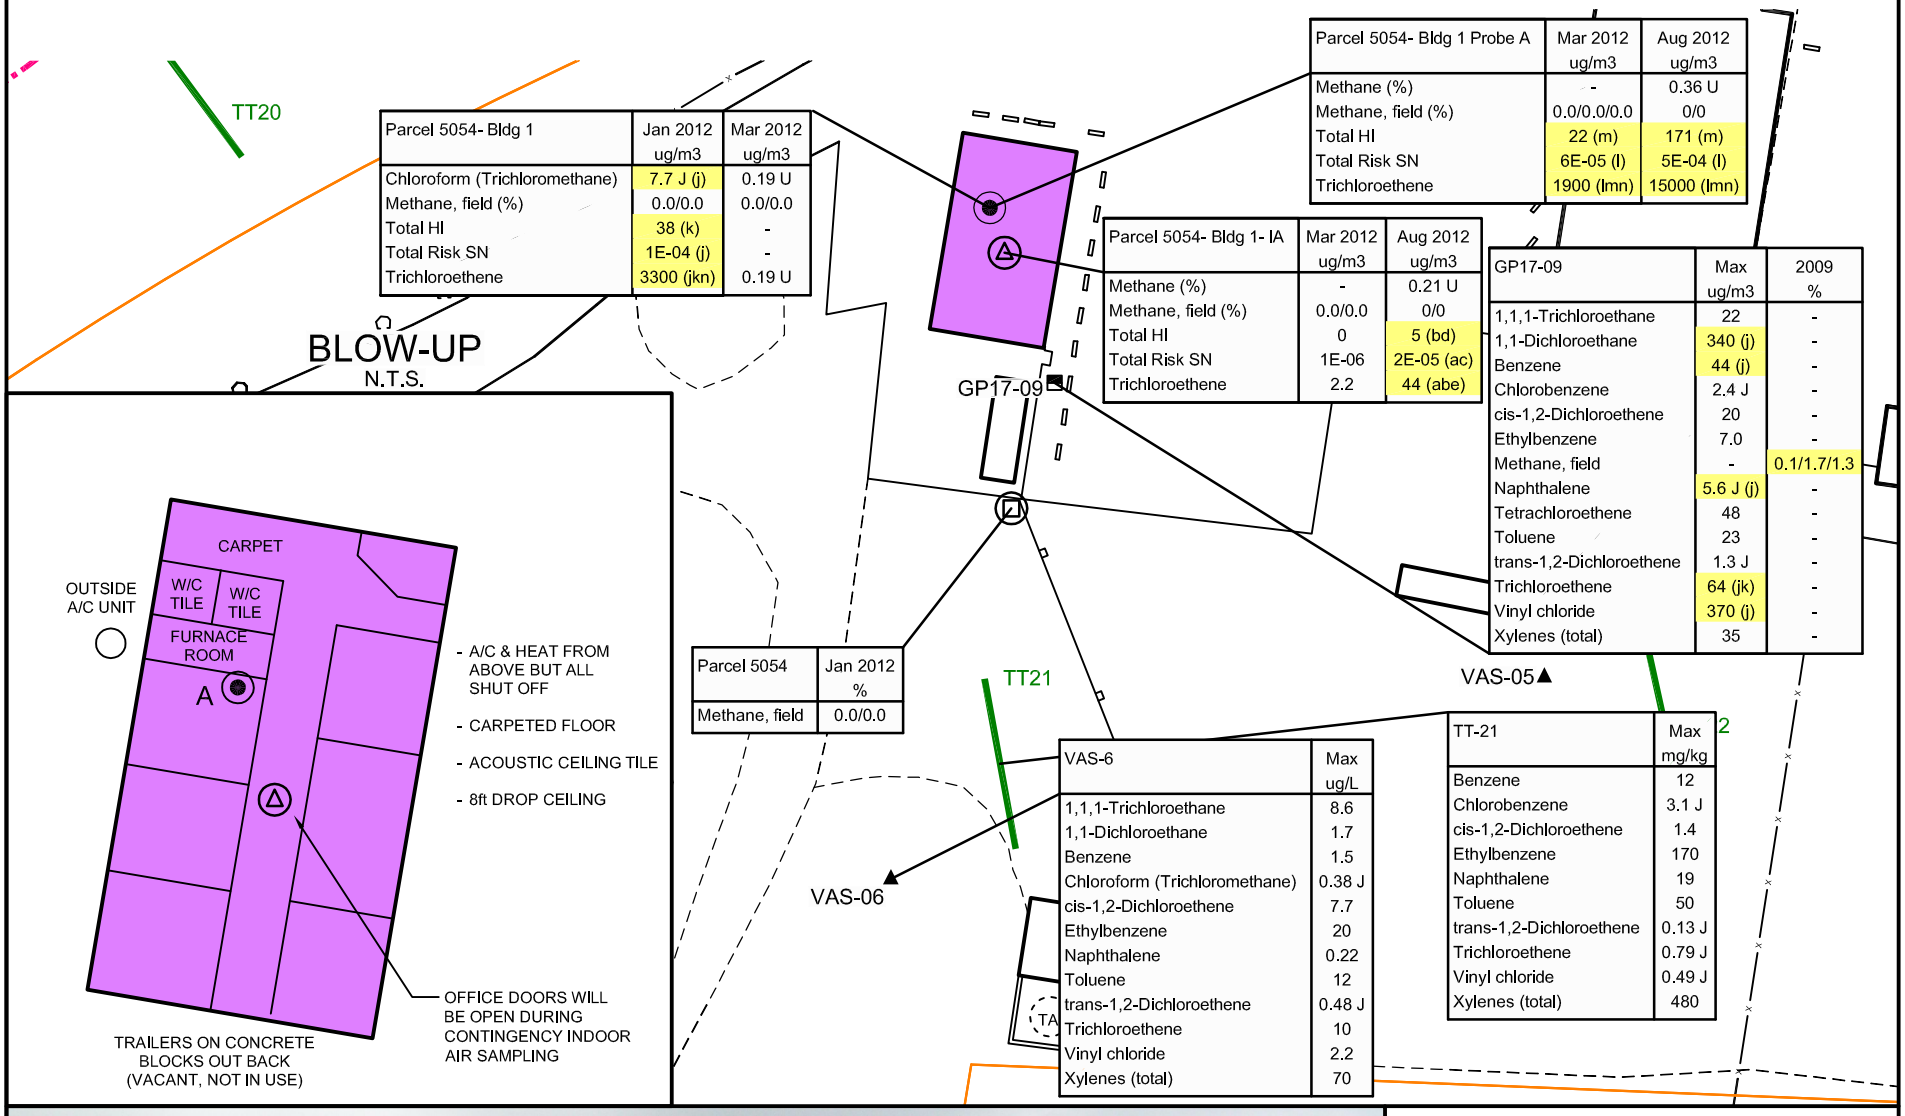
FIGURE 2.1 PARCEL 5054 – VALLEY ASPHALT PLANT BUILDING 1

Parcel 5054- Bldg 1	Jan 2012 ug/m3	Mar 2012 ug/m3
Chloroform (Trichloromethane)	7.7 J (j)	0.19 U
Methane, field (%)	0.0/0.0	0.0/0.0
Total HI	38 (k)	-
Total Risk SN	1E-04 (j)	-
Trichloroethene	3300 (jkn)	0.19 U

Building Characteristics:
Single-story commercial-use building, constructed prior to 1993. Footprint is 1,500 sq. ft. Primarily office space (6 single offices) with bathrooms and kitchenette. 8 ft. drop ceilings. Brick building with steel cladding, windows are inoperable. Concrete slab-on-grade, covered with wall-to-wall carpeting. Average air tightness, weather seals in fair condition. Heating provided by forced air natural gas furnace, central A/C from exterior ground unit. Exterior openings - vents, utility pipe penetrations, 2 personnel doors.
Building has been vacant for 4 to 5 years.

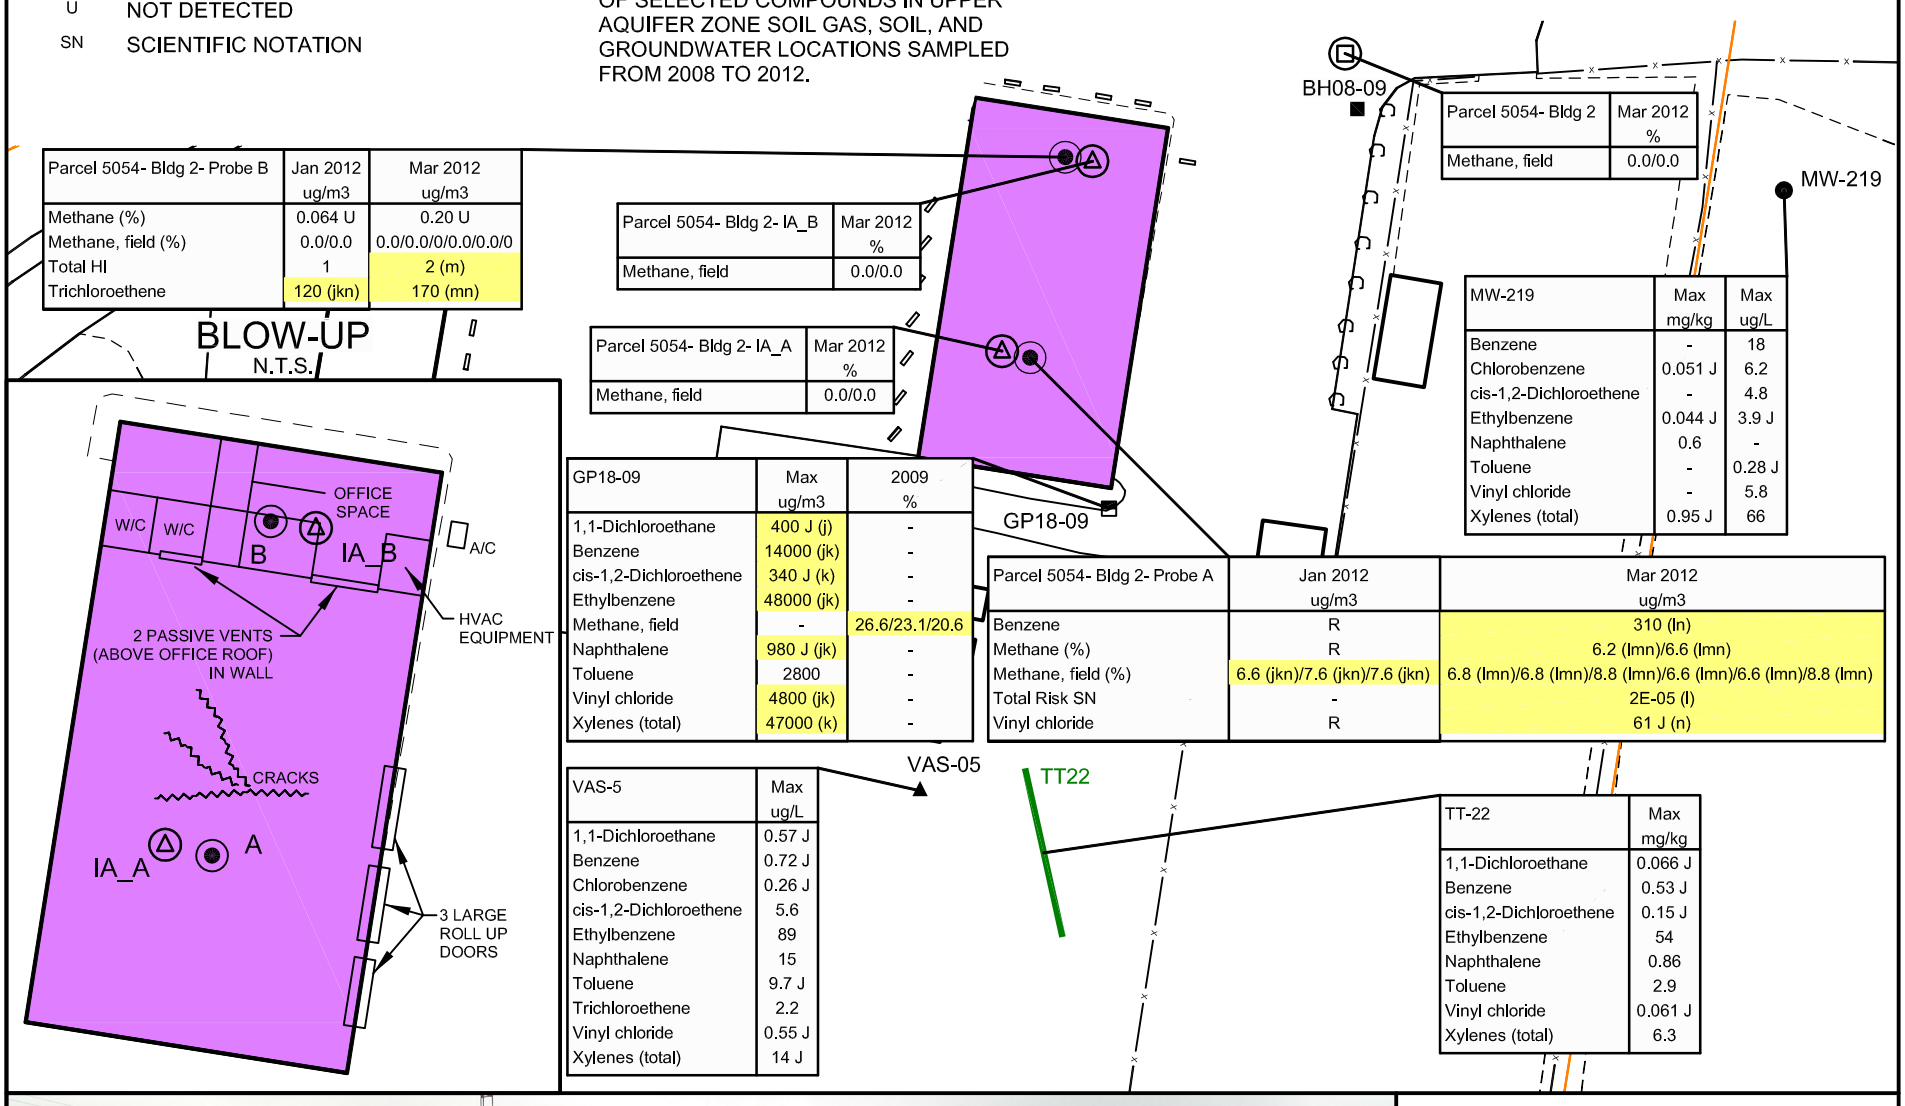
FIGURE 2.2 PARCEL 5054 – VALLEY ASPHALT PLANT BUILDING 2

Parcel 5054- Bldg 2- Probe B	Jan 2012 ug/m3	Mar 2012 ug/m3
Methane (%)	0.064 U	0.20 U
Methane, field (%)	0.0/0.0	0.0/0.0/0/0.0/0.0/0
Total HI	1	2 (m)
Trichloroethene	120 (jkn)	170 (mn)

Building Characteristics:
Single-story commercial/industrial-use building, constructed prior to 1959. Building divided into two sections with cracked cinder block wall between. Footprint is 4,888 sq. ft. Exterior openings - vents, fans, utility pipe penetrations, windows, bay doors, personnel doors. Building has been vacant for over 10 years.
Northern 1/4 of the building is brick, single story, office space, concrete slab-on-grade with wall-to-wall carpet (strong moldy/musty odor). Average air tightness. Heating provided by forced air natural gas furnace, central A/C from exterior ground unit.
Southern 3/4 of the building is steel, double-arch Quonset hut with bare concrete floor (visibly cracked in areas), used for storage. Not air tight, no weather seals present, broken windows. No HVAC.

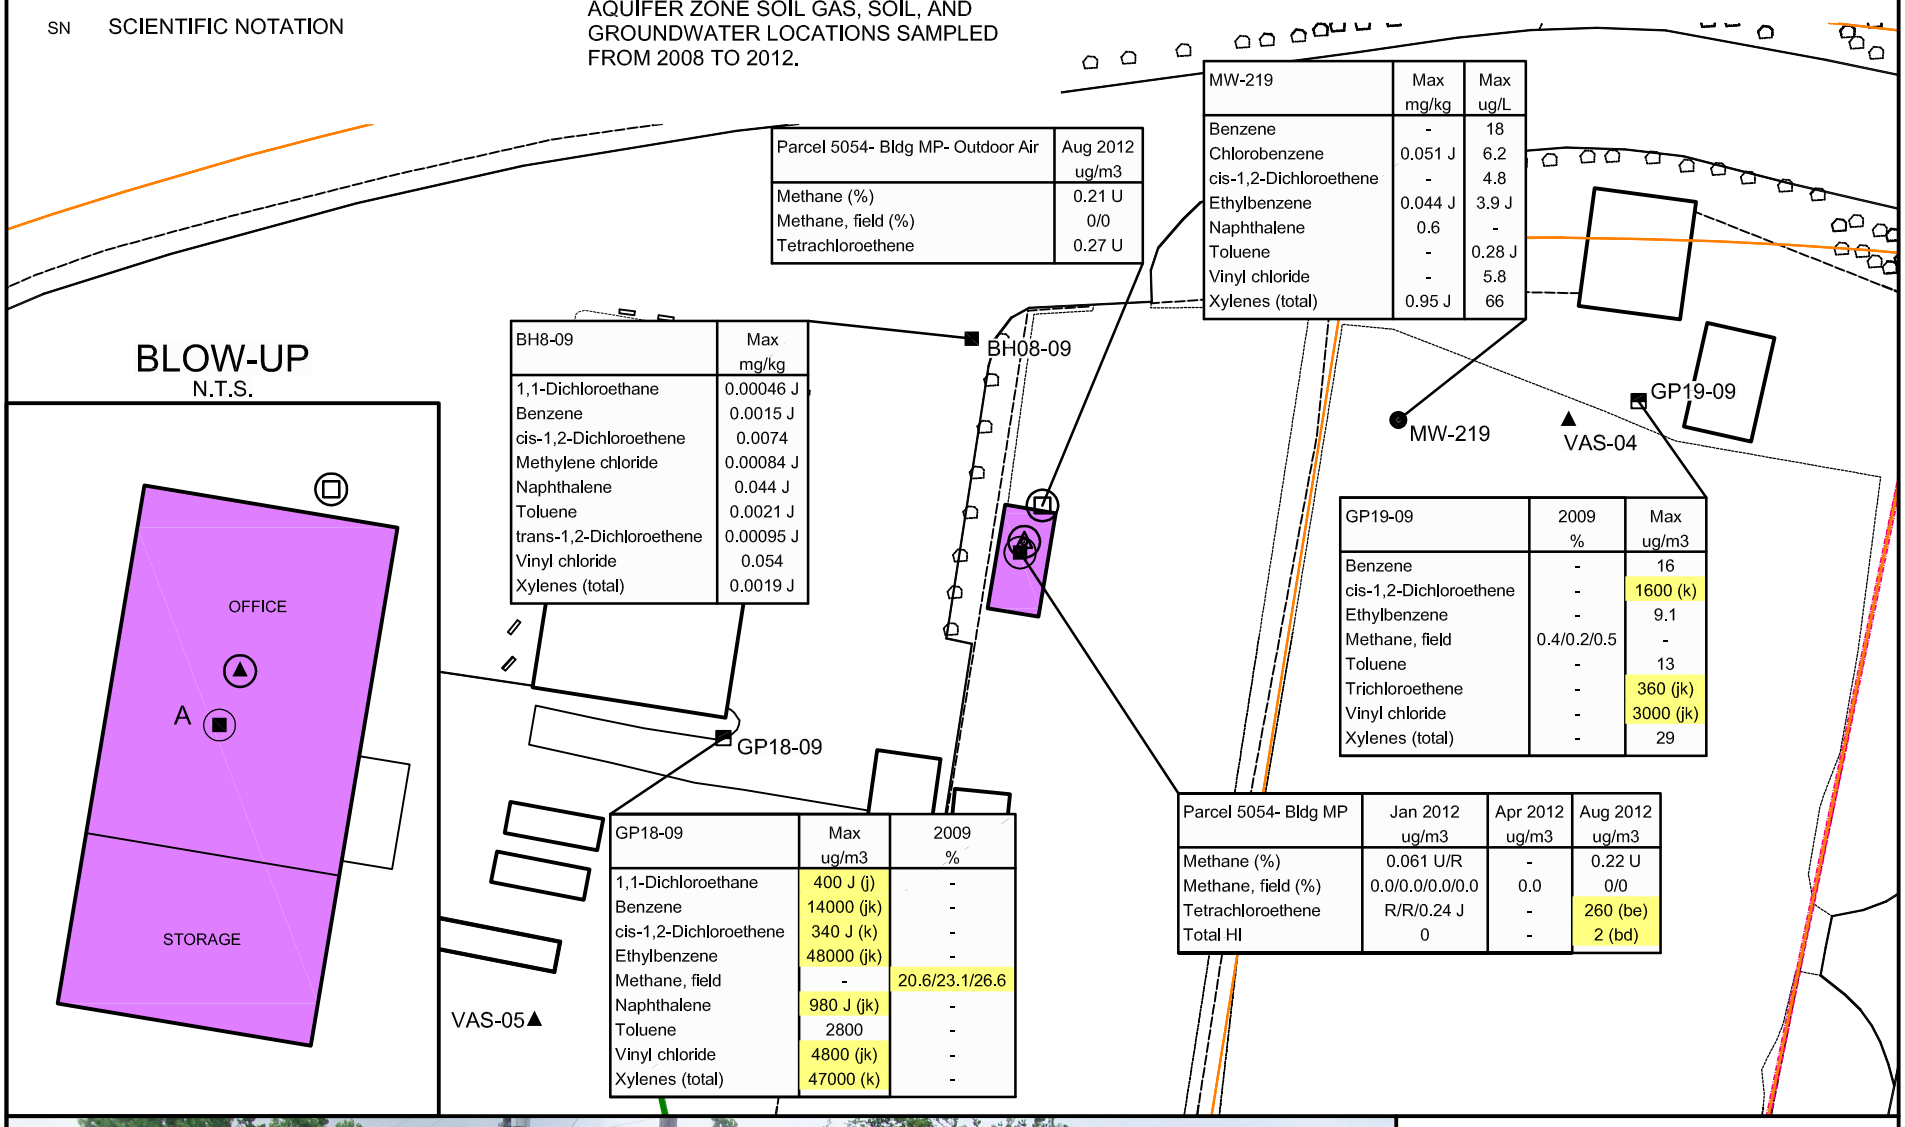
FIGURE 2.3 PARCEL 5054 – MURPHY'S PLUMBING BUILDING MP

Building Characteristics:
Single-story commercial-use building. 365 sq. ft building on raised foundation, with wood siding, constructed prior to 1950s. No weather seals present, not air tight. Exterior openings - windows, door. No HVAC systems present.
Occupancy - vacant since July 1, 2011.

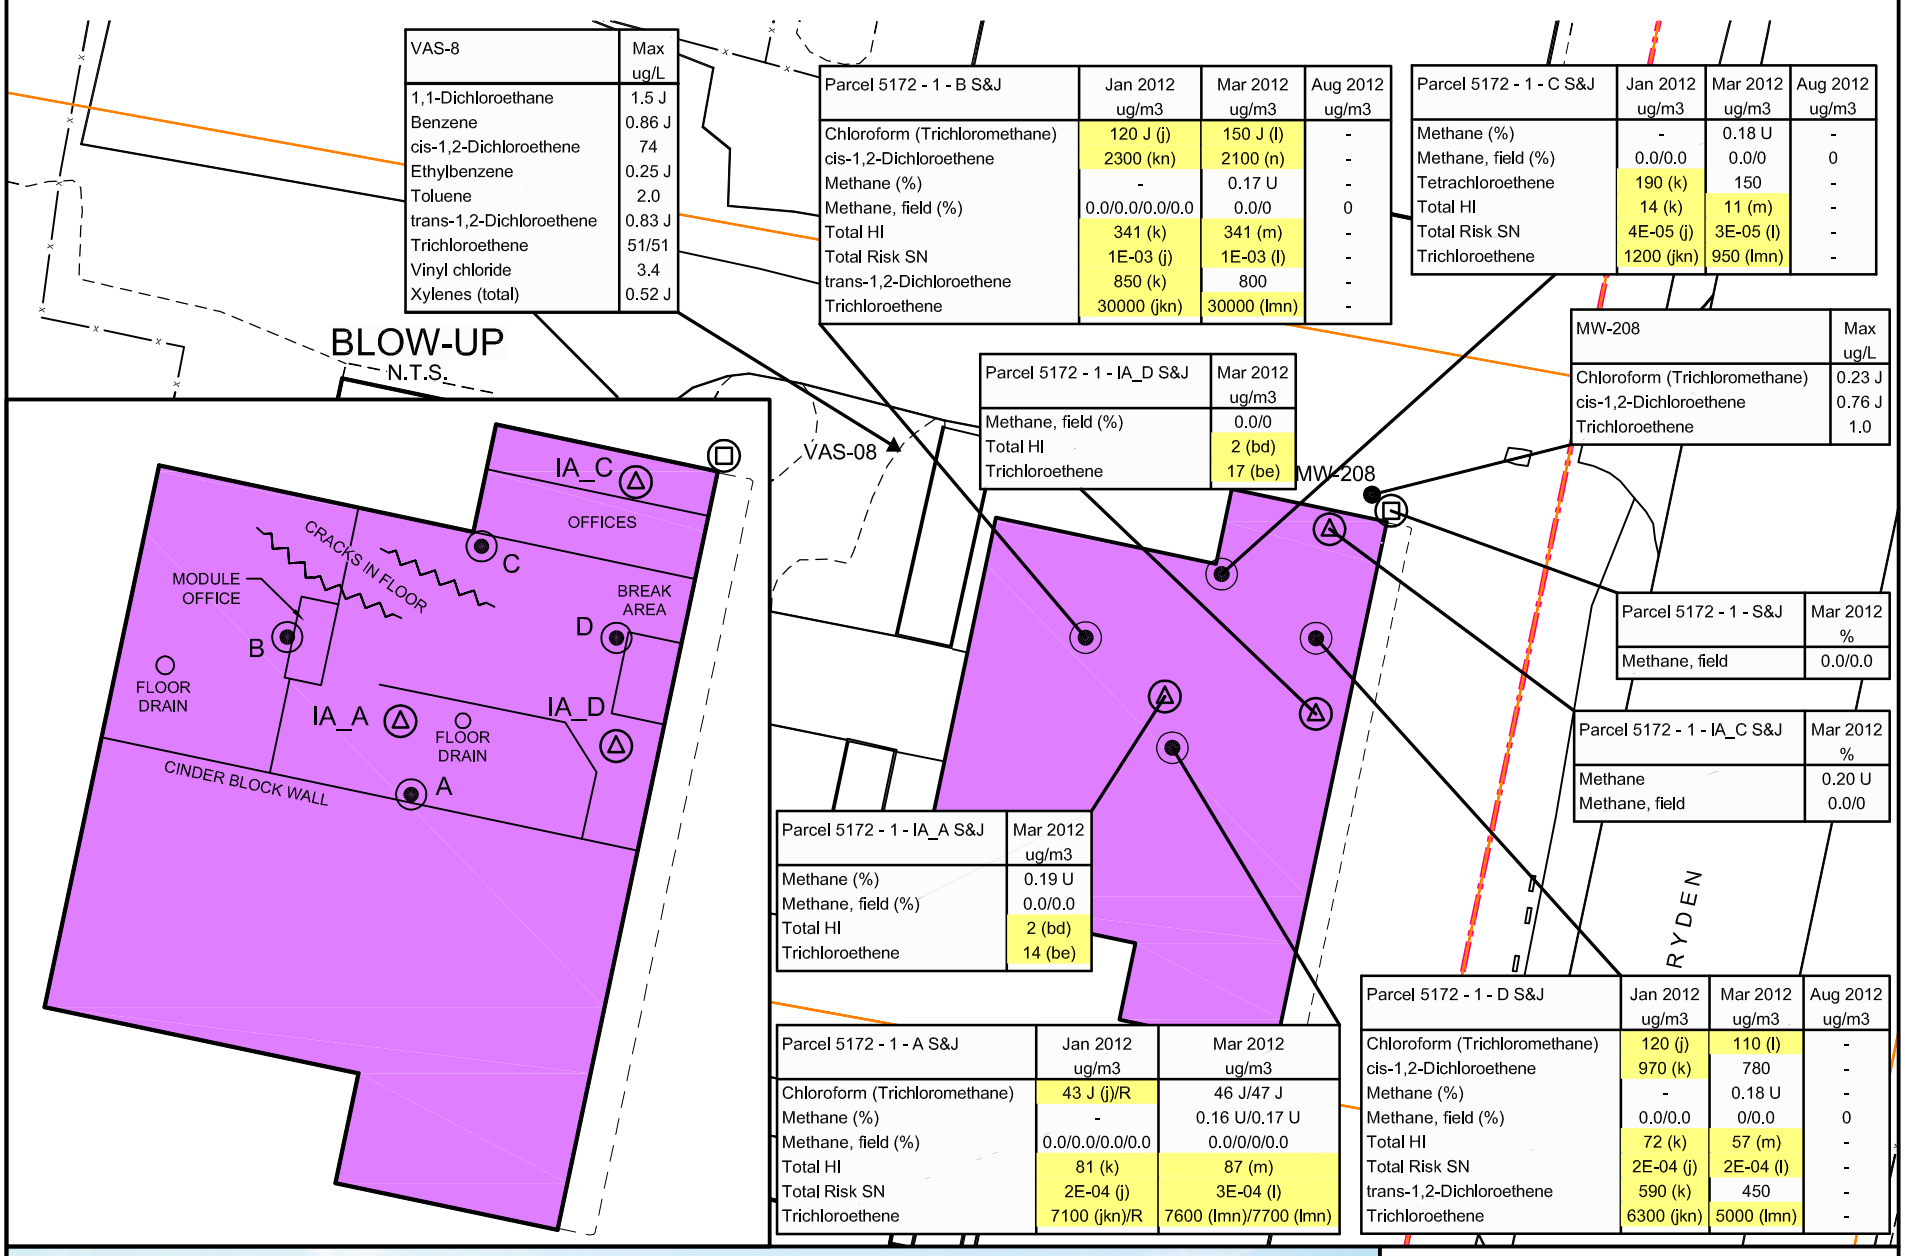
FIGURE 2.11 PARCEL 5172 – S&J PRECISION BUILDING 1

TCE concentrations in SS samples collected from sub-slab probes in 2015 and 2019 Dryden Road, Parcel 5172 Building 1 (S&J Precision and Overstreet Painting), and 1951 Dryden Road, Parcel 5171 Building 2 (B&G Trucking) were greater than 1,000 times the applicable screening level, indicating a more rapid response may be required. As previously discussed in Section 2.1, USEPA agreed to delay submission of mitigation plans for the S&J Precision and Overstreet Painting building until after the completion of the Round 1 follow-up VI sample event. During the June 2011 building survey, CRA observed a can of PCE in 2015 Dryden Road (S&J Precision). During the December 2011 SS probe installations at S&J Precision, CH2M Hill took photographs of the chemicals stored on top of cabinets, due to the potential for contributions to indoor air quality.

Building Characteristics:
Single story, industrial-use building, constructed in the 1950s. Divided into two equal sections, north and south sides. Total footprint is 11,600 sq. ft. Approximately 16 ft. high. Slab-on-grade, concrete block building with brick front. Exterior openings - windows, utility pipe penetrations, bay doors, personnel doors.
North side is the S&J Precision building. Majority of space is a metal working shop and warehouse with some office space. Bare concrete floor in shop and warehouse with cracks and 2 floor drains, staining on warehouse floor and near drain. North office space has elevated floor with floor tile (possibly asbestos) and wall-to-wall carpet on top. Heating provided by forced air natural gas furnace, central A/C. Not insulated, average air tightness, weather seals in fair condition. Occupied weekdays from 6 AM to 5 PM by 5 adult workers.
South side is the Overstreet Painting building. See figure 28.

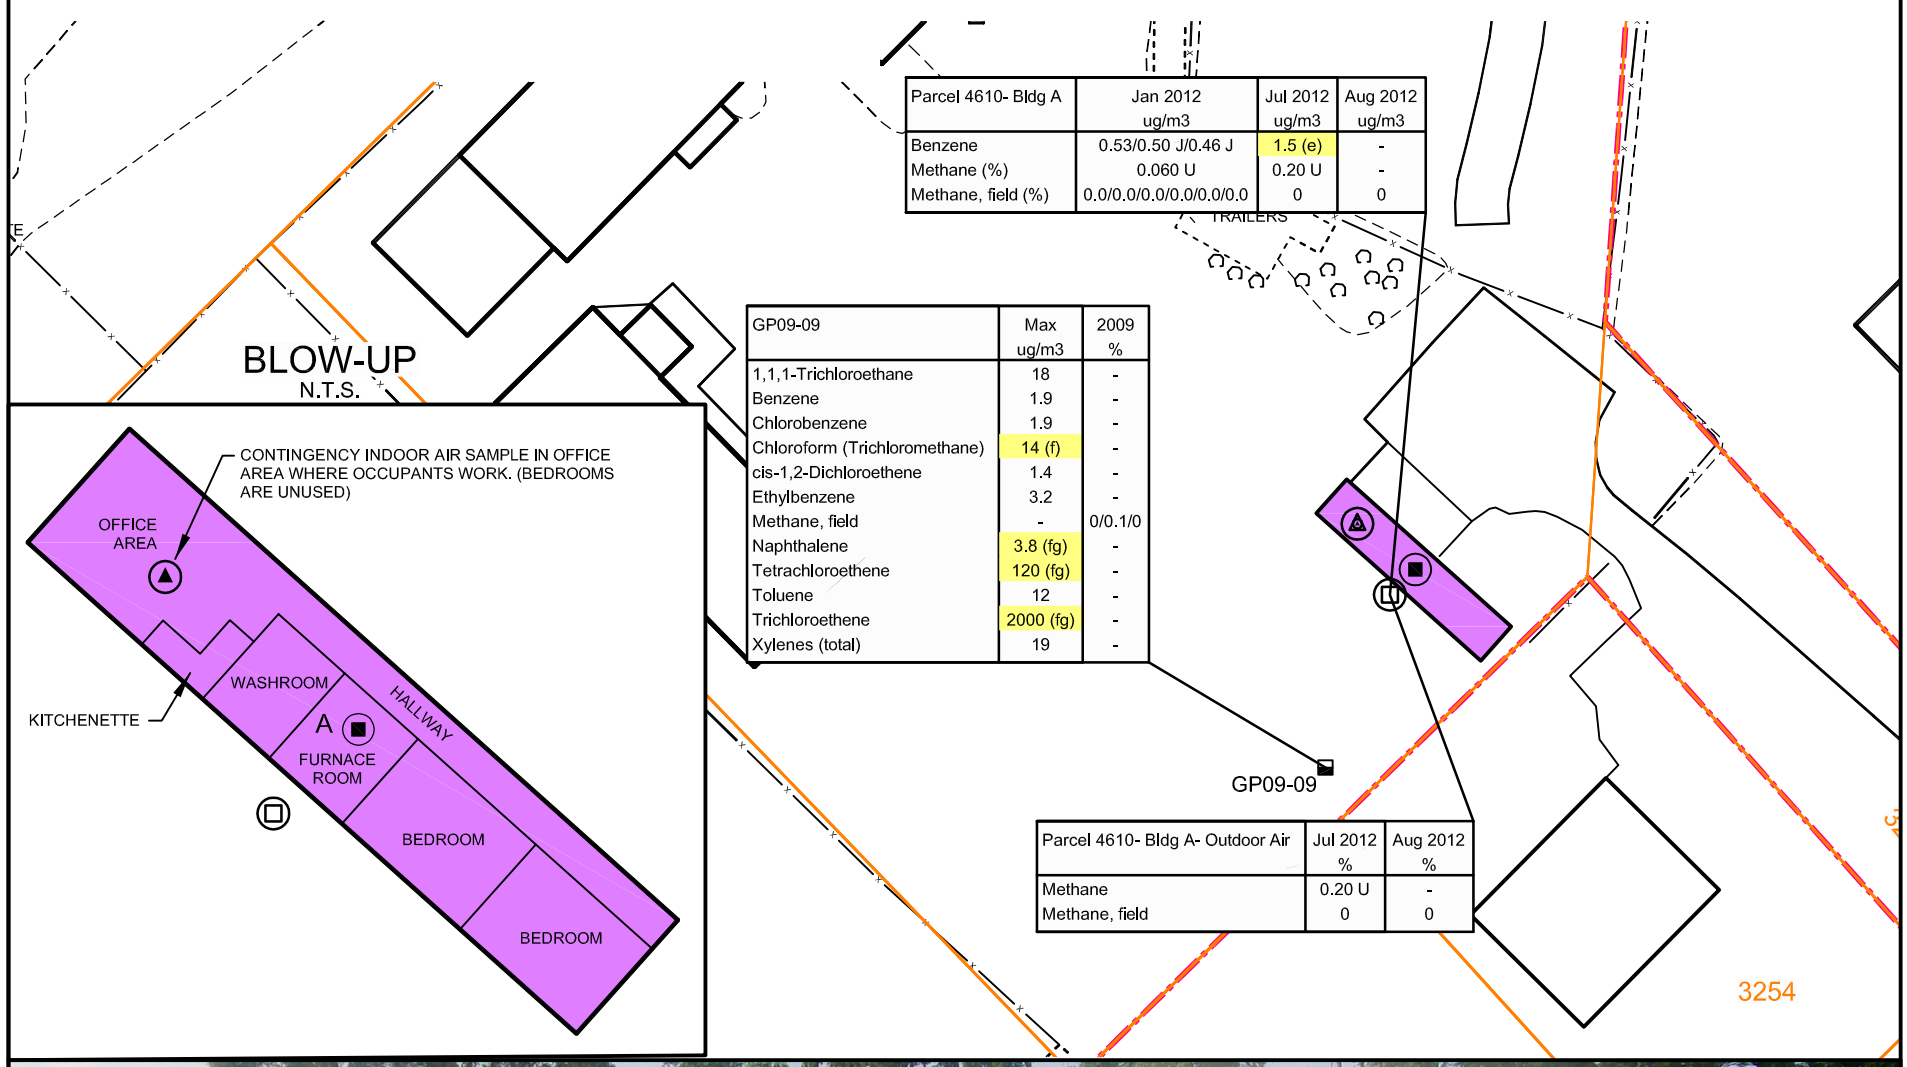
figure 2.18

Building Characteristics:
Single-story, residential trailer, constructed early 1990s. 685 sq. ft. trailer with crawl space enclosed by wood skirting in poor condition, over a concrete pad. Concrete and wood appear damp. Insulated trailer with average air tightness, weather seals in fair condition. Heating provided by forced air propane furnace. Central A/C present. Exterior openings - vents, utility pipe penetrations, windows, doors.

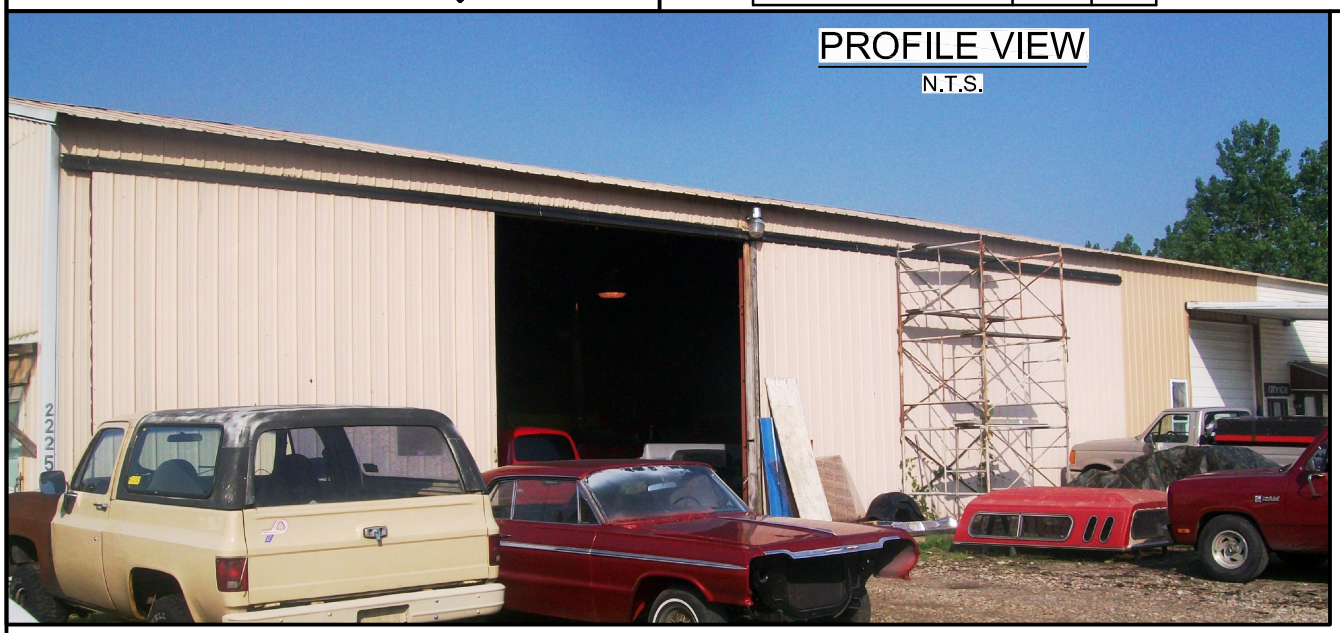
figure 2.22

Building Characteristics:
Single-story commercial-use car repair building with office and storage areas, construction completed by early 1990s. 1,200 sq. ft. unsealed, four-inch concrete slab-on-grade, approximately 20 ft. high building, with steel cladding. Significant floor cracks in office and adjacent storage area. Not air tight, weather seals in office are in fair condition, no weather seals in storage area. Electric baseboard heating and window A/C present in office. Wood stove present, vents through roof. Exterior openings - utility pipe penetrations, windows, sliding bay and overhead garage doors.
No regularly scheduled occupancy - occasional evening and weekend occupancy by two adults. Office may be occupied during normal working hours by one adult.

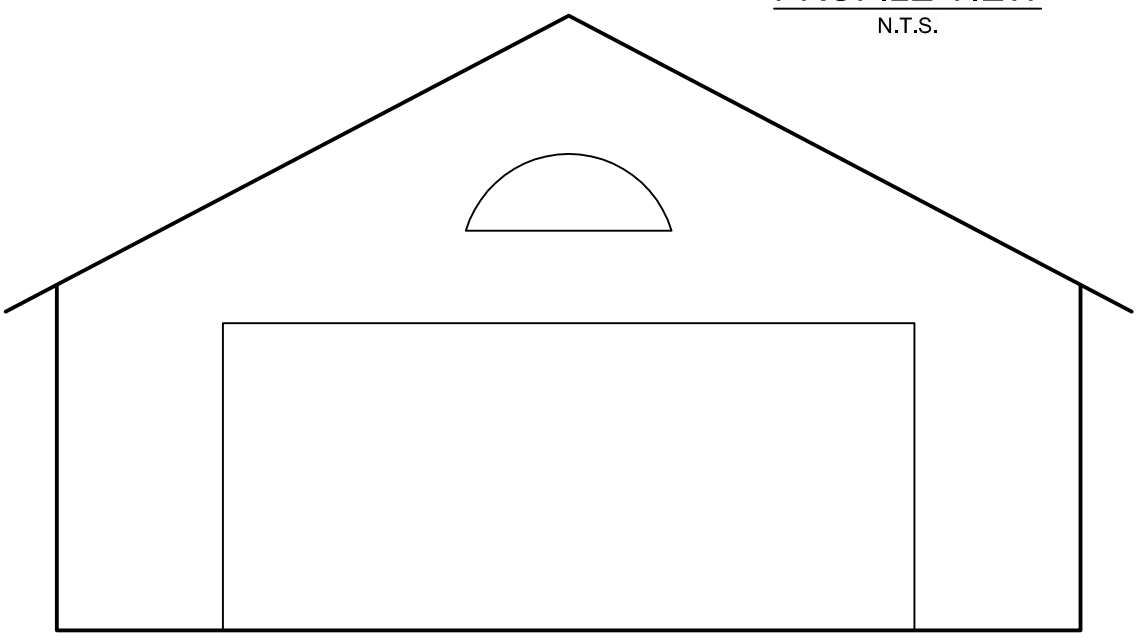
figure 2.27

Building Characteristics:
Single-story, 2-car garage constructed early 1990s. 1,128 sq. ft. slab-on-grade, vinyl-sided, building with poured concrete floor composed of six separate poured sections with unsealed joints. Unsealed, poured concrete four inch-high foundation walls in good condition. Average air tightness; weather seals in good condition. No HVAC systems present. Exterior openings - 2 windows, overhead and personnel doors. Grass and concrete exterior ground cover.
No regular occupancy - storage only
