Western Mineral Products Industrial Site, Minneapolis MN

Attachment D

Table 1- Air Data Summary
Western Mineral Industrial Site

Attachment E

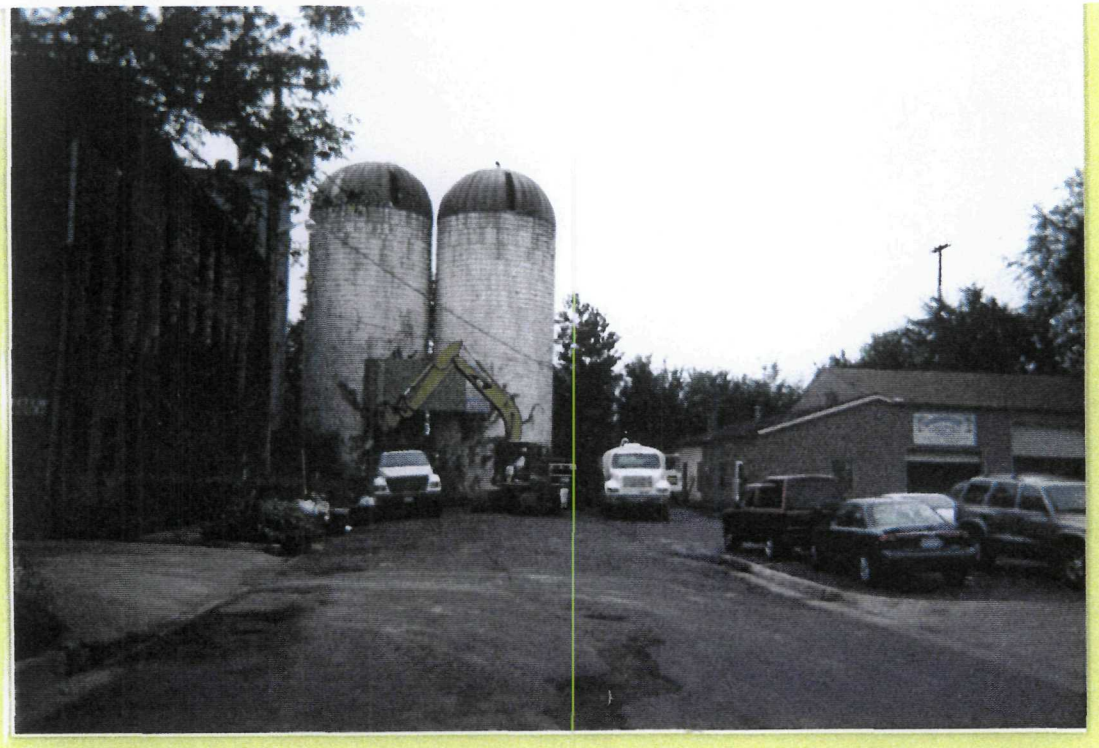
Site: Western Mineral Industrial Site **Date:** 9/18/2001 **Time:** 1100 **Photo ID:** WMI-02
TDD: 0108-009 **Direction:** East **Photographer:** B. Maradkel
Subject: View of ERRS excavating on north property.

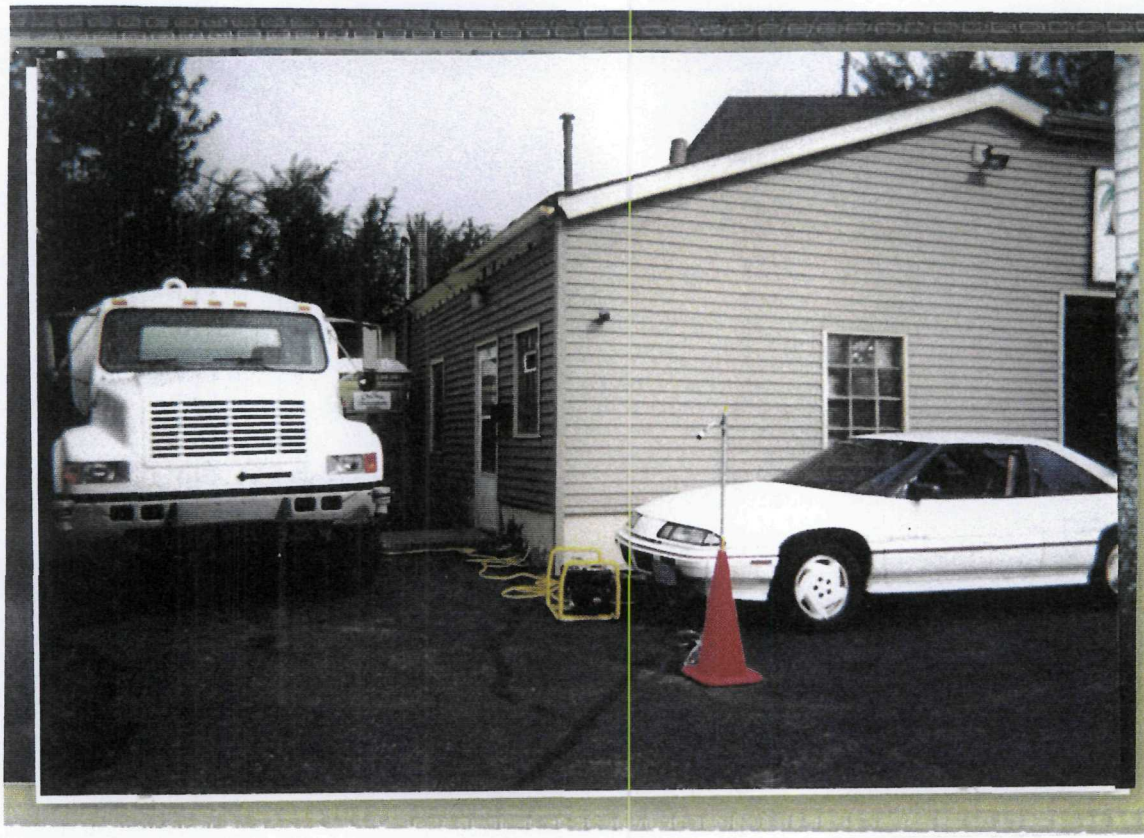
Site: Western Mineral Industrial Site **Date:** 9/19/2001 **Time:** 1135 **Photo ID:** WMI-10
TDD: 0108-009 **Direction:** NE **Photographer:** B. Maradkel
Subject: View of sample AT-091901-Madison-A.

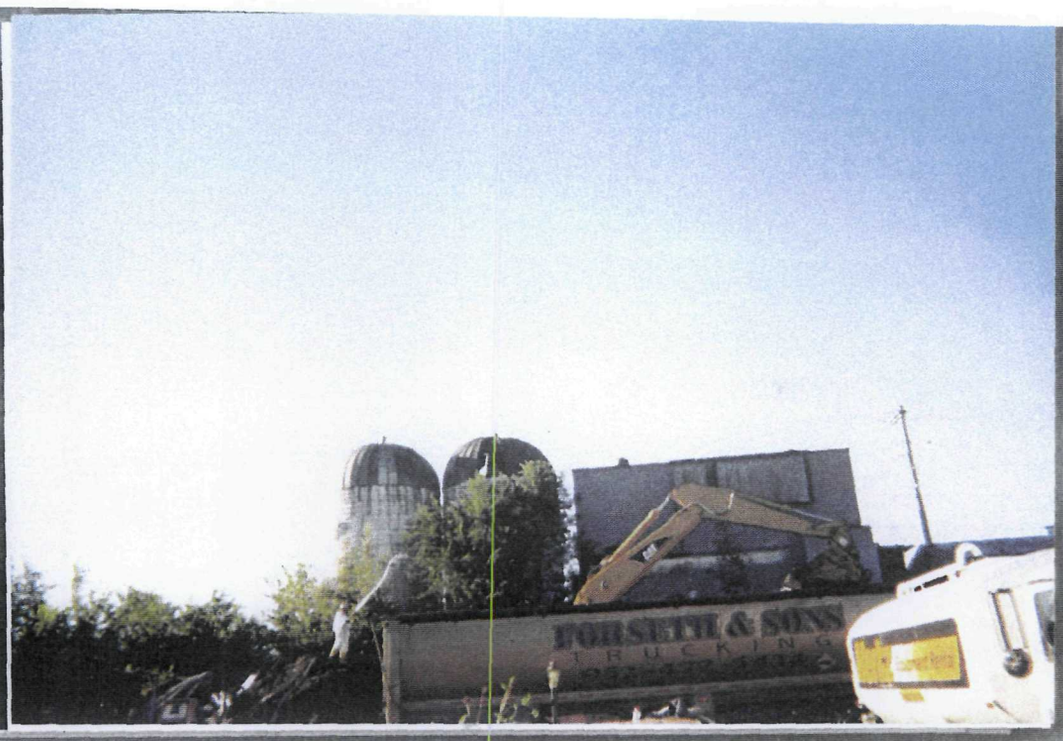
Site: Western Mineral Industrial Site **Date:** 9/24/2001 **Time:** 0845 **Photo ID:** WMI-26
TDD: 0108-009 **Direction:** East **Photographer:** B. Maradkel
Subject: View of ERRS loading truck

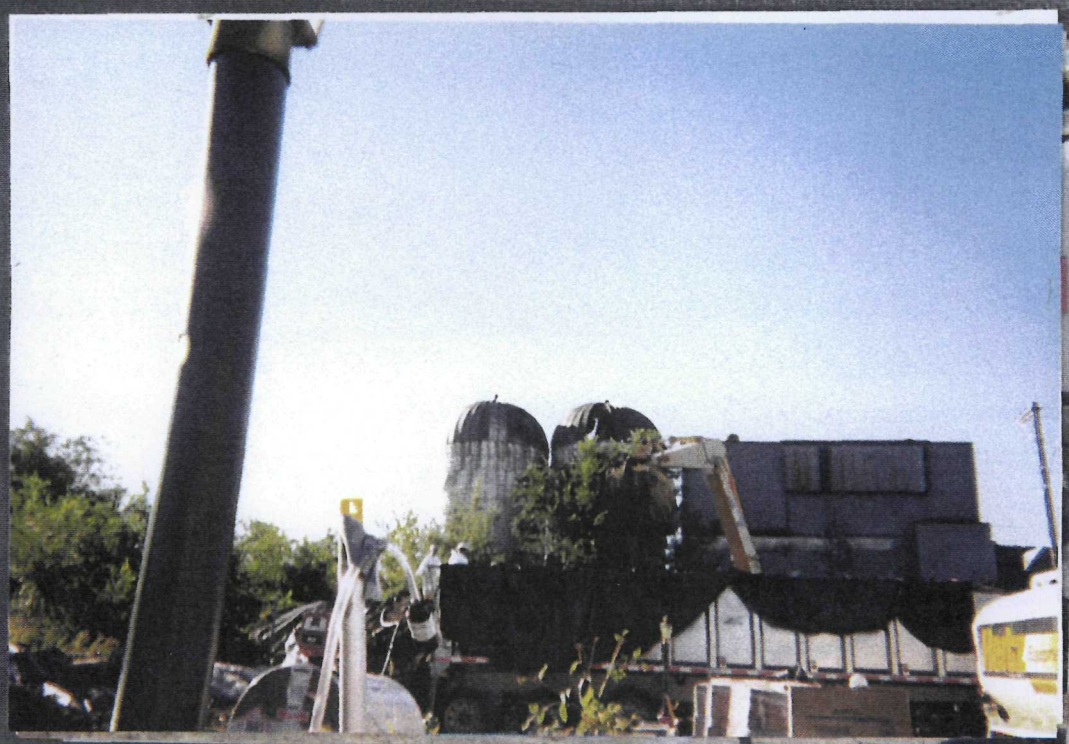
Site: Western Mineral Industrial Site **Date:** 9/24/2001 **Time:** 0930 **Photo ID:** WMI-29
TDD: 0108-009 **Direction:** East **Photographer:** B. Maradkel
Subject: View of Sample AT-092401-NW-B

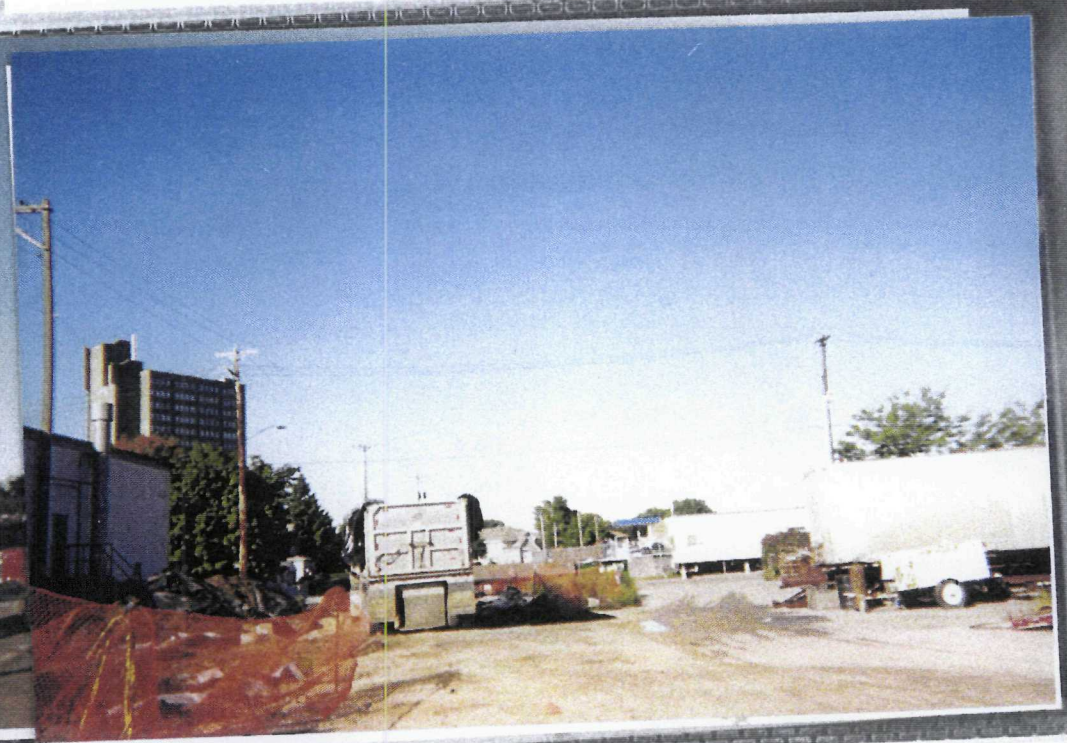
Sit **Site:** Western Mineral Industrial Site **Date:** 9/24/2001 **Time:** 0940 **Photo ID:** WMI-31
TD **TDD:** 0108-009 **Direction:** South **Photographer:** B. Maradkel
Su **Subject:** View of ERRS working North of Silos
