NEW MEXICO
ENVIRONMENT DEPARTMENT

Memorandum

Subject: **Pre-CERCLIS Screening Assessment of the Section 19 Mine, New Mexico: No Further Action Under CERLCA Recommended**

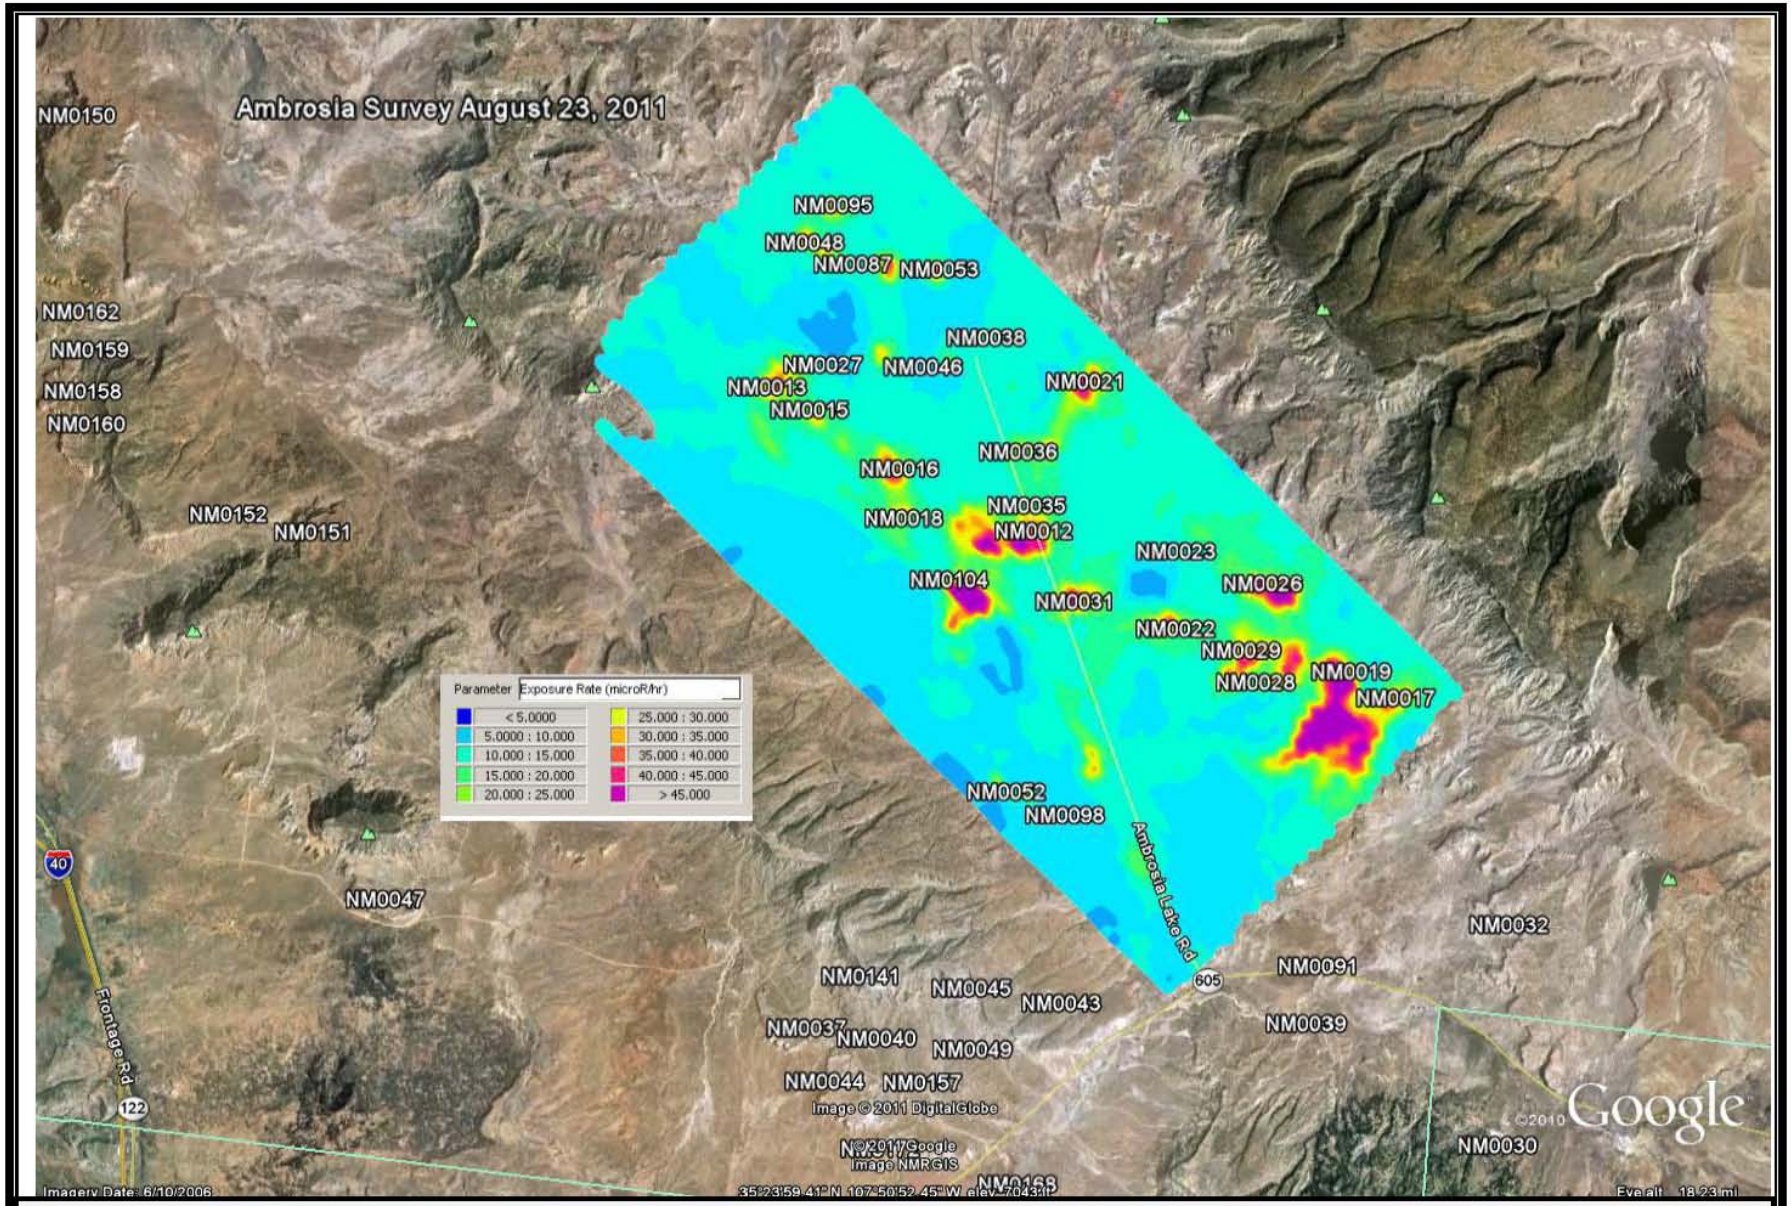
Figure 2. U.S. EPA ASPECT Exposure Rate Contour Map of Ambrosia Lake Mining District.

Airborne Spectral Photometric Environmental Collection Technology (ASPECT) operated by EPA has developed exposure rate contour map of the Ambrosia Lake Mining Sub-District that includes the Section 19 (NM0036) mine (Figure 2). The EPA ASPECT exposure rate

measurements were performed in part to evaluate if surface reclamation has been effective in the long-term elimination of such threats to human health and the environment. The map estimates radiation exposure rates on the ground and can be used to identify hazardous levels of radiation. Typical exposure rates in New Mexico range from 5 – 20 micro Roentgens per hour (µR/hr.). The ground surface exposure rates in and around the Section 19 mine are over one thousand times higher than the typical range, that is, ground surface radiological hazards were identified at most Ambrosia Lake uranium mine sites including the Section 19 mine (Ref. 6).
