2017 ASPECT Preliminary Report
Arkema Plant Response
Crosby, TX

August 31, 2017
0600 hrs to 1900 hrs

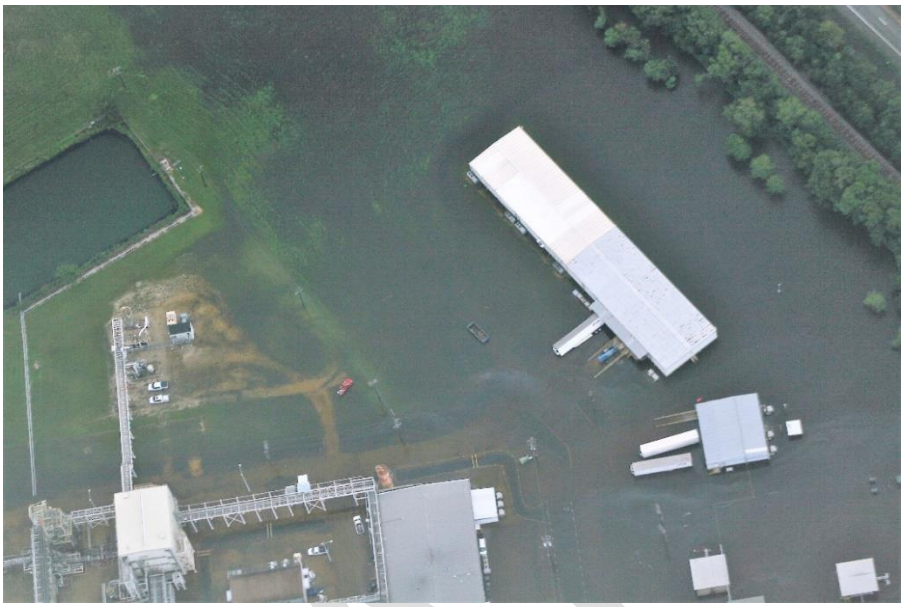
High-resolution oblique photos provide an alternative view of the area. Figures 3 - 4 show visual conditions when the aircraft arrived on site. Cloudy weather combined with low light conditions are reflected in these images.

Figure 3: Oblique photo prior to explosion/fire on 30 August 2017.

Figure 4: Oblique photo after explosion/fire on 31 August 2017

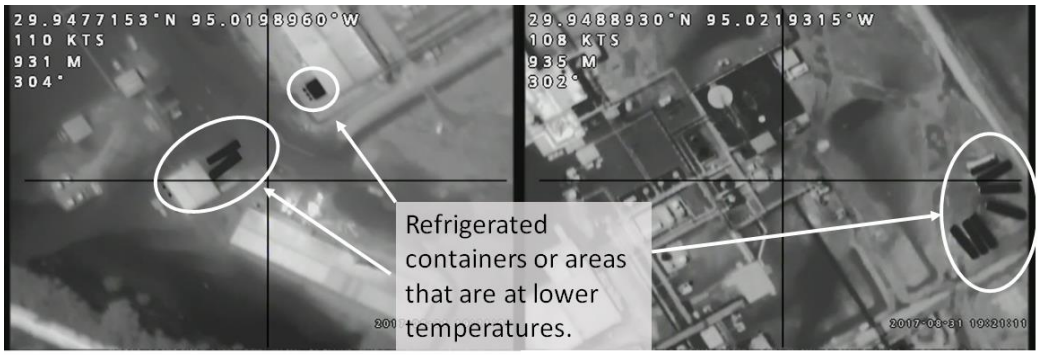
Figure 12 provides snap shots taken from an infrared video collected during the afternoon flight. Dark areas indicate lower temperatures. Eight tanks are identified in these images.

Figure 12: Infrared images obtained from an infrared video (1320 hrs CST) clearly showing heat signatures which identifies which containers are cooled (black colors) at the Arkema facility. Note the northernmost tank in the image to the right. It is painted blue which may affect its heat signature. These photos show eight tanks that are being refrigerated.
